# Guideline

October 2020

Welcome to this update on technical and informative advice for the building and construction industry on issues relating to building controls and good construction practices.

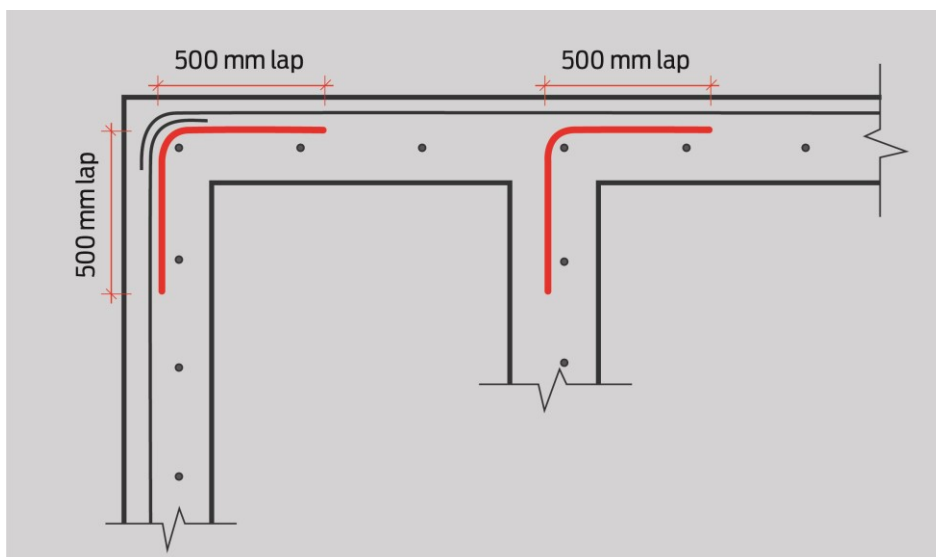
At corners, the laps must also be at least 500 mm in each direction (Figure 1). The lapping requirements are found in NZS 3604:2011 *Timber-framed buildings* clause 6.11.7.1 and Figure 6.15(a).

Figure 1. Reinforcing laps at corners.

Horizontal reinforcing steel generally consists of 12 mm diameter deformed (D12) bars and R10 for vertical starter bars. Where horizontal reinforcing bars must be lapped – for example, where they change direction – the overlaps must be a minimum of 500 mm.

Lapped reinforcing is tied together with 1.6 mm black annealed steel tie wire at each end of the lap and at regular spacings in between, sufficient to hold it in place.

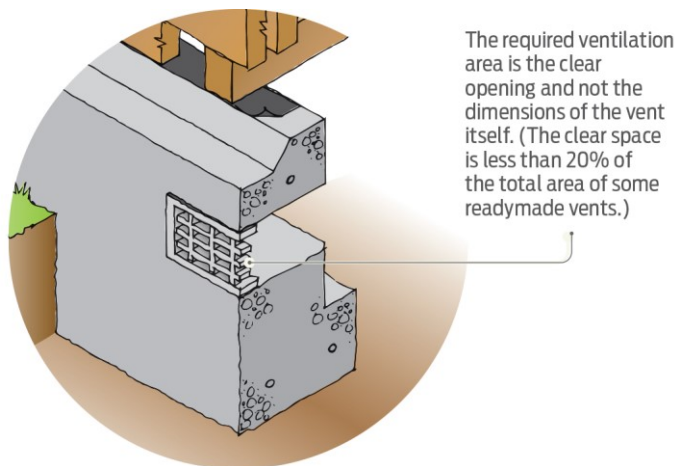
With suspended timber floors, NZS 3604:2011 requires subfloor vent openings at least 3,500 mm<sup>2</sup> per m<sup>2</sup> of floor area. The mistake is to treat this figure as vent dimensions – of course, the requirement actually applies to clear opening space and not vent dimensions (Figure 2). Rodent protection or decorative work on some vents means that the actual open space vents can be less than one quarter of the vent dimensions. If you are buying new vents, ask the supplier about the open space measurement as well as overall dimensions.

Figure 2. For subfloor ventilation, the area required for vent openings in NZS 3604:2011 is not the dimension of the vents themselves
