## Airtightness in apartments in New Zealand

The airtightness of low-rise, stand-alone dwellings in New Zealand is fairly well understood. However, before this research little was known about apartments, which represent a significant and growing percentage of new building consents. BRANZ measured nine apartment buildings as an indication of the airtightness provided by the wider stock of apartments. In general, apartments had levels similar to typical new-build houses, approximately five air changes per hour at 50 pascals on average, with a strong dependence on construction style. Inter-apartment leakage was also investigated.

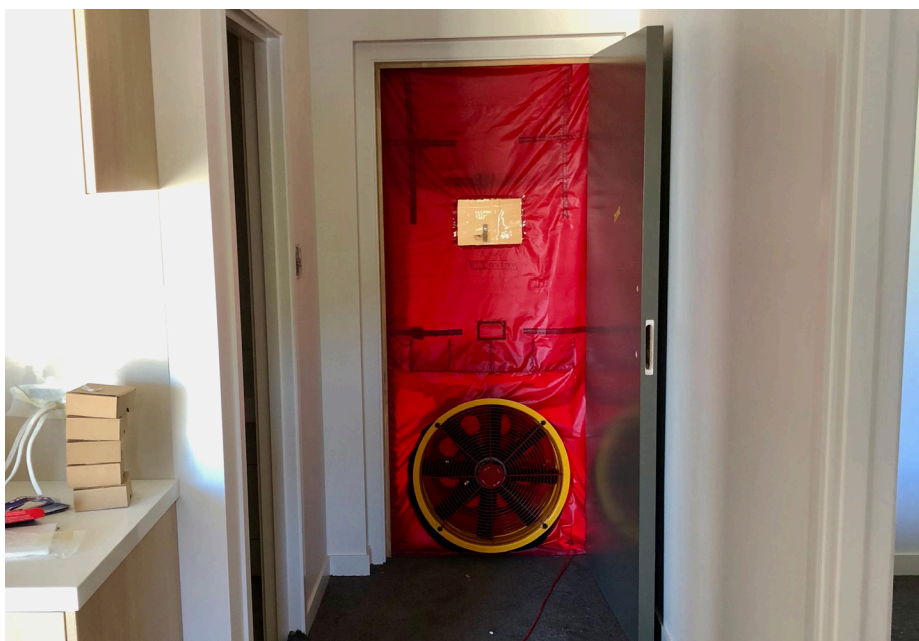
The blower door (Retrotec Blower Door, 5000 and 6000 series) was mounted in the entrance doorway of each apartment. Measurements were collected over a range of pressure differences and the overall result

Blower door fan mounted in entrance doorway.
