Insulation, ventilation, space heating and water heating

For the Pilot Housing Survey, trained assessors visited 832 houses, recording information on physical characteristics such as insulation, space heating and water heating, the presence of mould and general condition. The findings point to specific areas where New Zealand's housing stock can be targeted for improvement.

This Research Now covers the survey's findings around thermal insulation, ventilation, space heating and water heating and the presence of smoke alarms. For findings around house condition, see BRANZ Research Now: *Pilot Housing Survey #2 House condition*. For more about the survey design, see BRANZ Research Now: *Pilot Housing Survey #1 Survey methodology*.

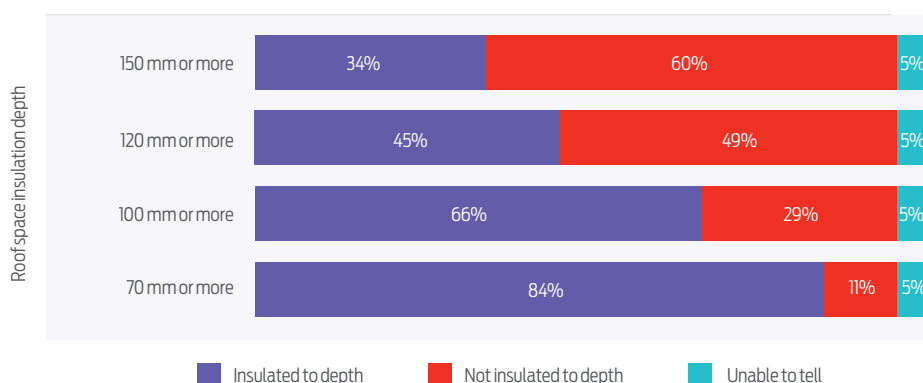
Figure 1 Depth of roof space insulation in surveyed houses

The results suggest 45% of houses with a roof cavity had at least 120 mm insulation (Figure 1), while 49% had less than 120 mm. (EECA recommends bulk roof space insulation of at least 120 mm thick, and this figure is one measure in the healthy homes standards for rental housing.) There was no significant difference between owned and rental stock. Of the houses with less than 70 mm insulation and an accessible roof cavity, only around 1% had no insulation at all.

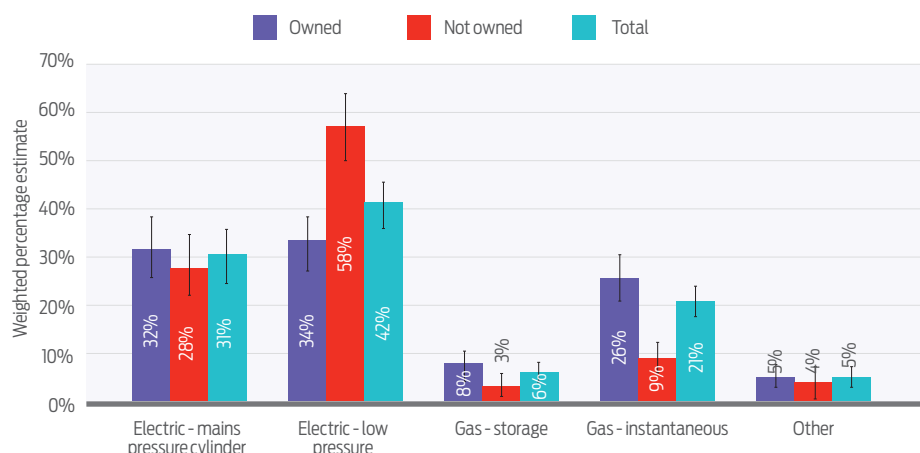
Figure 6 Water heating types in all houses

The survey finds a difference in hot water system types in owned and rented dwellings. In the latter, low-pressure electric cylinders were the most common type of water heating, found in 58% of rentals (Figure 6). In owner-occupied dwellings, low-pressure and mains-pressure cylinders were seen in similar proportions (34% and 32%).
