Comparative study of corrosion rates in vented and unvented roof cavities

Stephan Rupp

BRANZ Study Report SR462

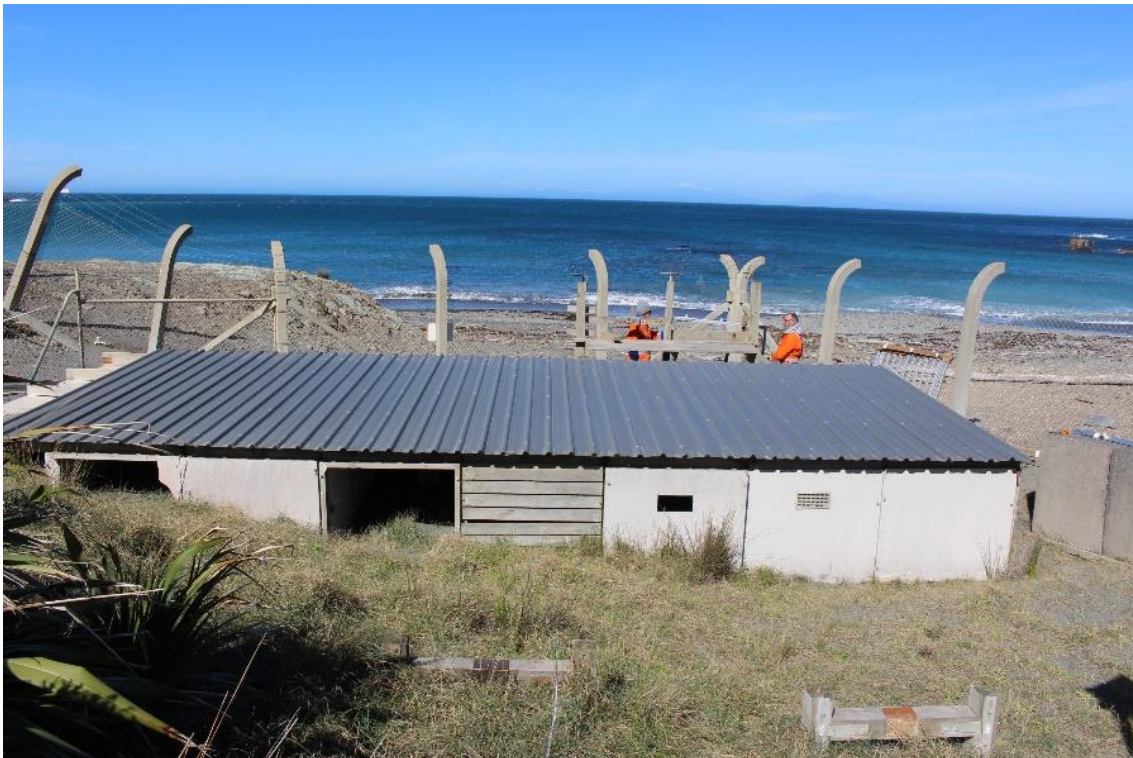
Figure 1. Test structure located at the remote south coast of Wellington.

The whole structure has a footprint of 9 m x 4 m and is located approximately 70 m from the seashore (Figure 1). The short dimension of the dwelling is roughly in a north-south orientation with the high side facing the sea. This seaward side of the roof is approximately 1.6 m above the ground.

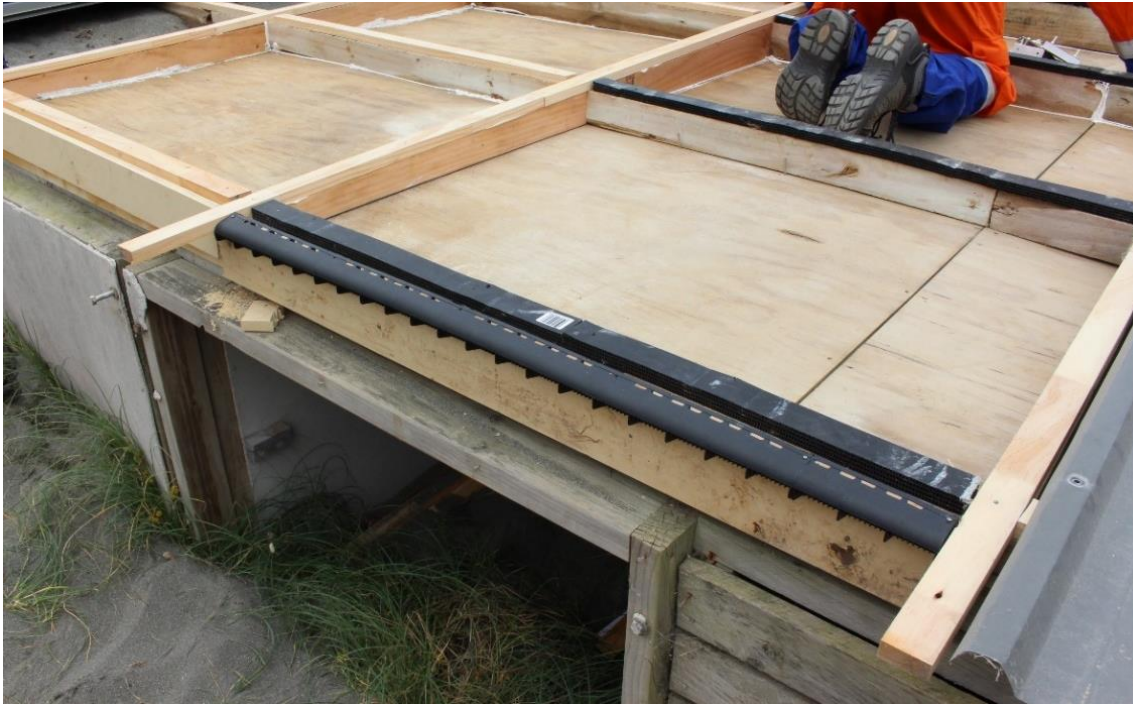
Figure 3. Over-fascia vent next to a vented batten, terminating the lower end of the roof cavity.

The northern end of the vented cavity was terminated with an over-fascia element (Figure 3). While giving a predefined opening to the roof space, the grid was fine enough to give some protection from insects entering the cavity.

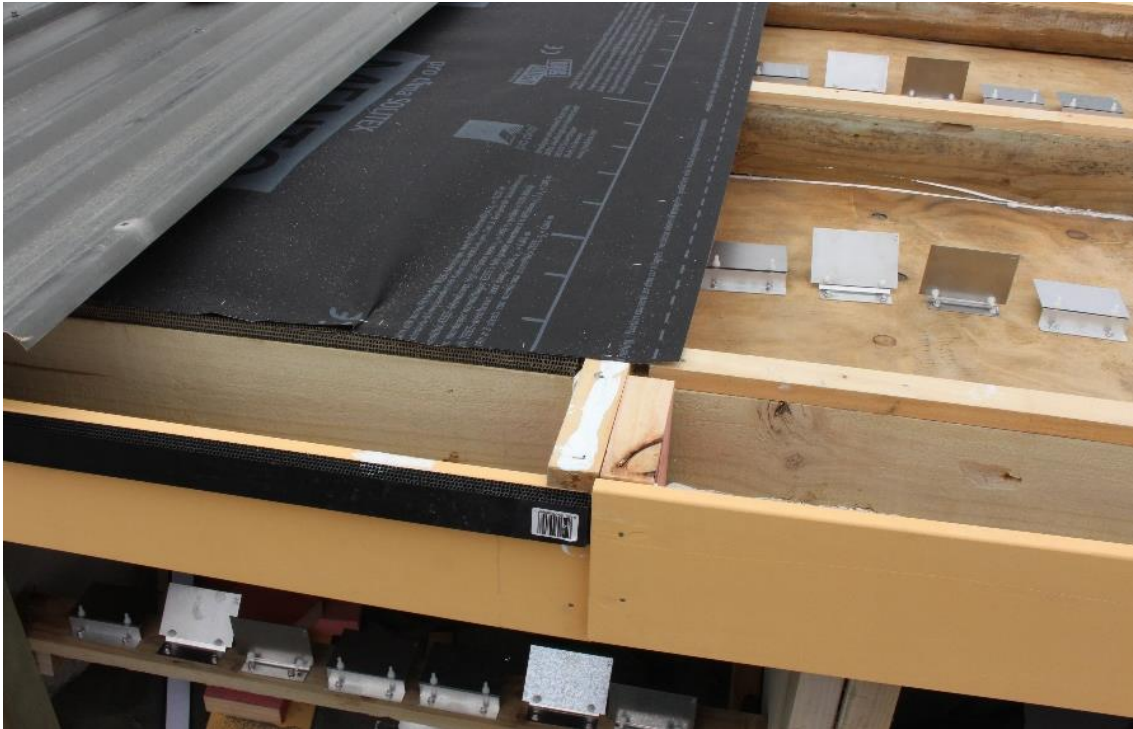
Figure 5. Roofing underlay being installed over the vented cavity.

The cavities were then covered with a commercial roof underlay without any mesh support (Figure 5).

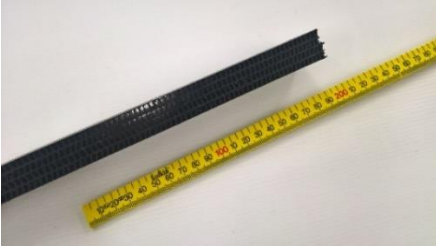
<p>Vented batten t = 20 mm, d = 45 mm, l = 1 m</p>

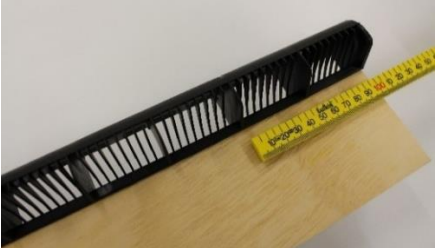
$Q [l/s \cdot m] = c \cdot \Delta p^n$	5.12	0.629
<p>Over-fascia vent</p>

$Q [l/s \cdot m] = c \cdot \Delta p^n$	14.32	0.504

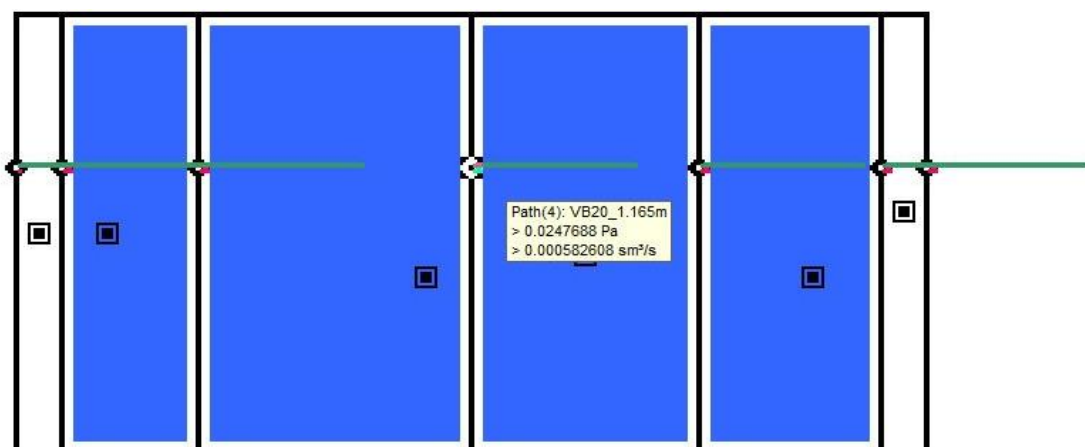
**Figure 6. Graphical representation of the vented cavity in CONTAM.**

These measured characteristics can be used as airflow resistance elements in the numerical simulation tool CONTAM² to estimate the number of air exchanges in the roof cavity as a function of wind action across the structure. Figure 6 gives a graphical representation of the vented cavity in CONTAM. The four bays, displayed in blue, are separated by the airflow resistance elements (black circles). The white areas represent the smaller soffit area volumes. The figure also indicates the simulated result in terms of pressure drop and flow through the third vented batten for a particular wind direction and speed. For the modelling, it is assumed that the roof and ceiling surfaces are absolutely airtight and any air exchange only occurs through the bays themselves. Thus, the airflow in metres per second given for the second vent element will be identical for all the other elements and indeed for the complete cavity.

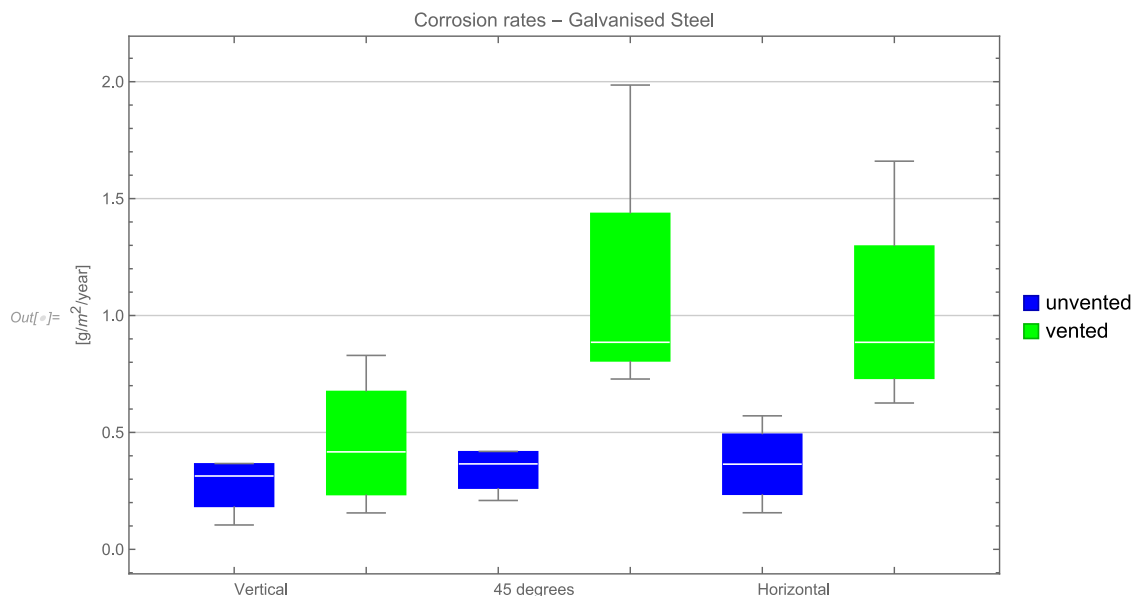
Figure 11. Corrosion rates for all galvanised steel samples at the various orientations inside the test structure.

A similar pattern is obtained for the galvanised steel samples. The corrosion rates of all orientations in the ventilated cavity are higher as compared to the unvented cavity. While again the vertical samples in both cavities show the lowest corrosion rates, there is no significant difference between the 45° and the horizontal samples in the vented and unvented space (Figure 11).
