# Comparing rates of corrosion in vented and unvented roof cavities

Passive ventilation in roof cavities in New Zealand is unlikely to impact the long-term performance of galvanised metal fixtures in these spaces. BRANZ investigated corrosion in steel samples placed inside vented and unvented roof spaces in a test structure on the south coast of Wellington. After 1 year, the observed corrosion in all samples was low. Samples in the ventilated area were slightly more corroded than those in the unvented area.

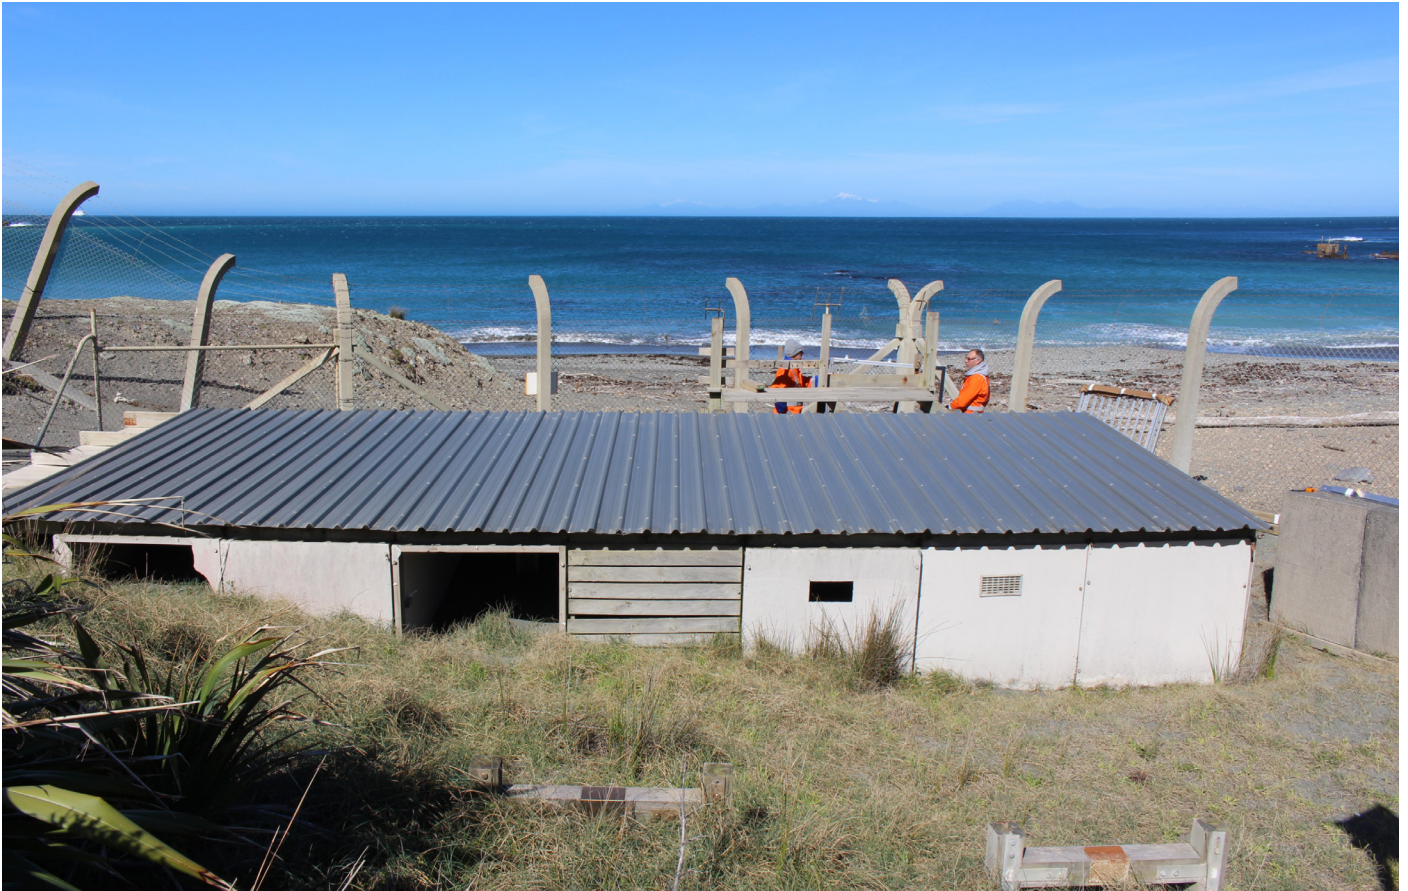
Figure 1. Test structure located on the south coast of Wellington used to measure rates of corrosion of steel samples placed in the roof cavity.

Steel samples were mounted inside and outside a test structure on the south coast of Wellington about 70 m from the shoreline (Figure 1). Based on previous findings elsewhere, the differences in the corrosion rate between the indoor samples were anticipated to be small. This extremely harsh environment was chosen so that any differences over a year would be detectable and measurable.

The test structure has two similar-sized roof cavities: one vented and one unvented. Mild steel and galvanised samples were mounted inside the vented and unvented roof areas at different angles: vertically, horizontally and at 45° to vertical. Samples were also installed outside the structure for comparison as a reference point.

The site is very close to the beach, and wind-blown sand was an issue. Any damp sand accumulating around the roof ventilation openings or on the outside samples was removed during regular visits.

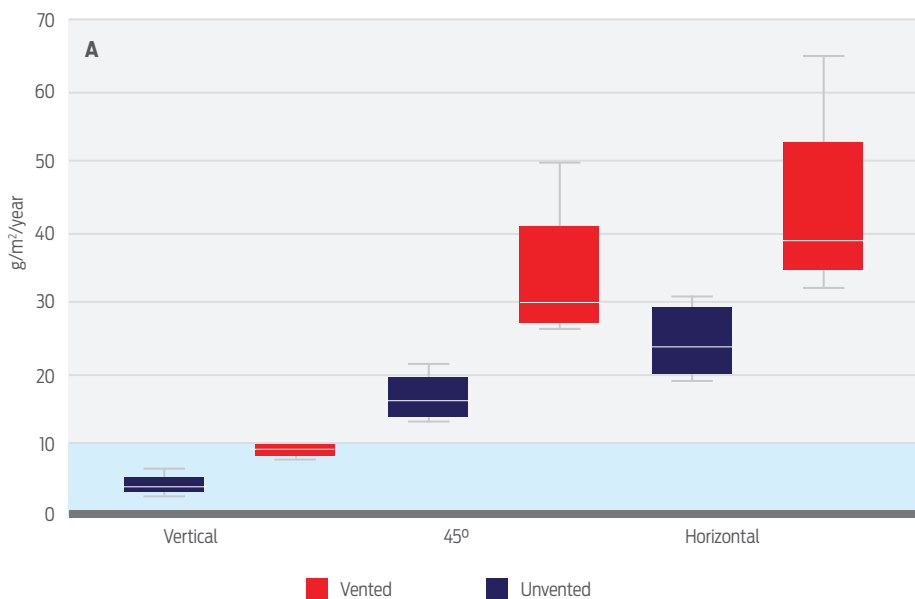
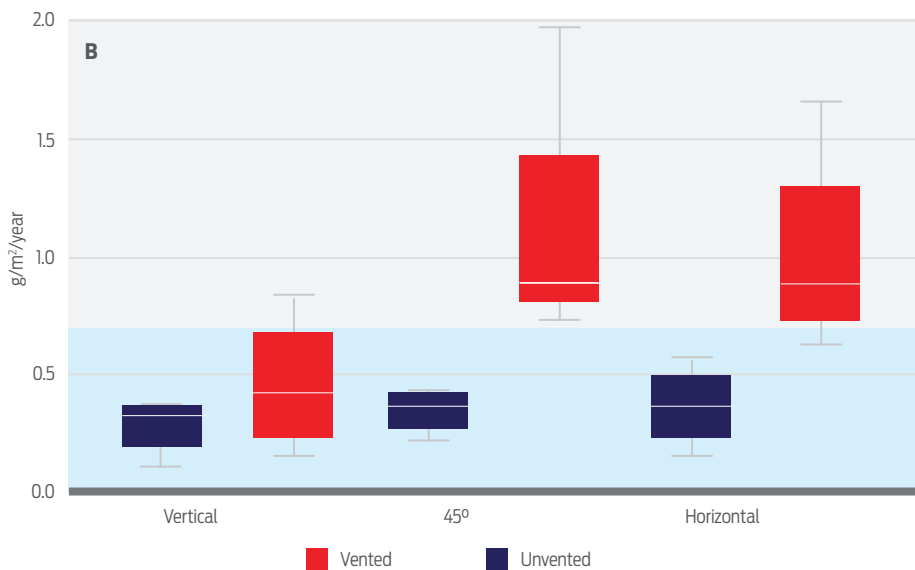
Figure 2. Measured corrosion for all (a) mild steel samples and (b) galvanised steel samples at vertical, 45° and horizontal orientations inside the vented and unvented areas of the roof test structure. In both graphs, blue corresponds to C1 Very low corrosion and grey shows C2 Low corrosion (see Table 1). The white horizontal bar indicates the median value, the upper and lower limits of the box give the 75% and 25% quartiles (the middle half of sample values) and the whisker lines show the highest and lowest rates of corrosion observed.

Corrosion rates were higher in the vented part of the roof space than for their counterparts in the unvented cavity for both types of steel, regardless of the orientation the sample was mounted at. This is consistent with expectations. However, the corrosion rates for all samples placed inside the test structure fall into the C1 Very low and C2 Low ranges of corrosion (Figure 2 and Table 1) so the difference between vented and unvented is small. The slightly higher rate of corrosion in the vented area may be because the increased air exchange within the roof cavity leads to a higher exposure to salt aerosols in the air.
