WEATHERTIGHTNESS OF DOMESTIC CLADDINGS.

R.C. Bishop and M. R. Bassett

Building Research Assn
of New Zealand

This is a report on an experimental study of the weathertightness of claddings for domestic buildings. It is part of a wider programme helping to develop weathertight roofs, claddings, and windows on all types of buildings.

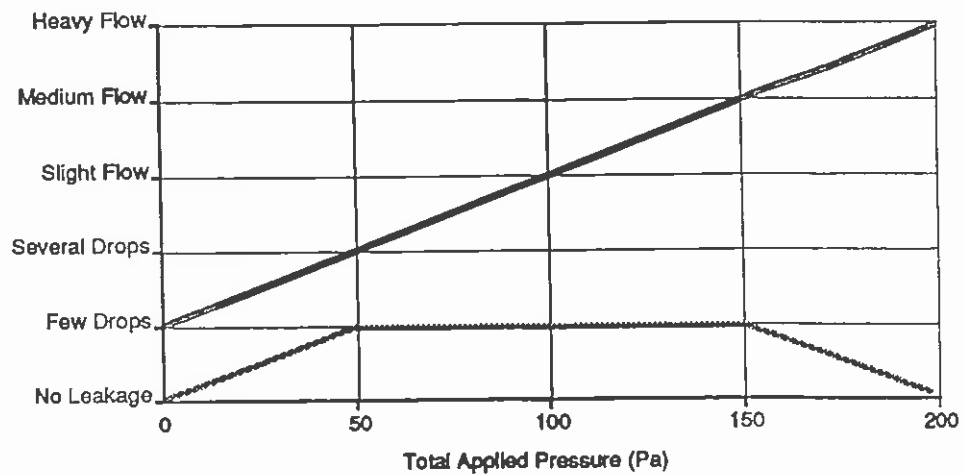
Figure 11 : Results of Window Flashing Improvement Tests

As is seen from Figure 11, there is a major reduction in water leakage around the window, from "Medium Flow" and "Heavy Flow" at the jamb and sill respectively, to only "Several Drops" and "Few Drops" there at most pressures.

The reduction in water leakage at the sill seen at the highest pressures in Figure 11 is probably due to either difficulties resolving such a small flow, or diversion of this leakage to another location.

● Initial Test
 ● After Improvements

Figure 15 compares the results of the same two tests that were shown in Figure 11, in the water leakage locations for equivalent tests. Again, these were performed on a lightweight horizontal cladding with no lining, with several weeks intervening between the tests, during which time the cladding was removed and replaced on the wall frame.
