STUDY REPORT

SR No. 204 (2009)

Seismic performance of brick veneer houses

Phase 4. Cyclic racking of a two-storey clay-brick veneer building

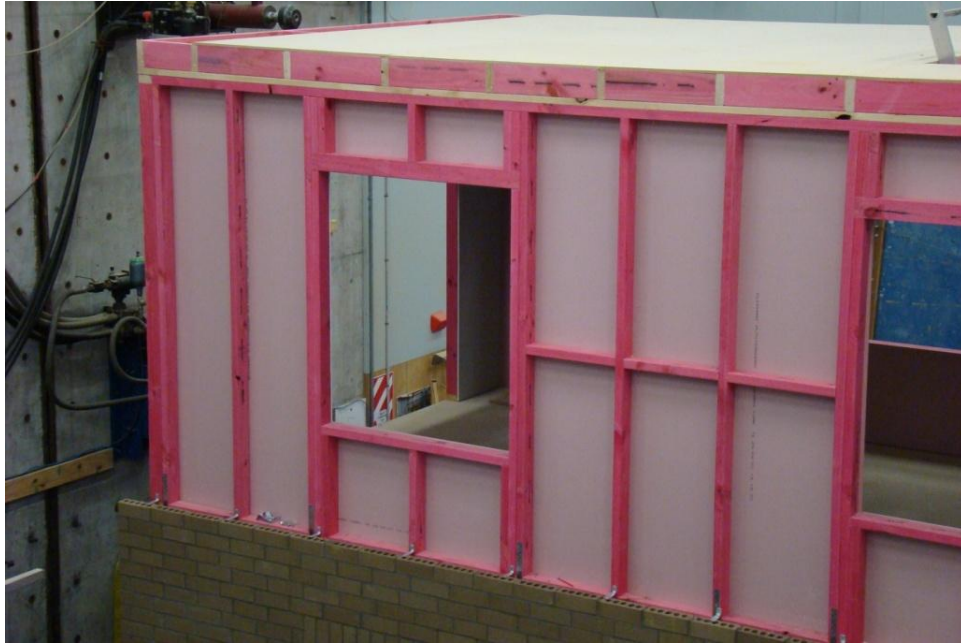
Figure 2. Laying brickwork against the LTF during construction

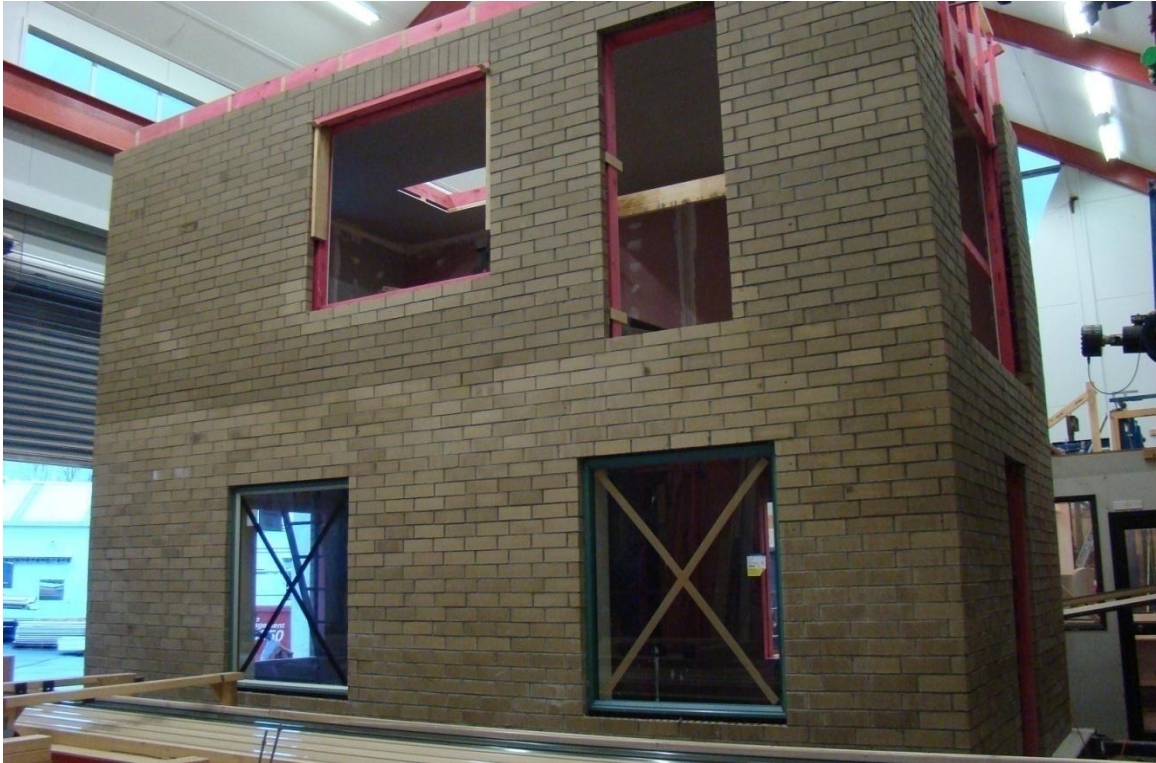
Figure 4. Photograph of building Side 2 before testing

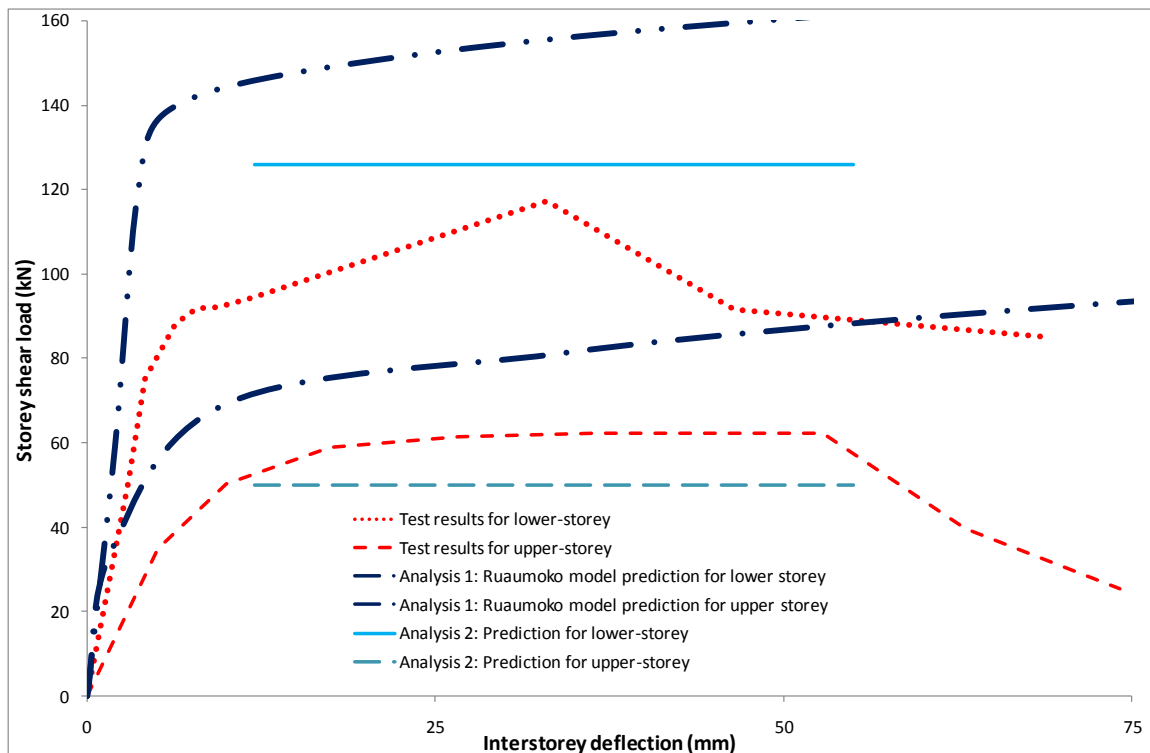
Figure 8. Comparison of backbone curve of inter-storey shear force versus inter-storey displacement for theory and test results for the two-storey building

Figure 8 also gives the Analysis 1 (Ruaumoko model) prediction. Analysis 2 results are also shown but these are discussed in Section 4.3.

Figure 8 plots the recorded total shear load applied to each storey plotted against the LTF inter-storey displacement. Note that the lower-storey shear load is the shear force directly measured at the base of the veneer. The upper-storey shear load is taken as the load applied at the roof. This would have been partially resisted by the lined LTF. As the upper-storey lining was only screwed at 600 mm centres and vertical joints were not stopped, the upper-storey LTF bracing strength was expected to be low, particularly at large displacements when the lining fixings had effectively failed.

The Ruaumoko model grossly overestimates the load carried by the veneer, particularly for the lower storey. This is largely attributed to the cracking mechanism assumed by the theory (Figure 6) varying from that found in the test. The main difference was that the horizontal cracking assumed at the top of windows did not occur in the test. Instead cracks (often diagonal cracks)

occurred in the spandrels, particularly the middle spandrel. Thus, the test had found a weaker mechanism than assumed. The agreement between theory and test is better for the upper storey which will be less affected by the diagonal cracks in the middle-storey spandrels.

The method described above was used to predict the shear load carried by the test building. The results are summarised in Table 1. This is compared with the measured strength in Figure 8. The theoretical values are lower than the Ruaumoko values. Compared to the test results, the prediction is slightly conservative for the upper storey. However, as the test results include some shear carried by the lined LTF and the model does not, all that can be said is the prediction is reasonable. The prediction is slightly unconservative for the lower storey. It is concluded that cracking of the middle height spandrels was a weaker failure mechanism which limited the shear that could be taken by the lower storey.

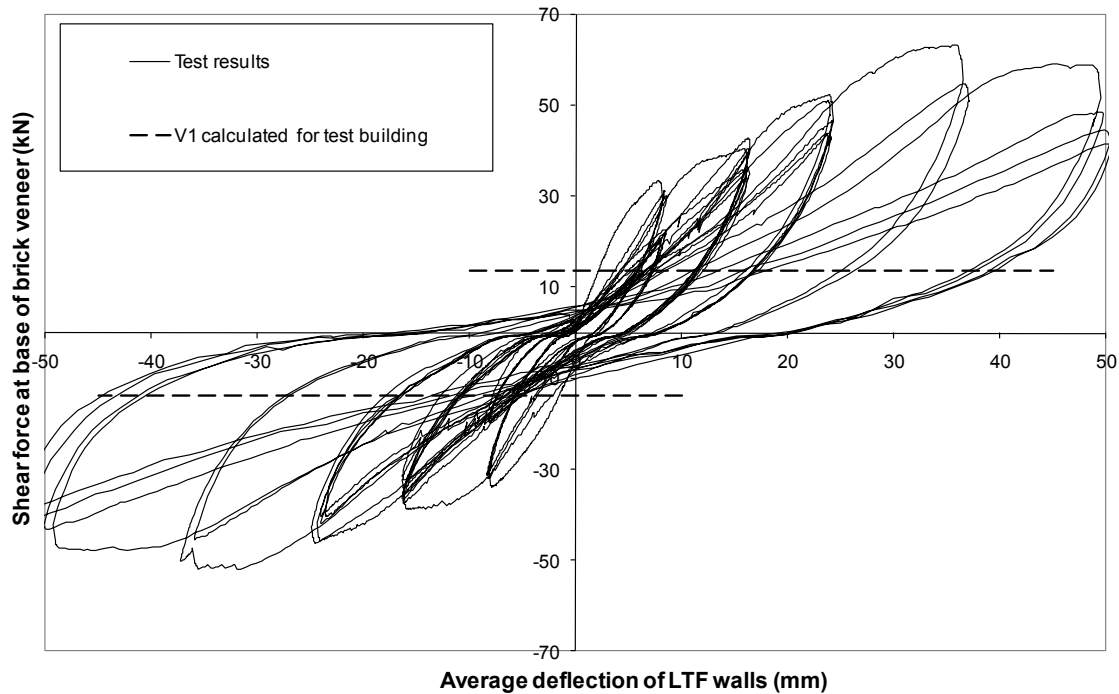
Figure 13. Comparison of design load for Room 1 and measured shear strength

This is plotted in Figure 13 for comparison with the test results. Clearly this design method is very conservative. The shear carried by the veneer in the test came from load transfer from the LTF via the brick ties, which is ignored in the proposed method. Note that the proposed design level of shear to be used is $0.5V1$, as discussed in Section 4.4.1.

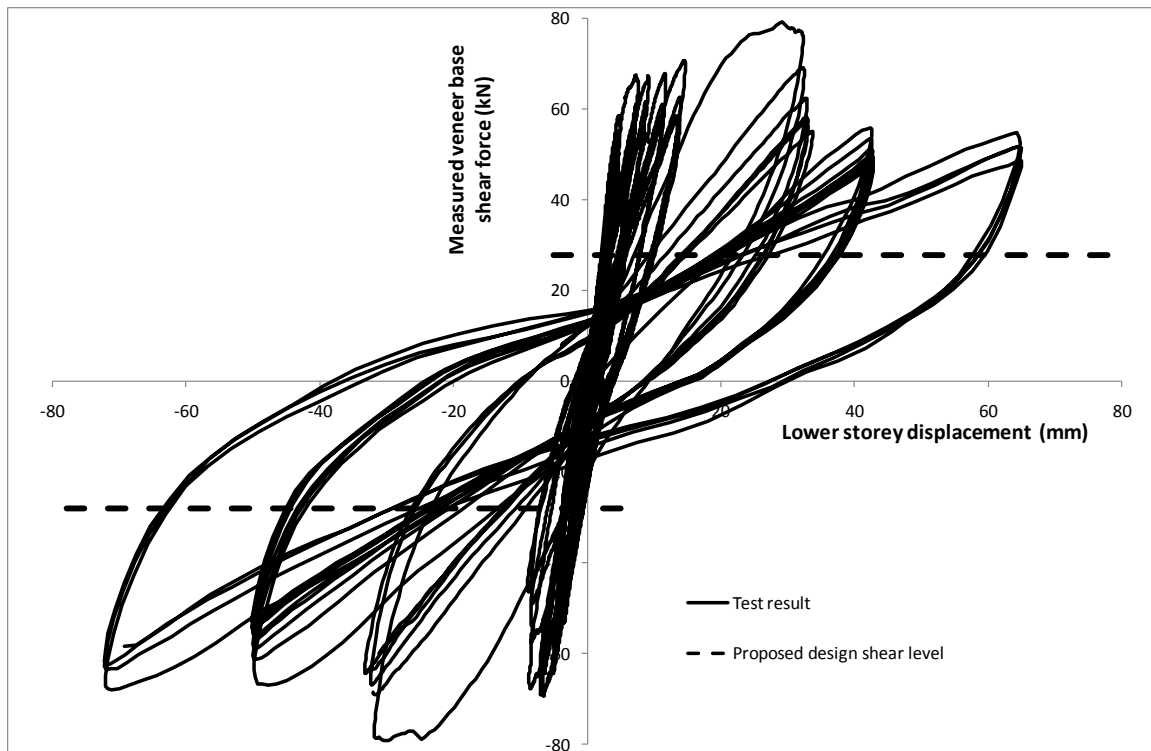
Figure 16. Comparison of design shear resistance for the lower-storey veneer of the two-storey building and the measured shear force at the bottom of the veneer

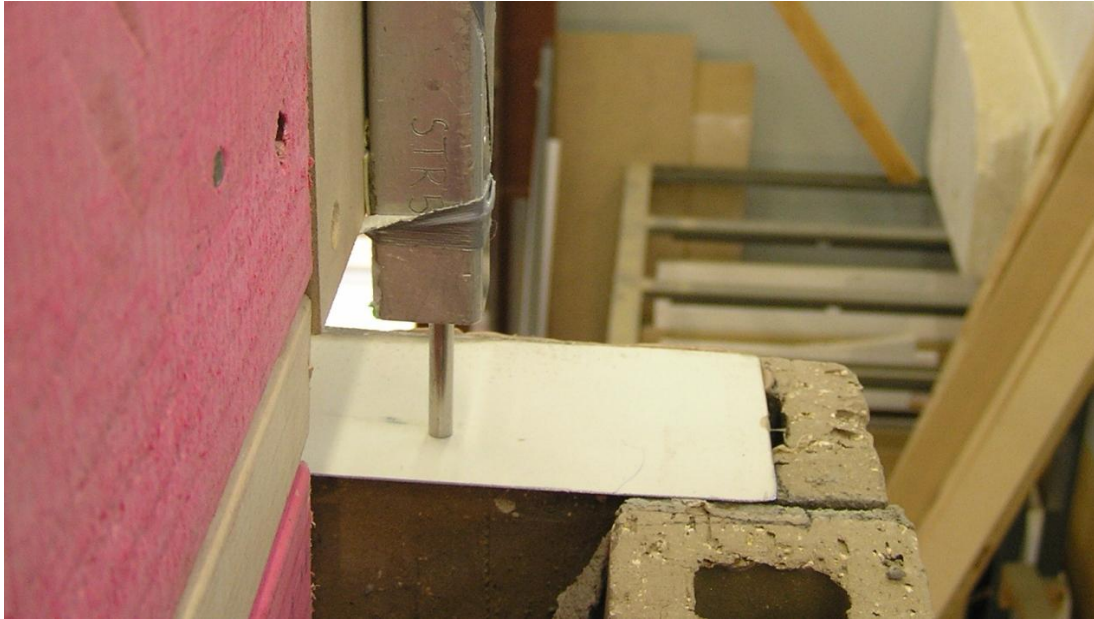
Figure 29. Measurement of vertical displacement of LTF relative to the veneer

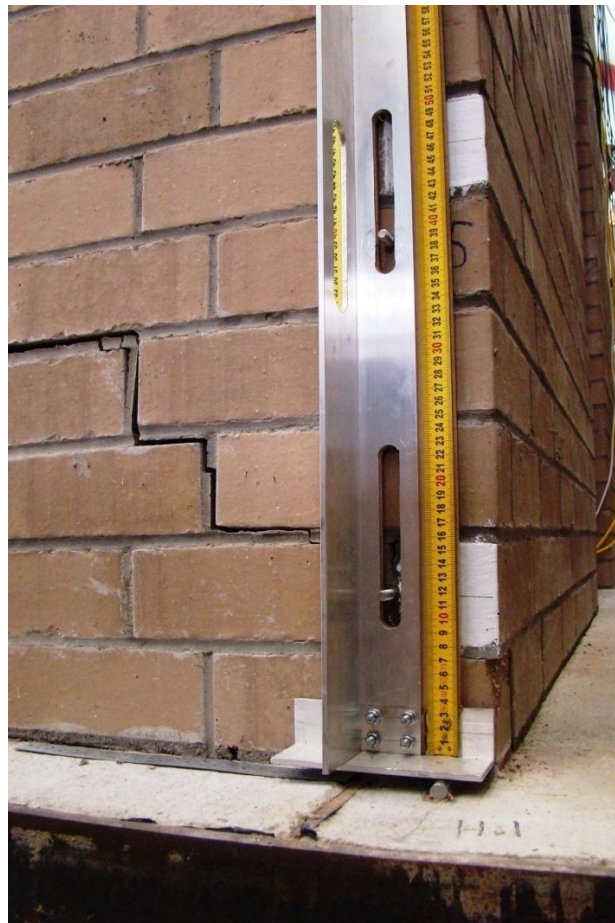
Figure 30. Measurement of veneer crack width by measuring height to scratch marks at eight locations up the height of the veneer

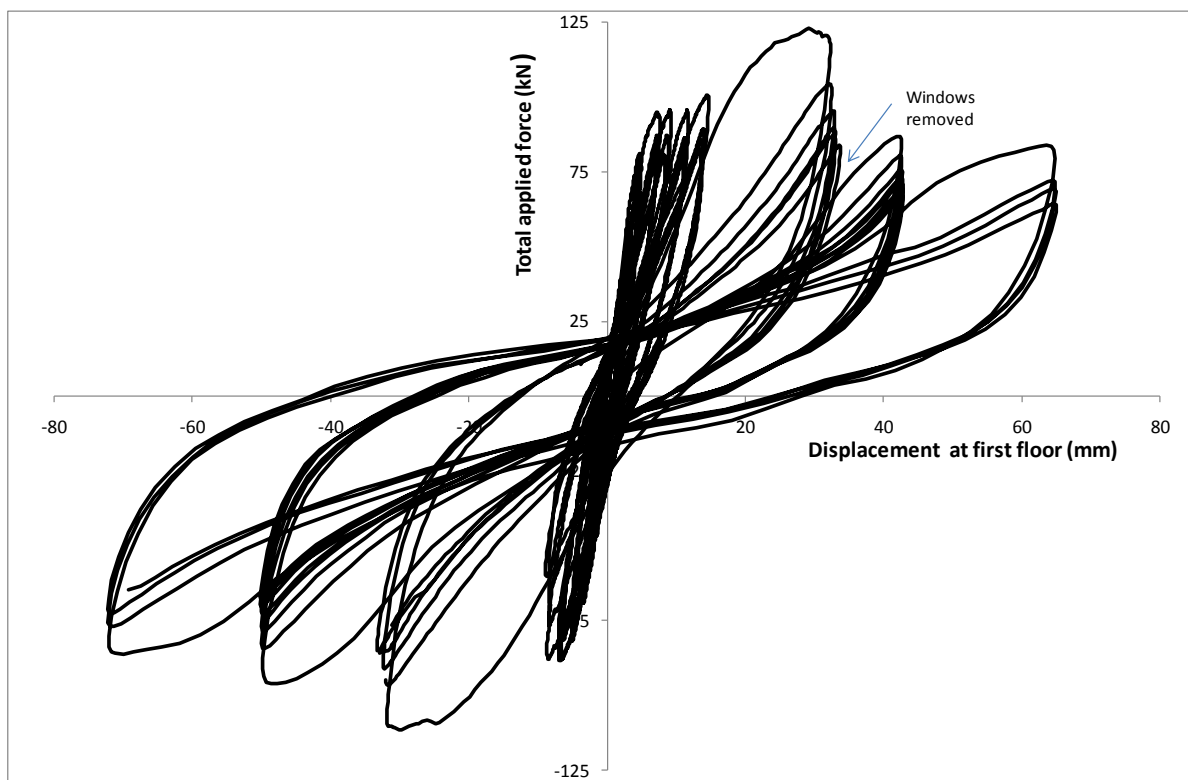
Figure 32. Total applied force at roof plus first floor versus displacement of first floor

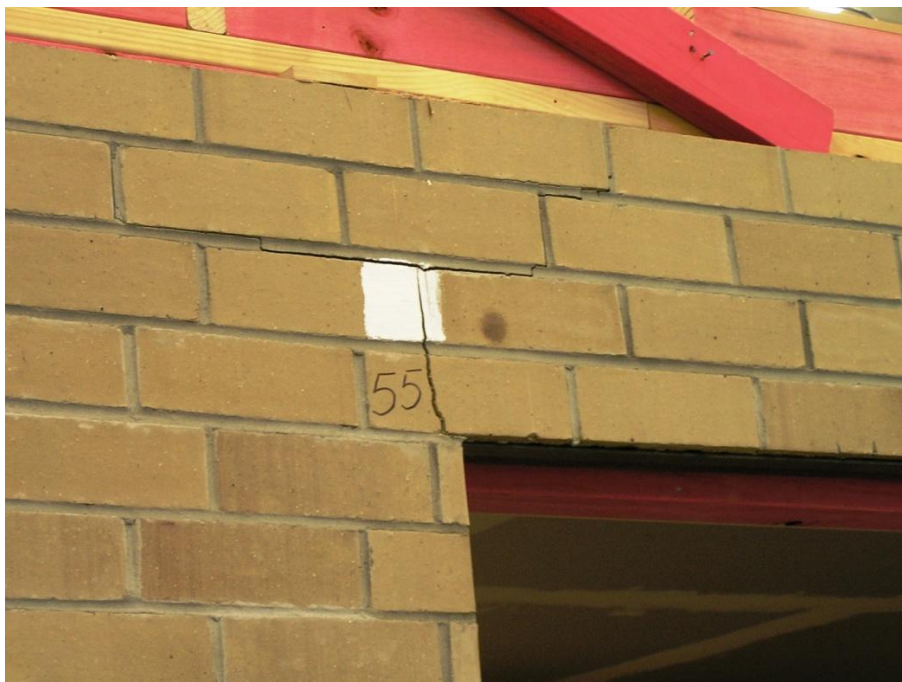
Figure 48. Lintel cracking above Side 1 Window S1D at peak push in Stage D

Cracks in Stages D and E were sufficiently wide at peak loads to be seen in photographs and the most significant are shown in Figure 48 to Figure 52 for cracking above the top windows. General cracking is shown in Figure 55 to Figure 64 for cracking in Stage D and Figure 63 to Figure 70 for Stage E. The horizontal cracks closed and were difficult to see at unload but the vertical and stepped cracks could sometimes be seen without difficulty. Figure 71 to Figure 73 show the most significant of these. The cracks above all upper-storey lintels were most easily seen in the unload state.

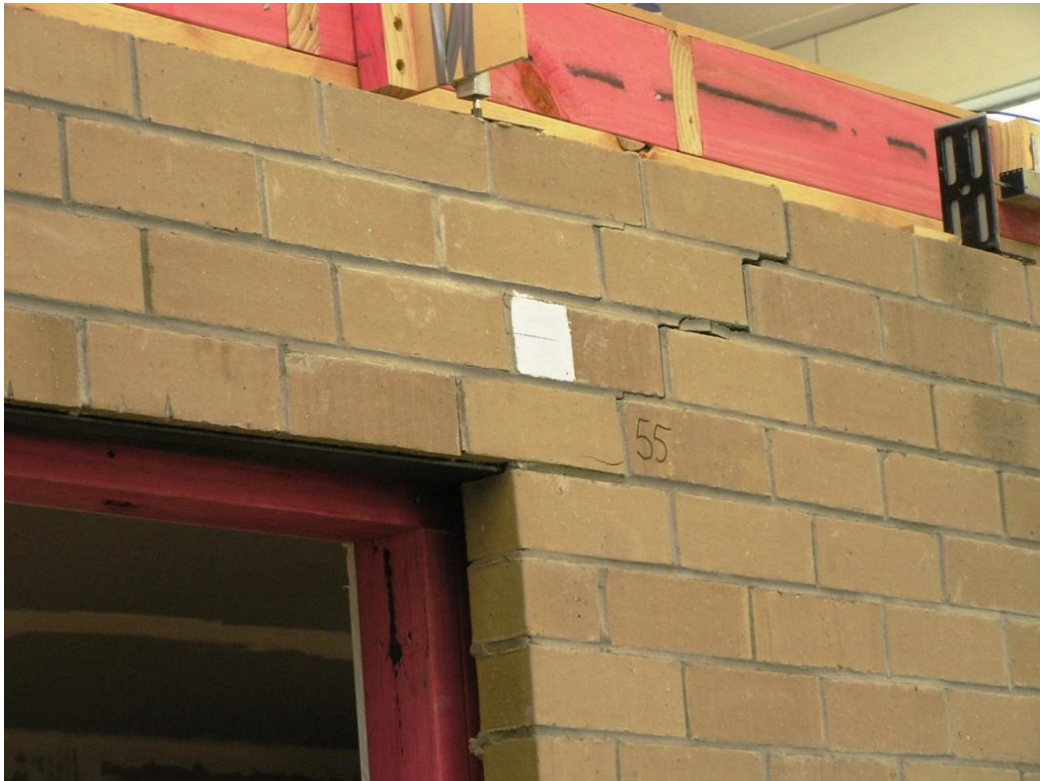
Figure 49. Lintel cracking above Side 1 Window S1C at peak push in Stage D

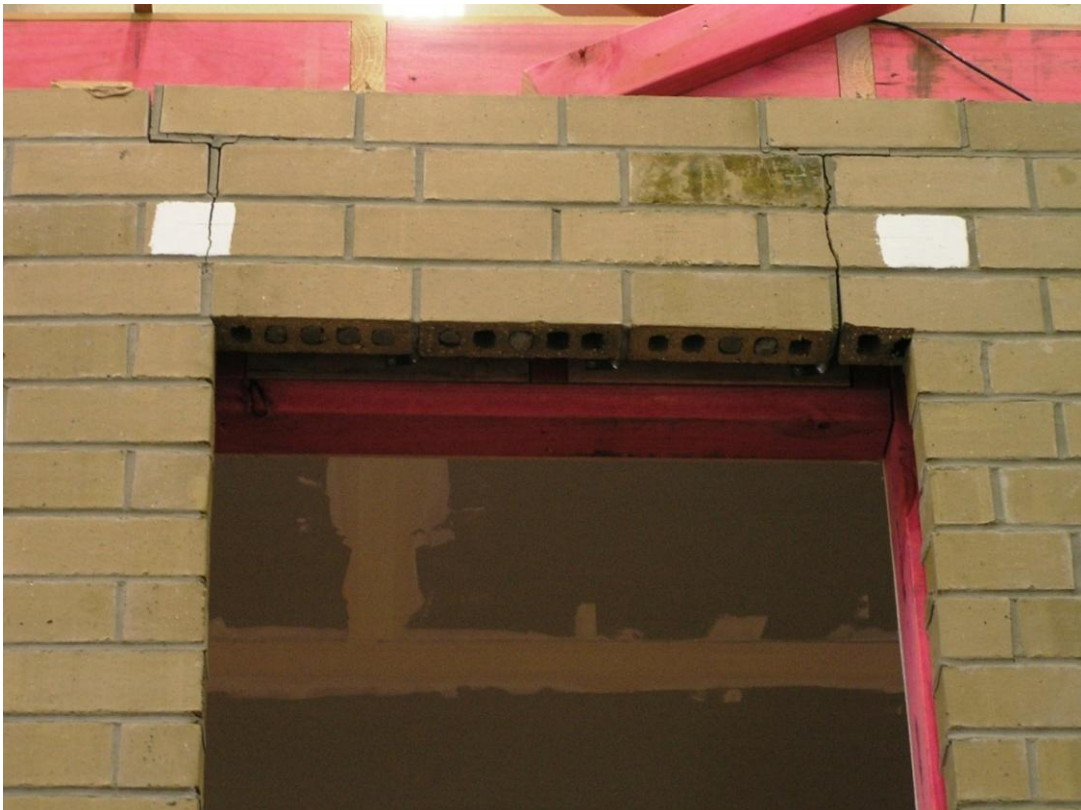
Figure 50. Lintel cracking above Side 2 Window S2C at peak push in Stage D

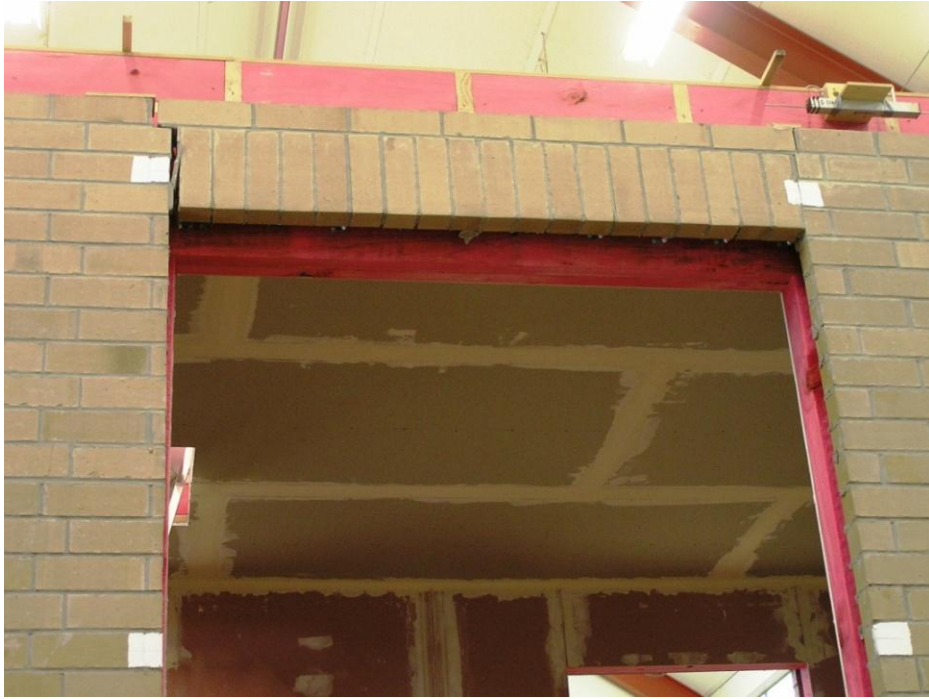
Figure 51. Lintel cracking above Side 2 Window C peak pull in Stage D

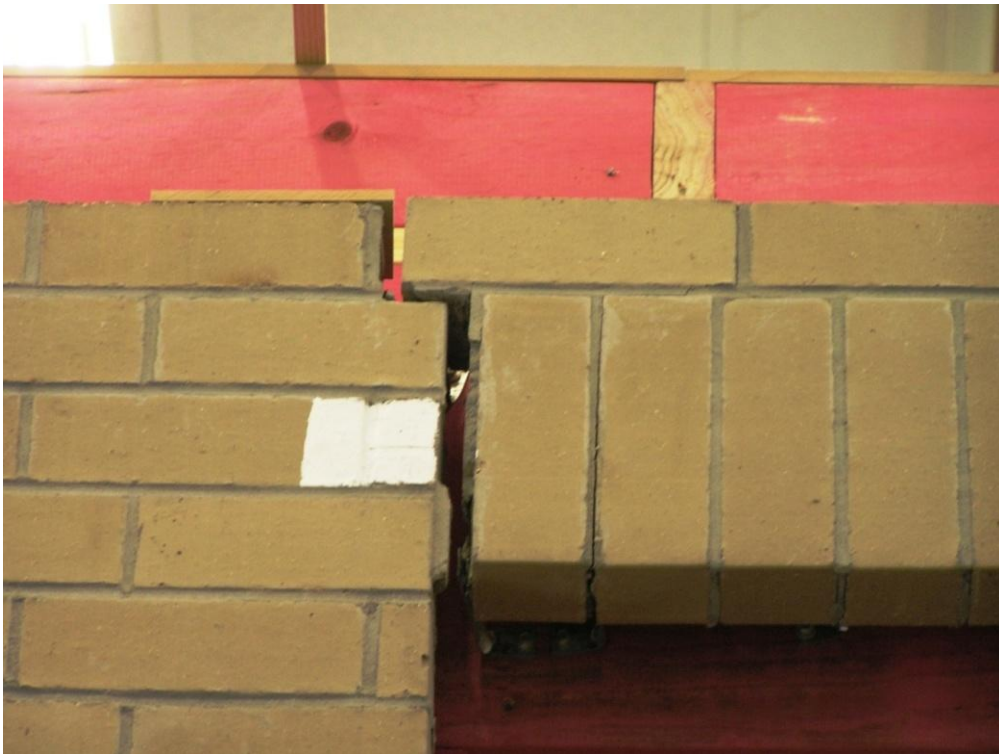
Figure 52. Lintel cracking above Side 2 Window S2C at peak pull in Stage E

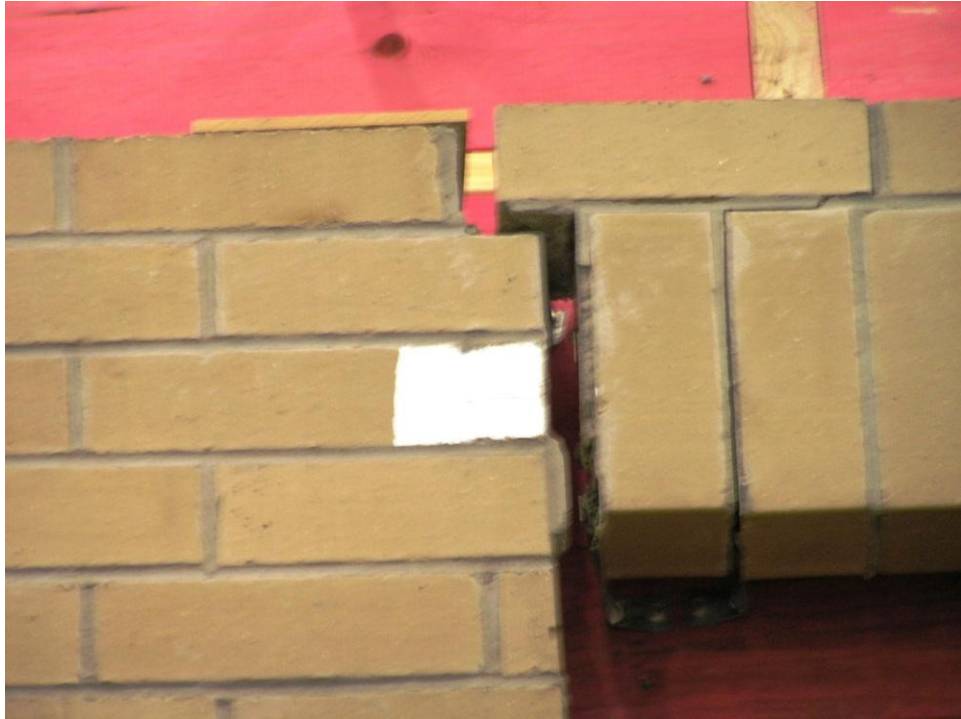
Figure 53. Lintel cracking above Side 1 Window S2C at peak pull in Stage F

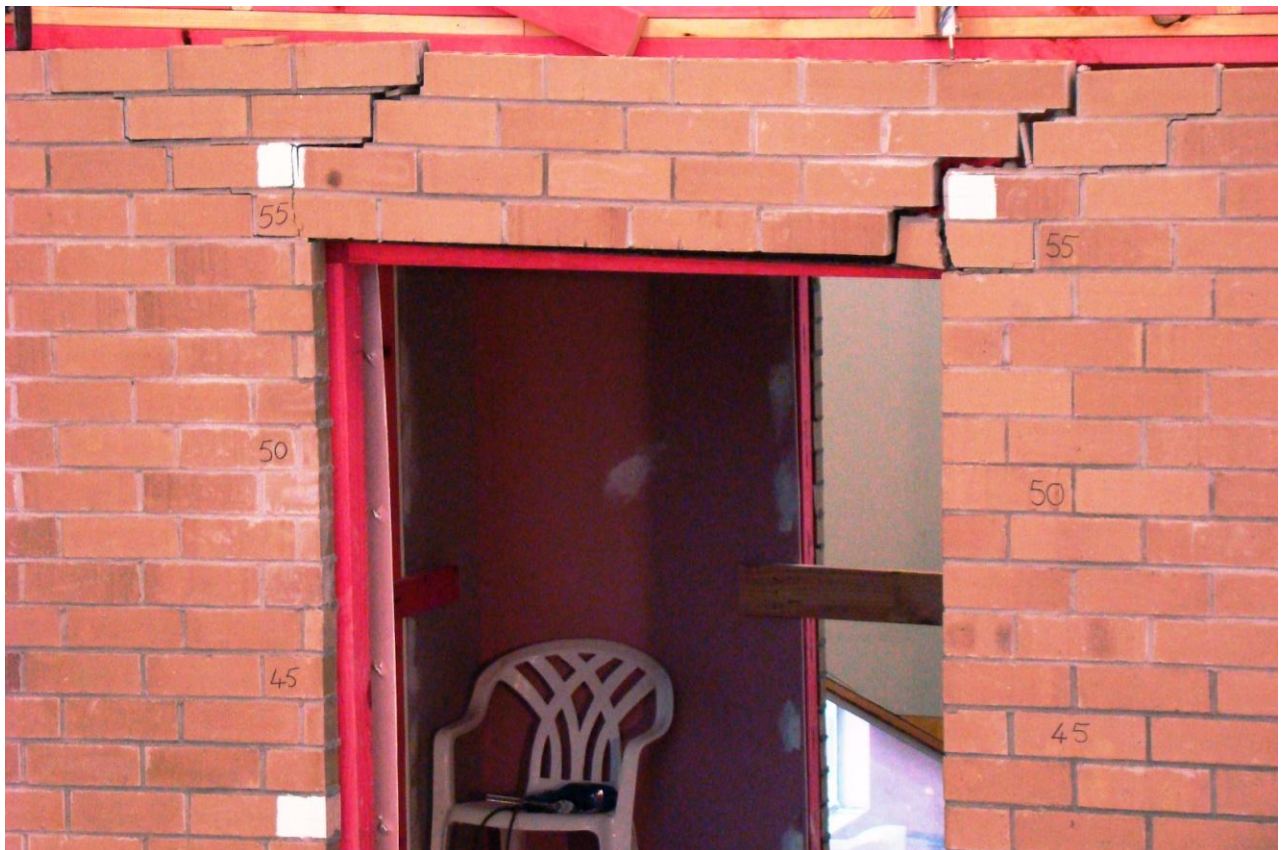
Figure 54. Lintel cracking above Side 1 Window S1C at peak pull in Stage G

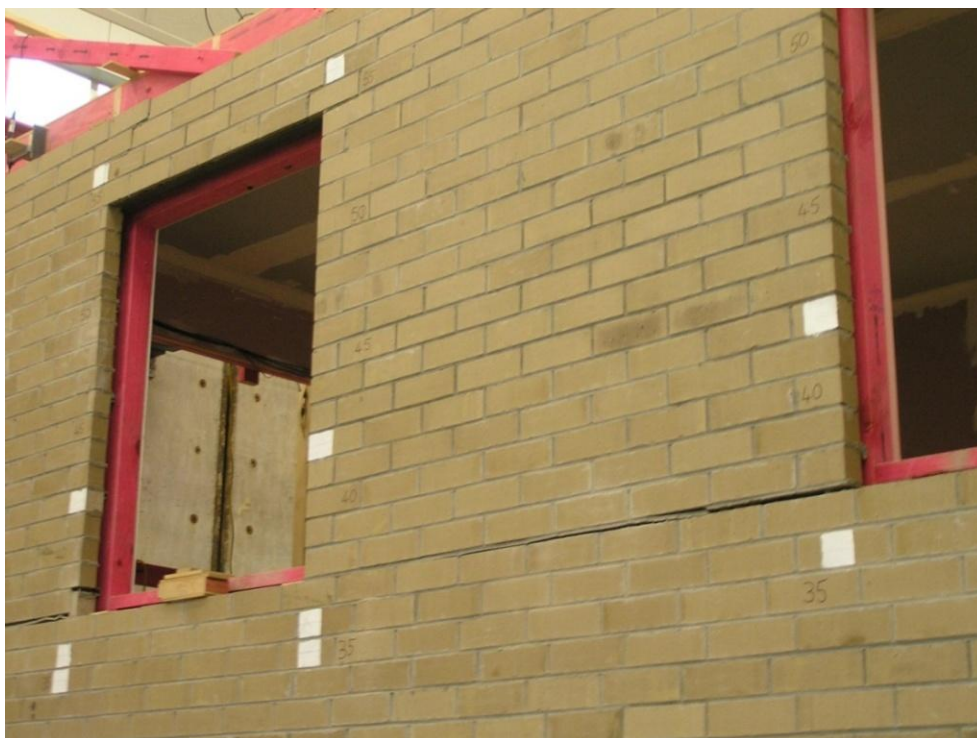
Figure 55. Cracking in Side 1 veneer at Panel B at peak pull in Stage D

The major mechanism for Stages A to E was rocking of the upper-storey panels about cracks which emanated from window corners. These were mainly horizontal cracks on Side 1 (Figure 55, Figure 56, Figure 63 and Figure 64) and diagonal cracks in the middle spandrel on Side 2 (the most significant being Figure 67 and Figure 68 for Panel F although Figure 69 and Figure 70 are other examples). A vertical crack did occur in the middle spandrel at Panel A of Side 1 under pull load in Stage E. The cracking in the lower storey (shown in Figure 35 and Figure 38) was fine and difficult to detect even at peak loads. Cracking above the top storey lintels at peak loads was wide in Stages D and E, as noted above.

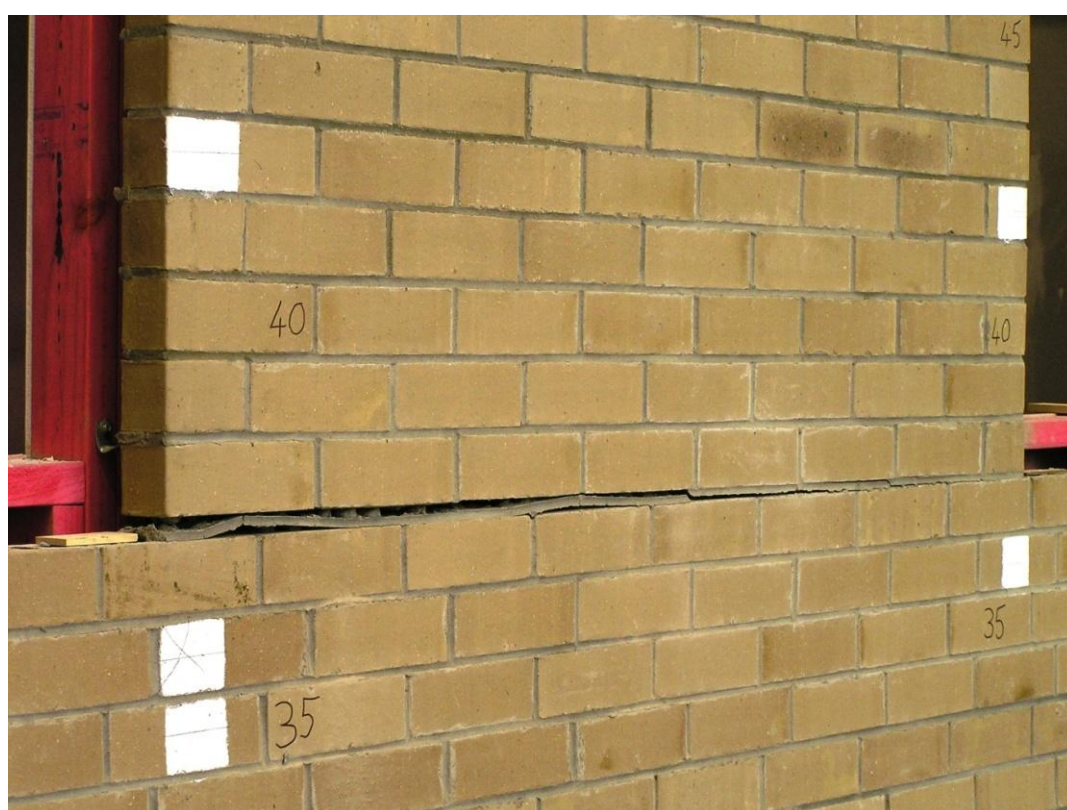
Figure 56. Cracking in Side 1 upper-storey veneer at Panel B at peak push in Stage D

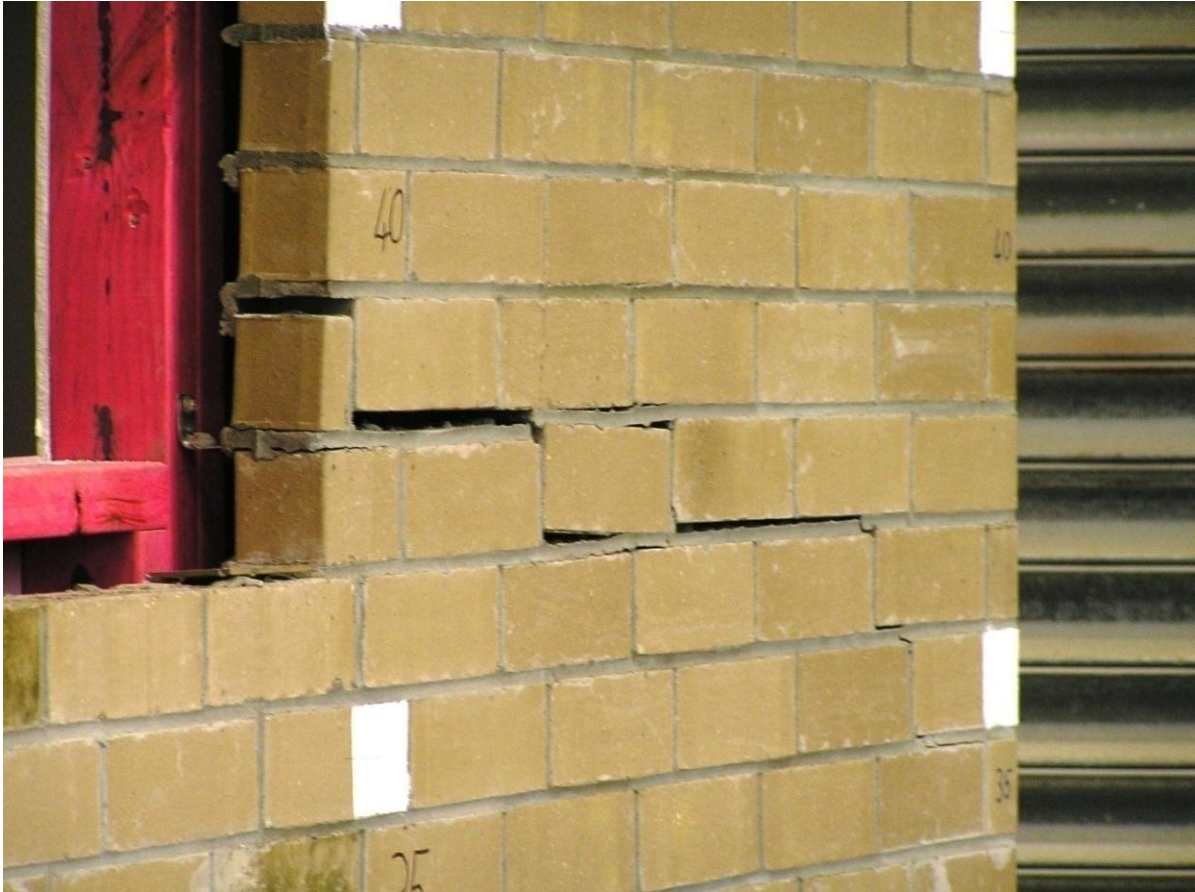
Figure 59. Cracking in Side 1 upper-storey veneer at Corner 2 at peak push in Stage D

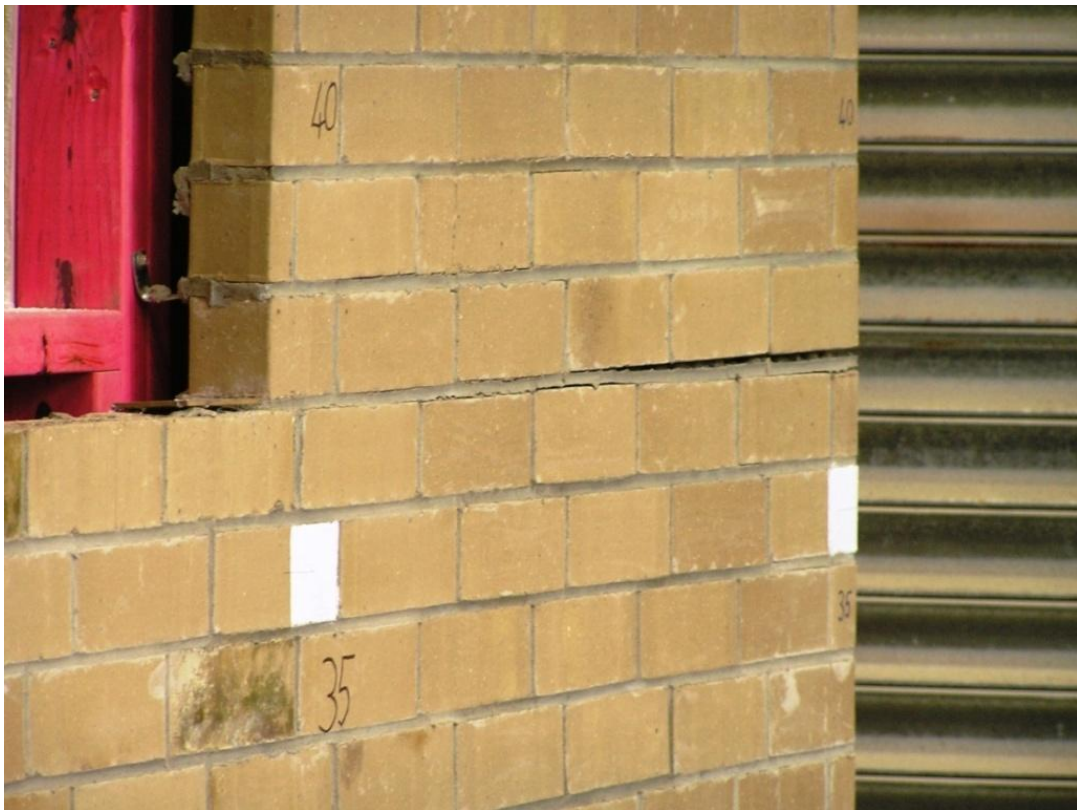
Figure 60. Cracking in Side 1 upper-storey veneer at Corner 2 at peak pull in Stage D

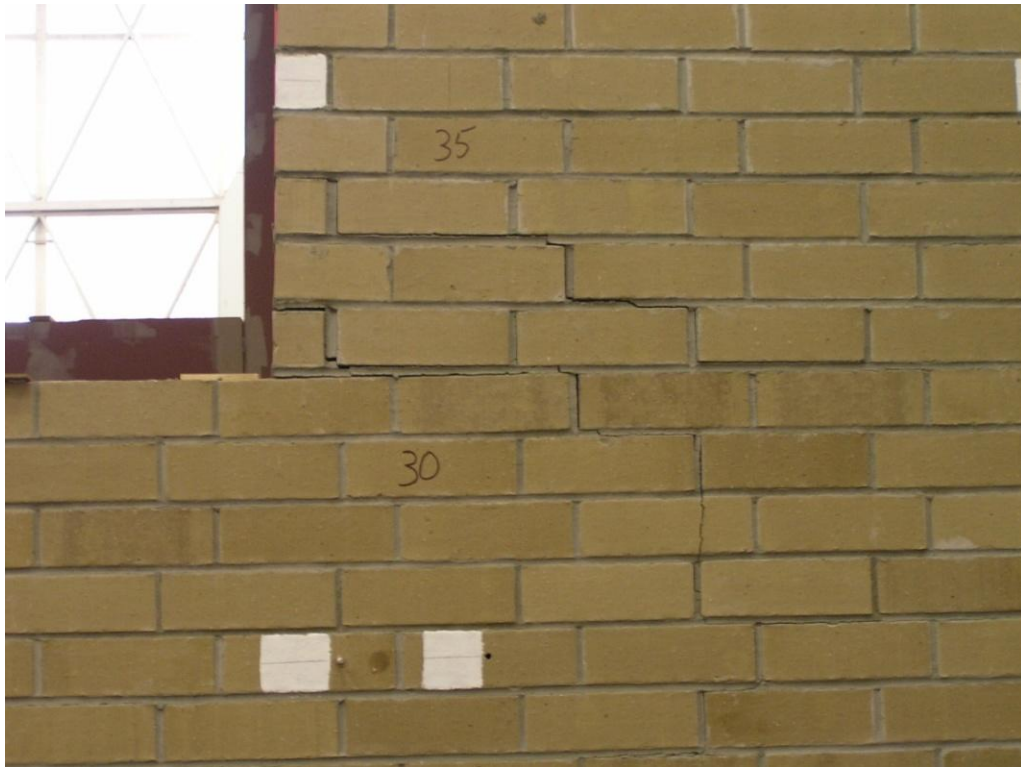
Figure 61. Cracking in Side 2 upper-storey veneer at Panel H at peak pull in Stage D

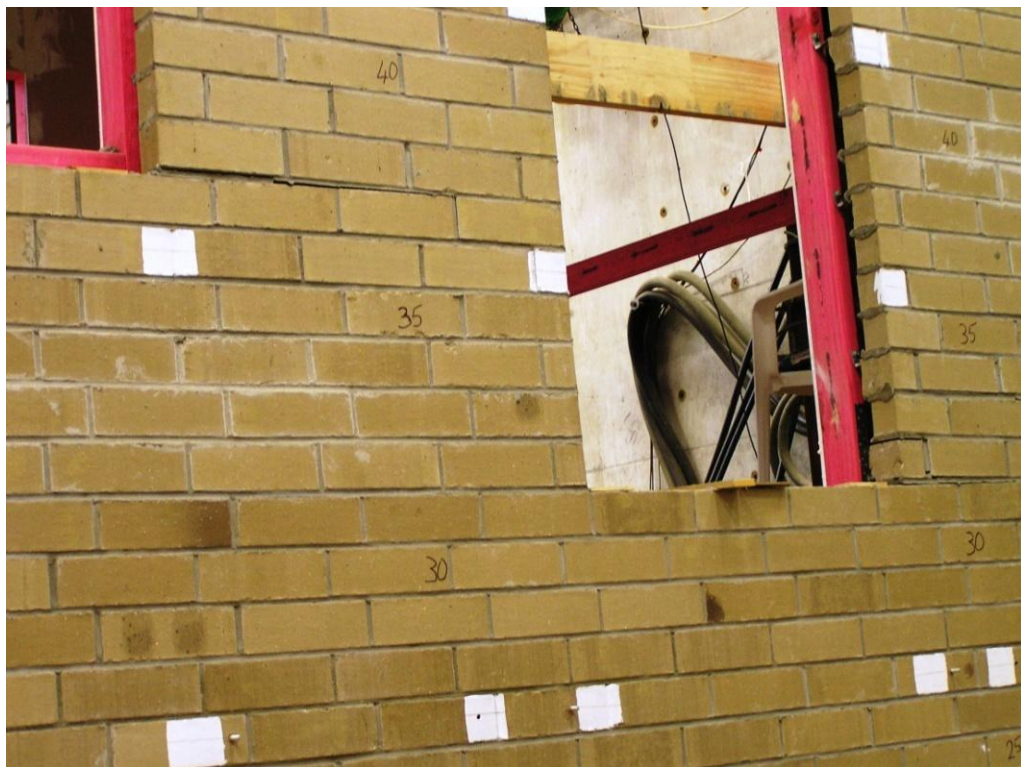
Figure 62. Cracking in Side 2 upper-storey veneer at Panel G at peak pull in Stage D

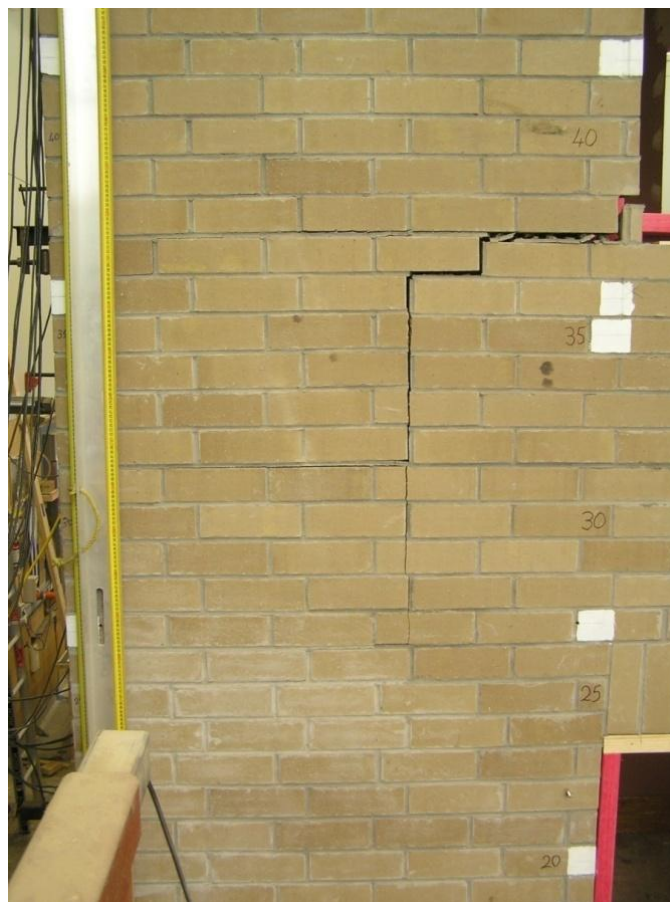
Figure 66. Cracking in Side 1 veneer at Panel A at peak pull in Stage E

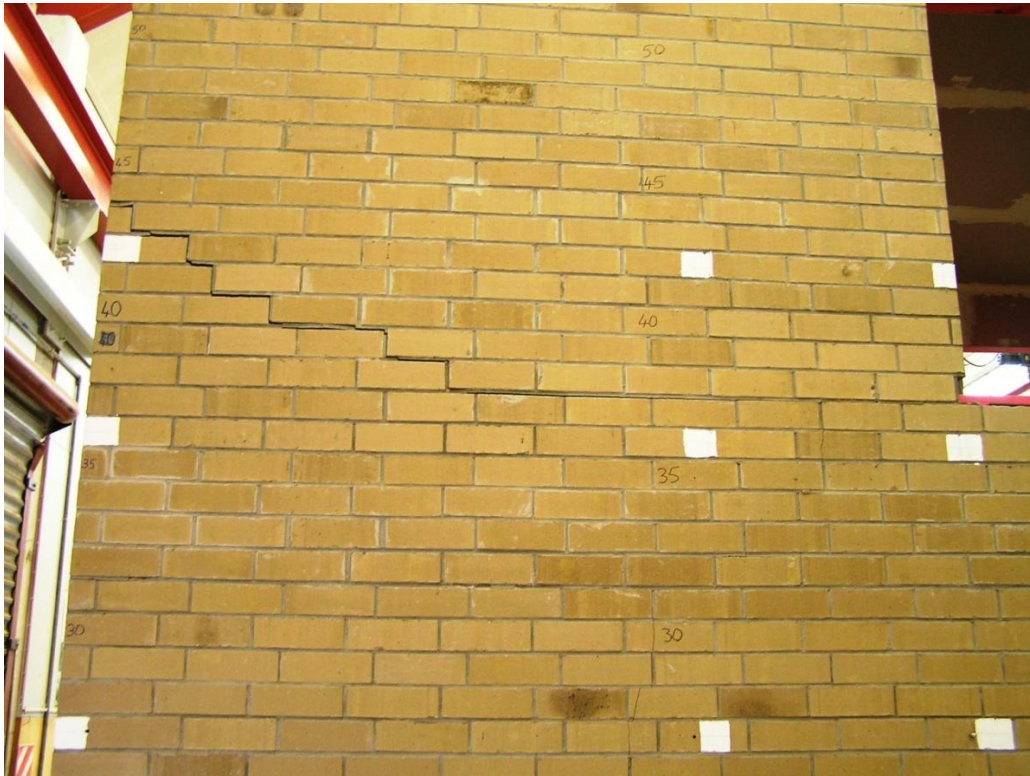
Figure 67. Cracking in Side 2 upper-storey veneer at Panel F at peak pull in Stage E

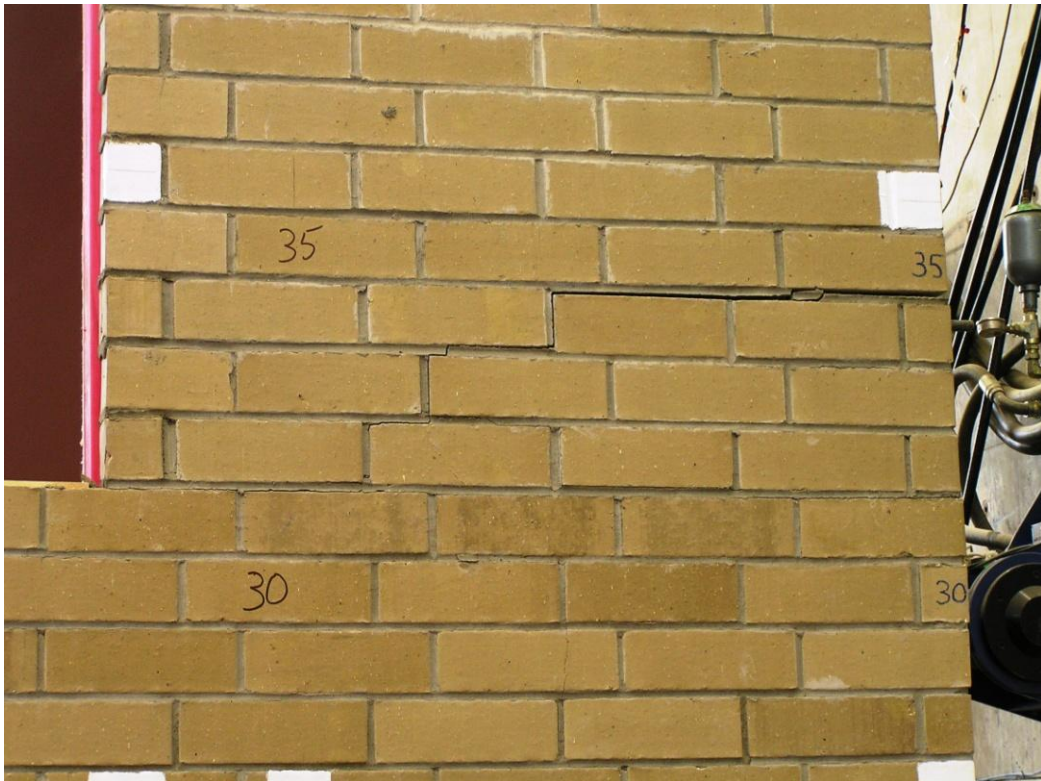
Figure 69. Cracking in Side 2 upper-storey veneer at Panel H at peak push in Stage E

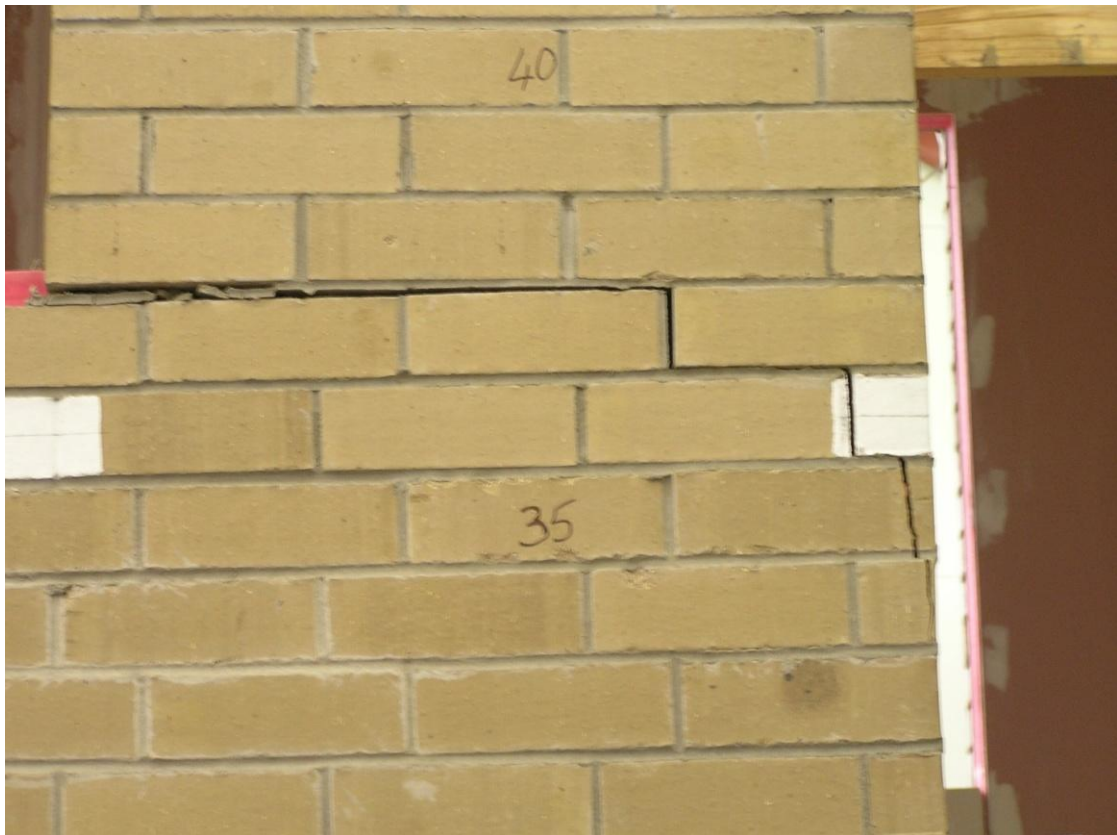
Figure 70. Cracking in Side 2 upper-storey veneer at Panel G at peak pull in Stage E

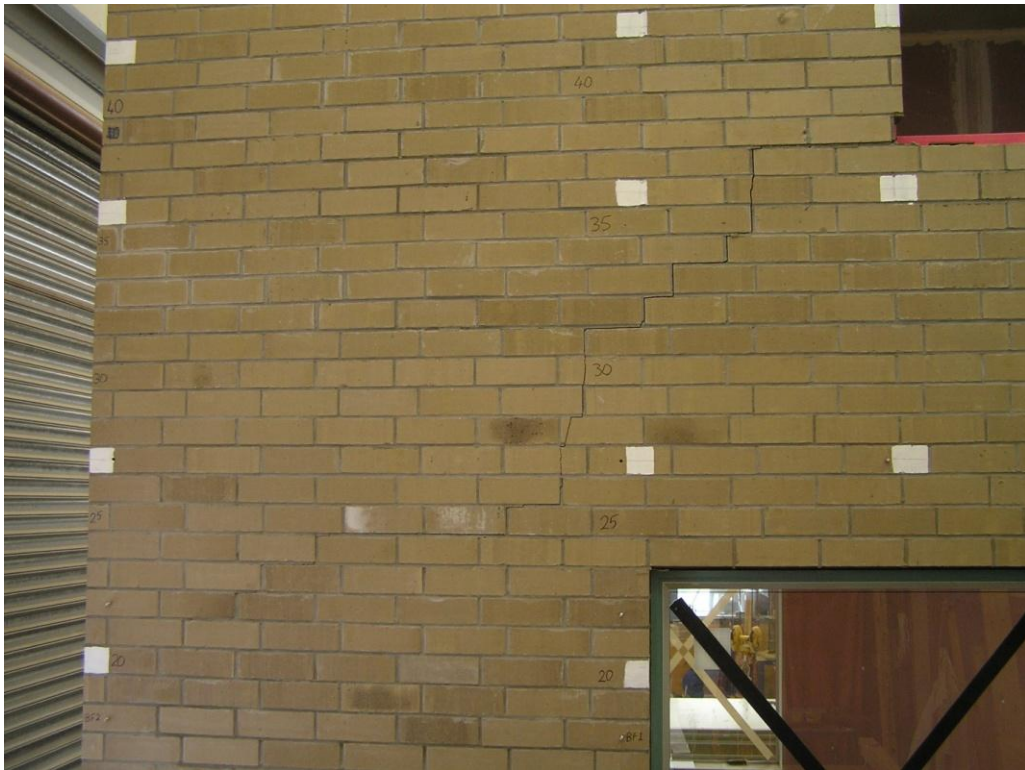
Figure 71. Residual cracking Side 1 Panel F veneer at zero load after Stage E cycling

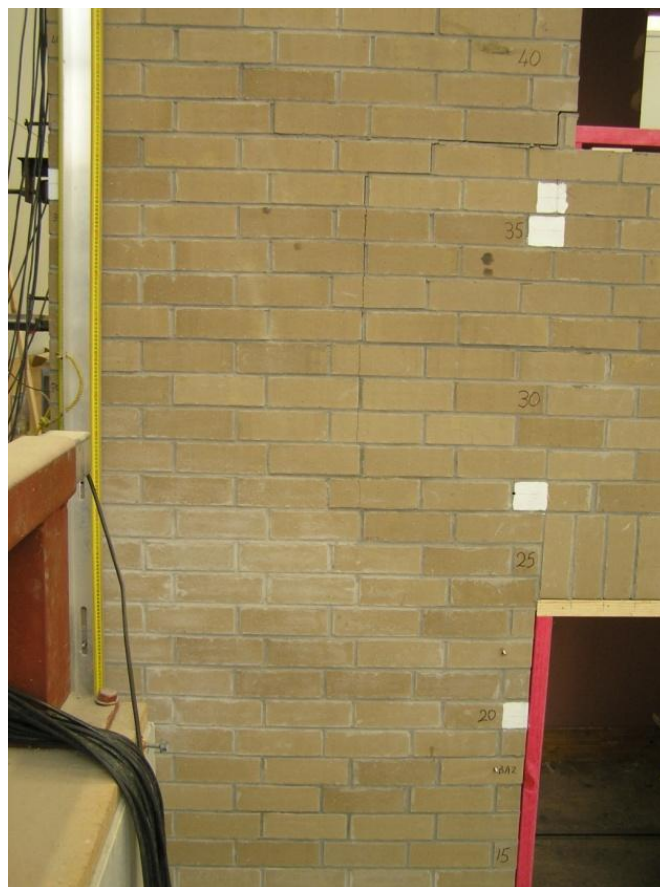
Figure 72. Residual cracking in Panel A Side 1 veneer at zero load after Stage E cycling
