STUDY REPORT

SR No. 204 (2009)

Seismic performance of brick veneer houses

Phase 4. Cyclic racking of a two-storey clay-brick veneer building

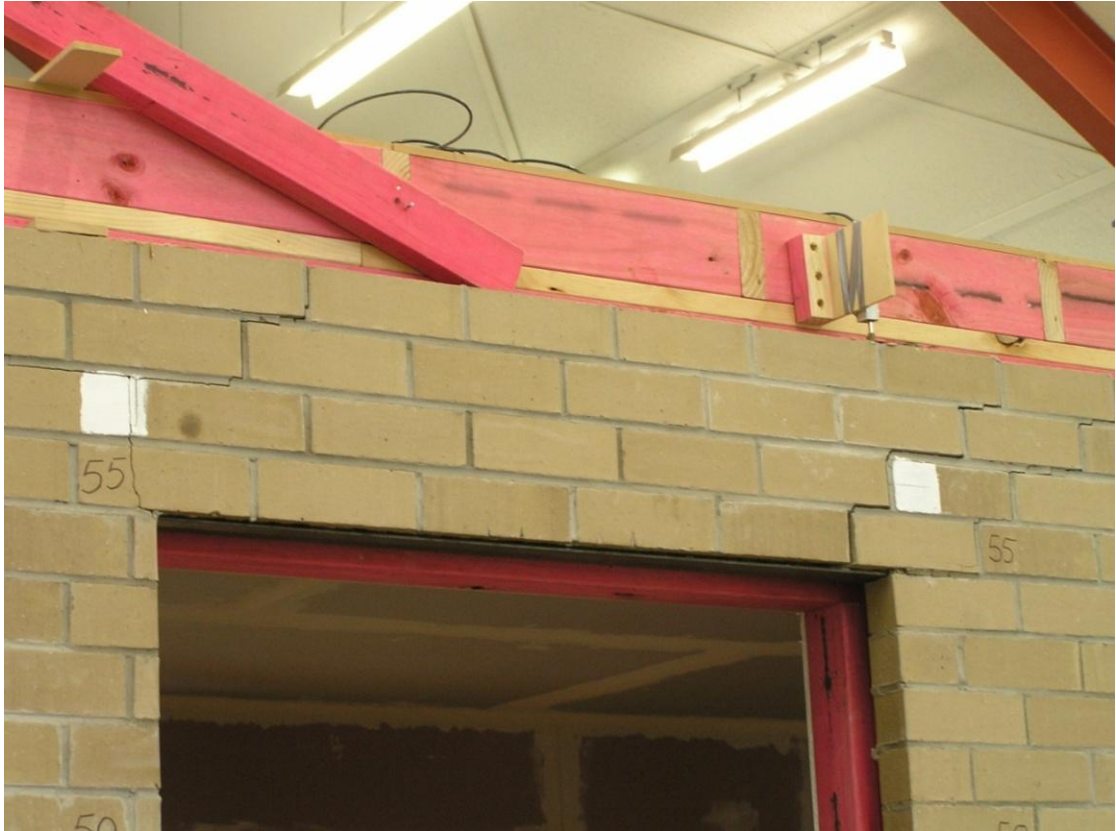
Figure 73. Residual cracking in Side 1 veneer above a top window at zero load after Stage E cycling

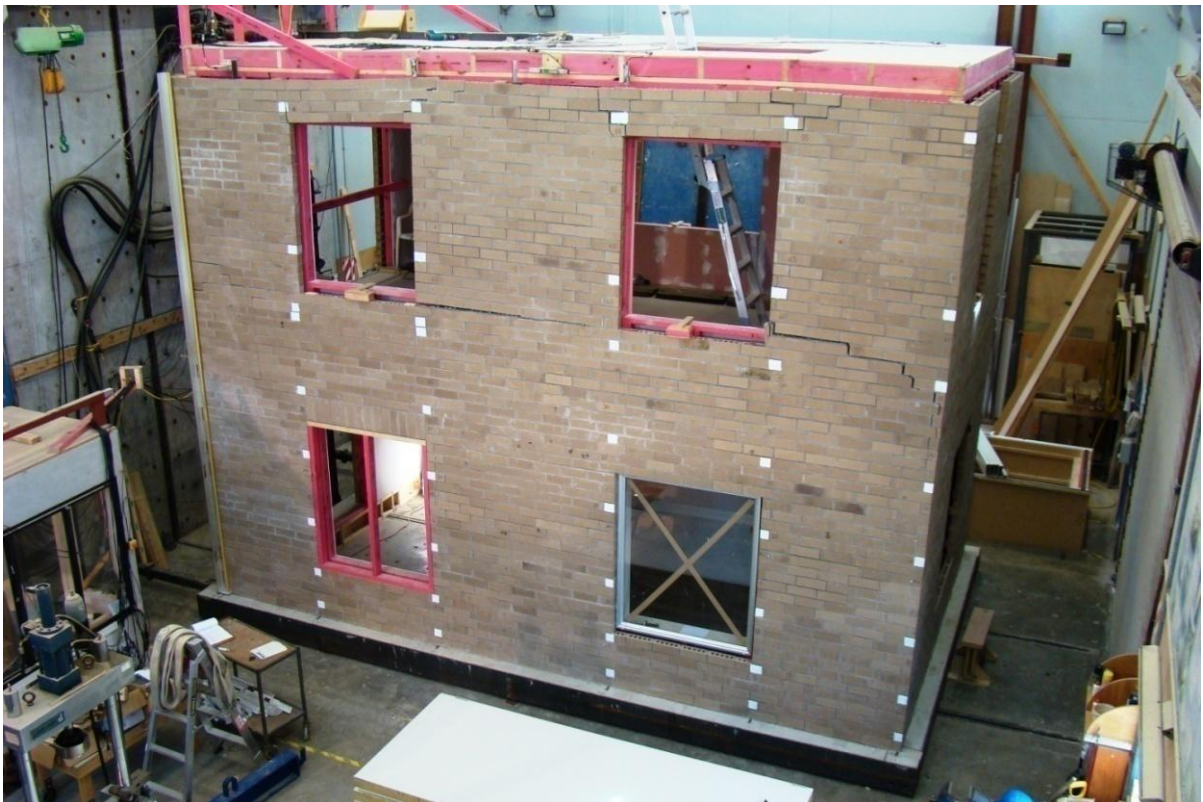
Figure 74. Cracking in Side 1 veneer at peak push in Stage F

At peak loads in Stage F the veneer cracks were sufficiently wide to be able to be seen in total building width photographs (e.g. Figure 74 and Figure 75 for Side 1 at peak push and pull respectively). Corresponding photographs for Side 2 are

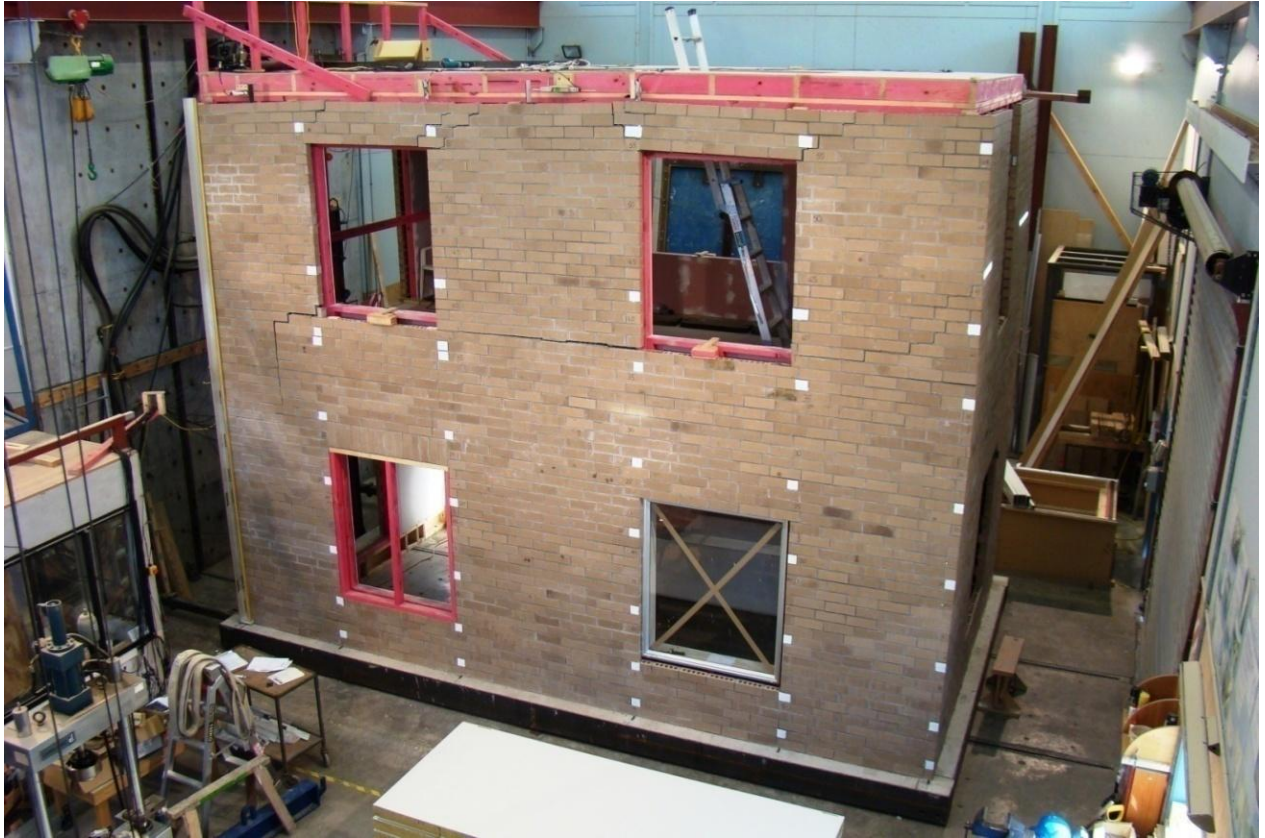
Figure 75. Cracking in Side 1 veneer at peak pull in Stage F

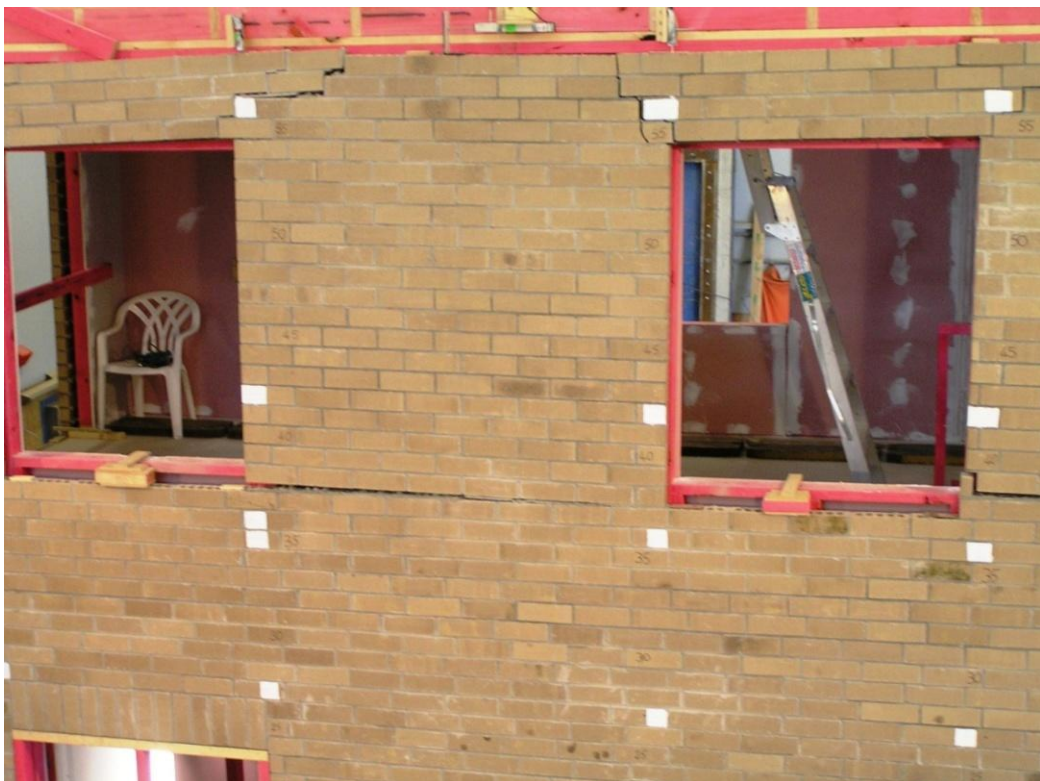
Figure 76. Cracking in Side 1 veneer at Panel B at peak push in Stage F

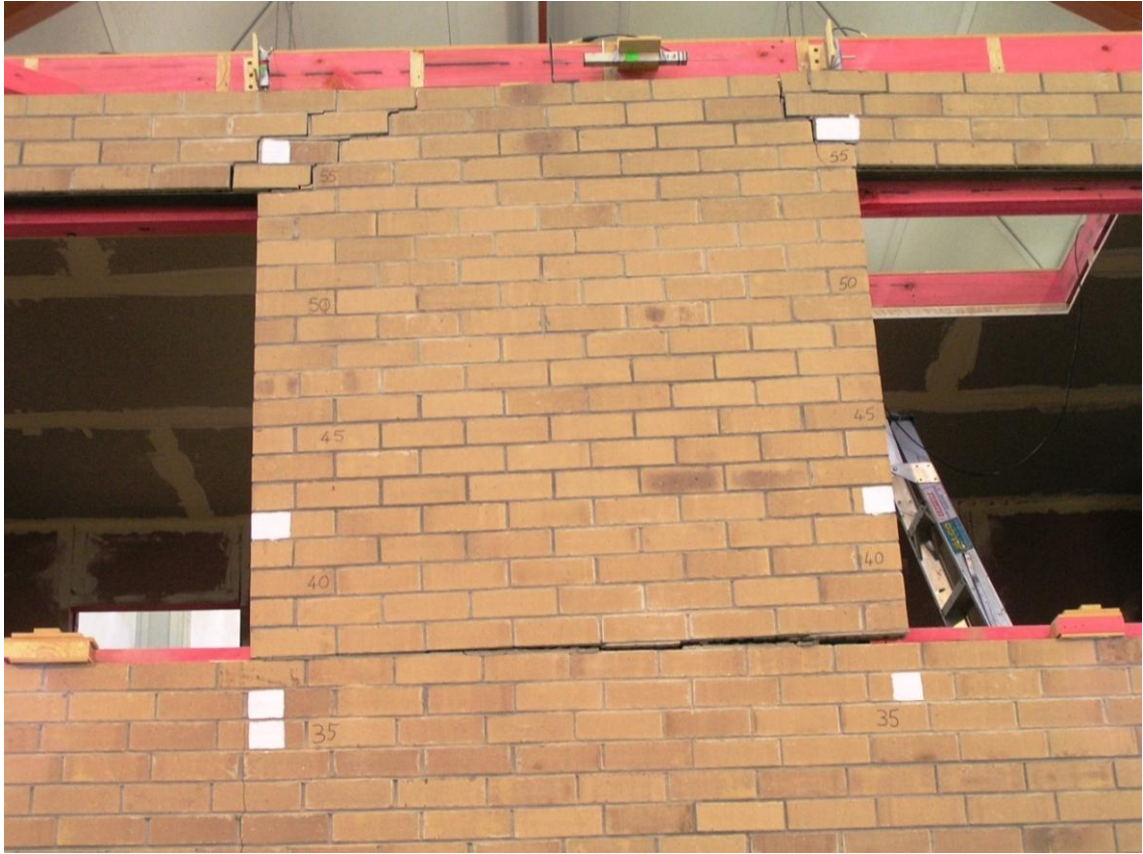
Figure 77. Cracking in Side 1 veneer at Panel B at Peak pull in Stage F

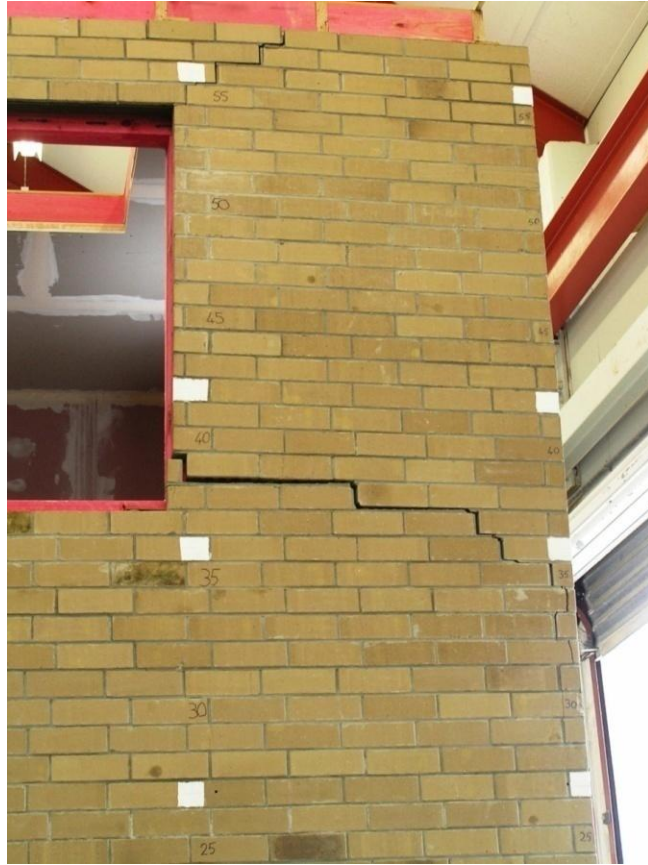
Figure 79. Cracking in Side 1 veneer at Corner 2 top window at peak push in Stage F

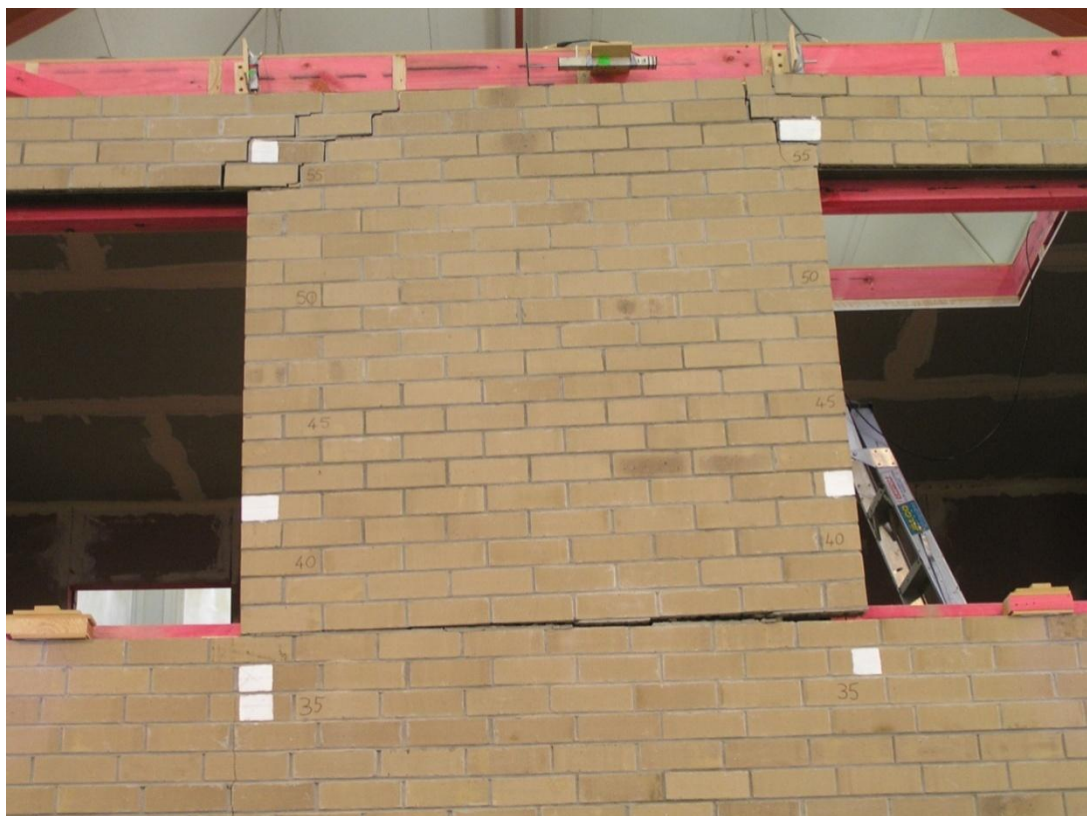
Figure 80. Cracking in Side 1 veneer at Panel B at peak pull in Stage F

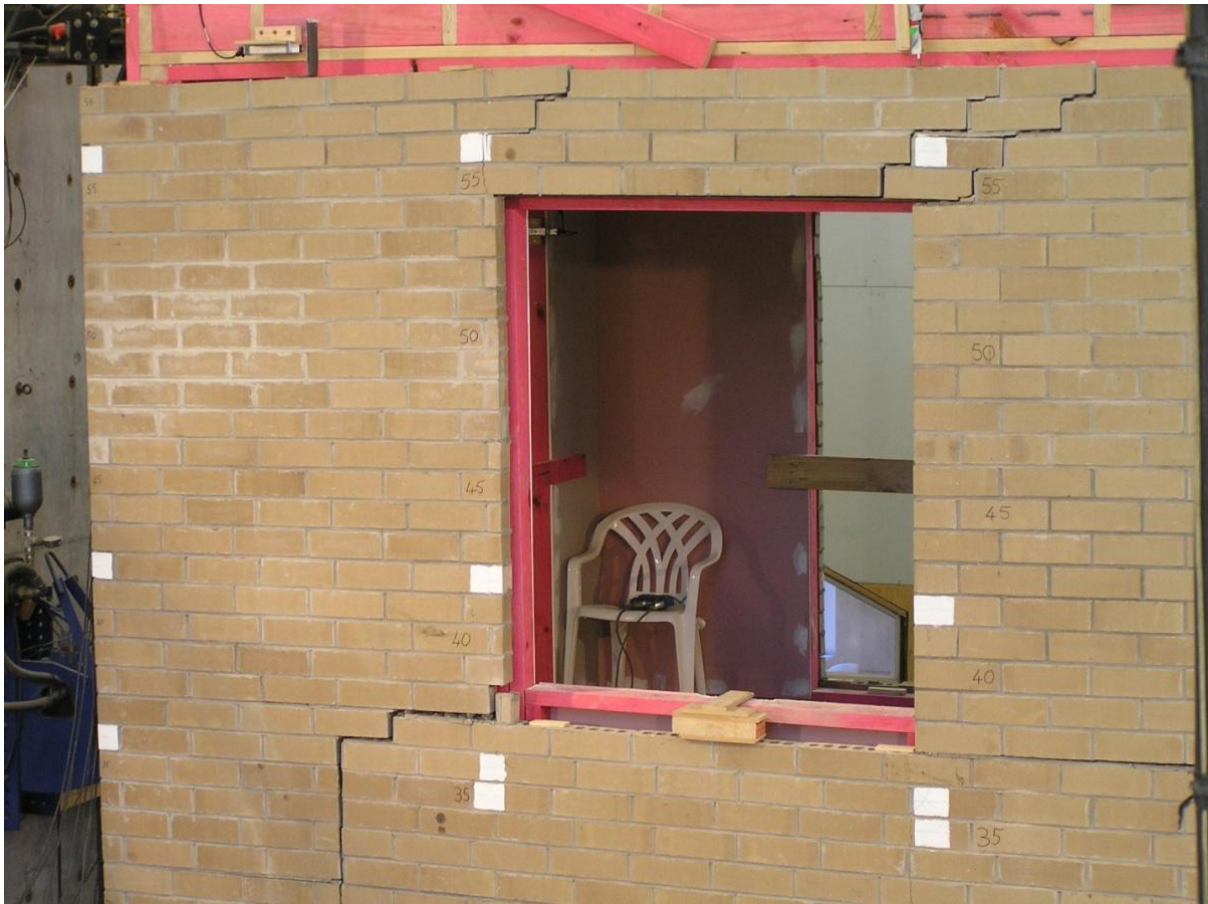
Figure 81. Cracking in Side 1 veneer at Corner 1 at peak pull in Stage F

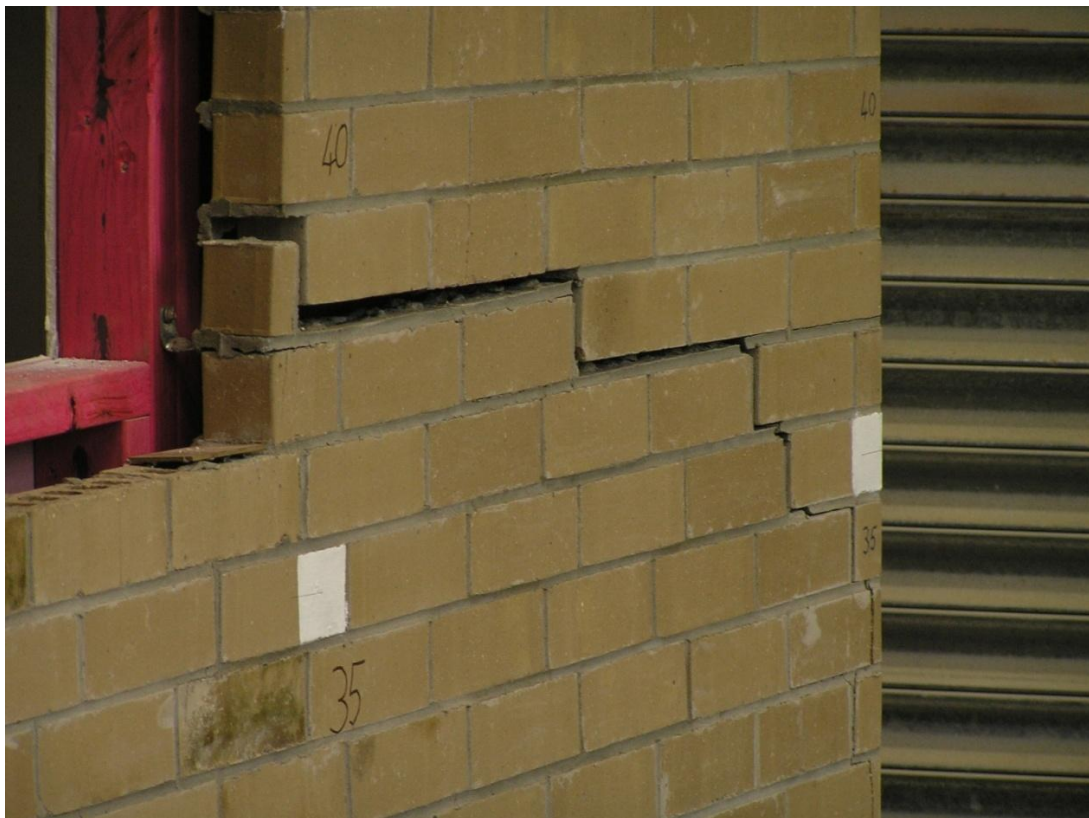
Figure 82. Cracking in Side 1 veneer at Panel C top window at peak push in Stage F

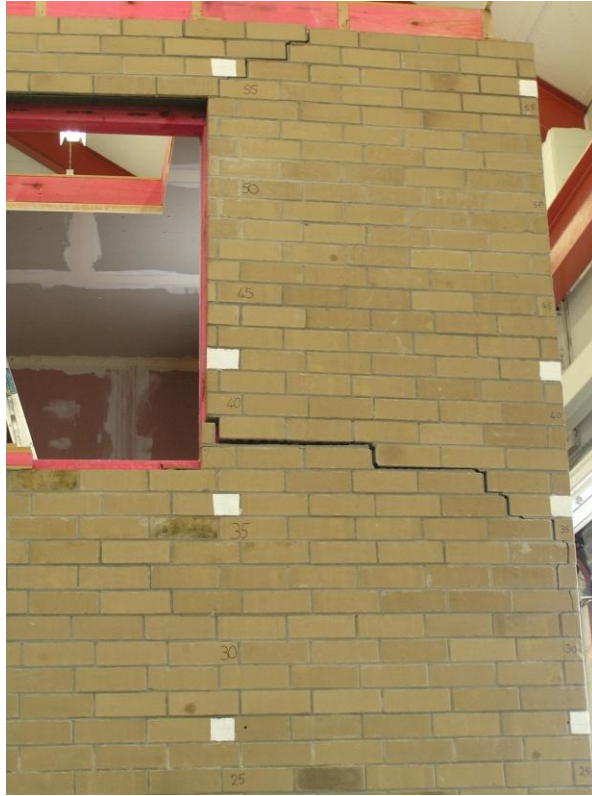
Figure 83. Cracking in Side 1 veneer at Panel C at peak push in Stage F

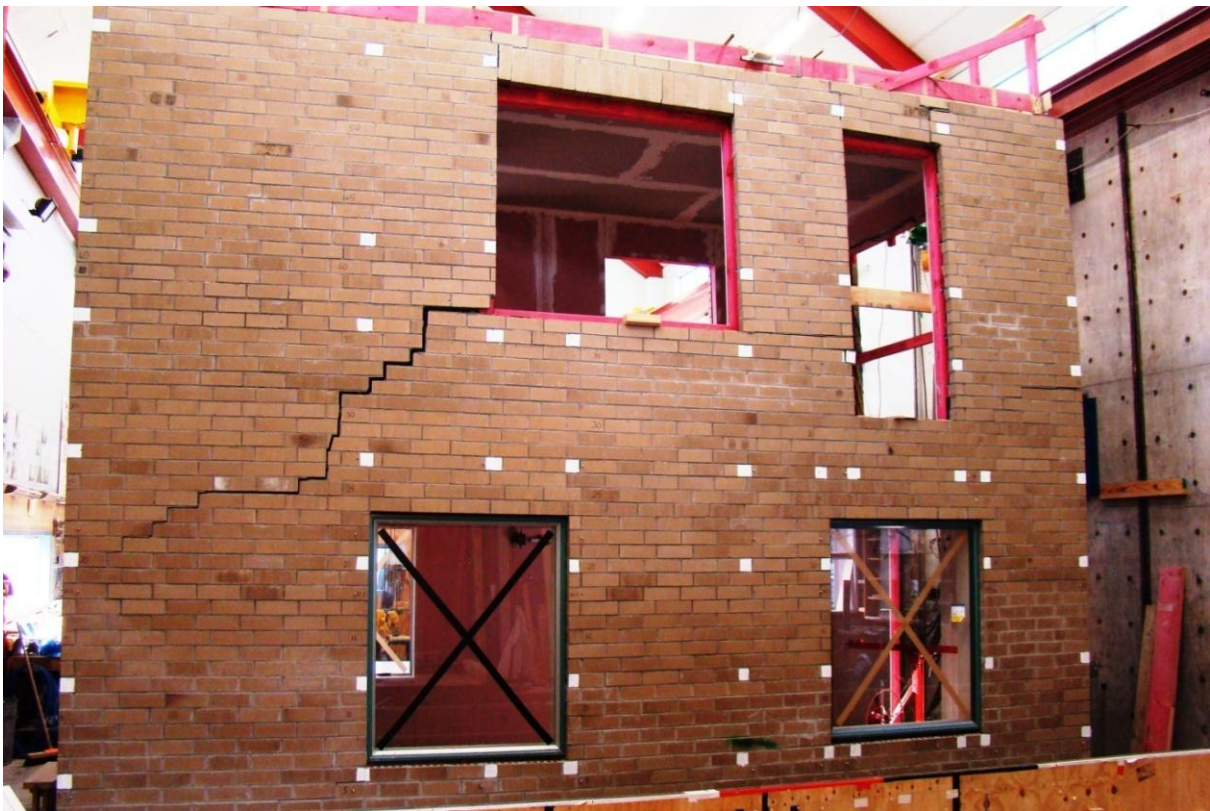
Figure 84. Cracking in Side 2 veneer at peak push in Stage F

Figure 84 and Figure 85. It can be seen that damage is largely confined to the upper storey which is not surprising as the peak lower-storey deflection was only 12 mm, even though the veneer carried 69 kN in shear which was 73% of the applied load. Although cracks did occur in the lower-storey veneer (Figure 34 to Figure 41), the cracks were very fine and cannot be seen in the photographs. Close-up photographs of the veneer cracking in Stage F are shown in Figure 76 to Figure 83 for Side 1 and Figure 84 to Figure 88 for Side 2. Figure 89 shows the cracking in End 2. Note the vertical cracks near Corner 3.

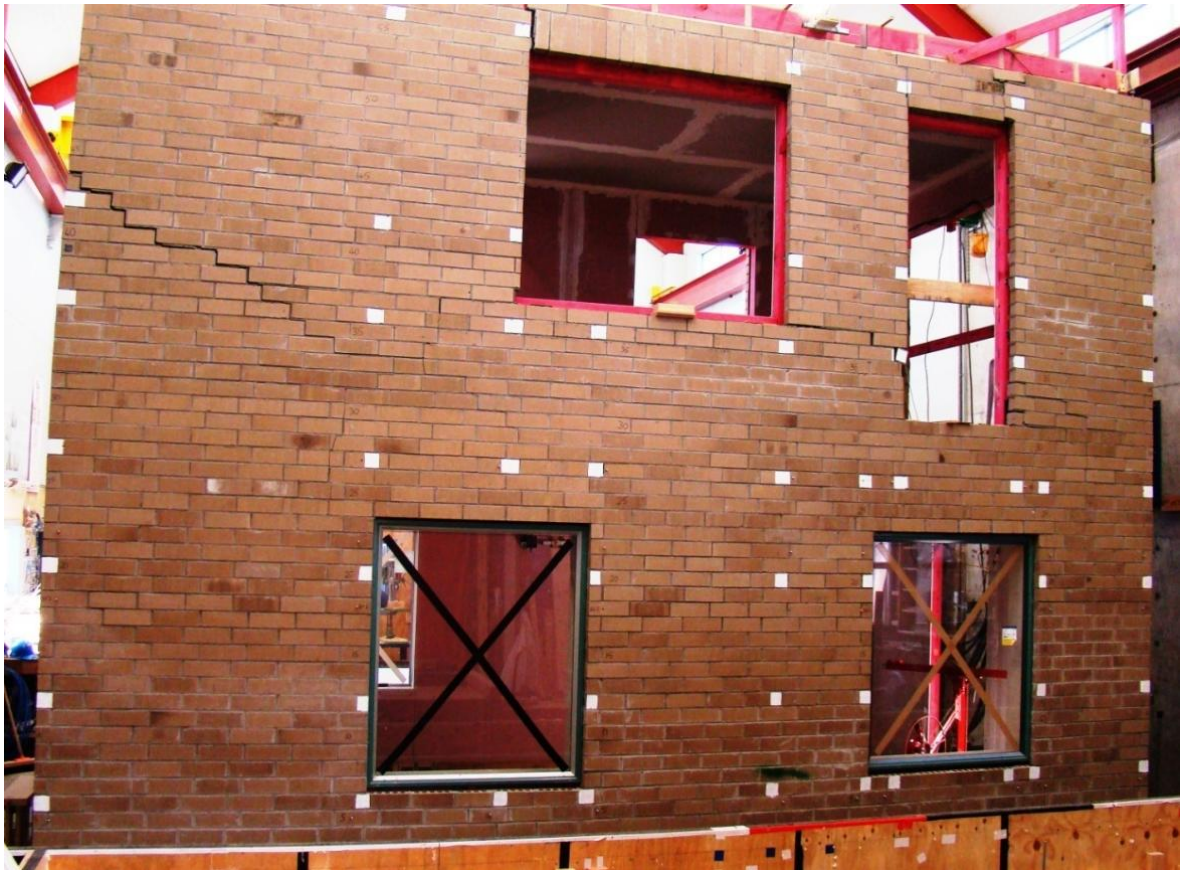
Figure 85. Cracking in Side 2 veneer at peak pull in Stage F

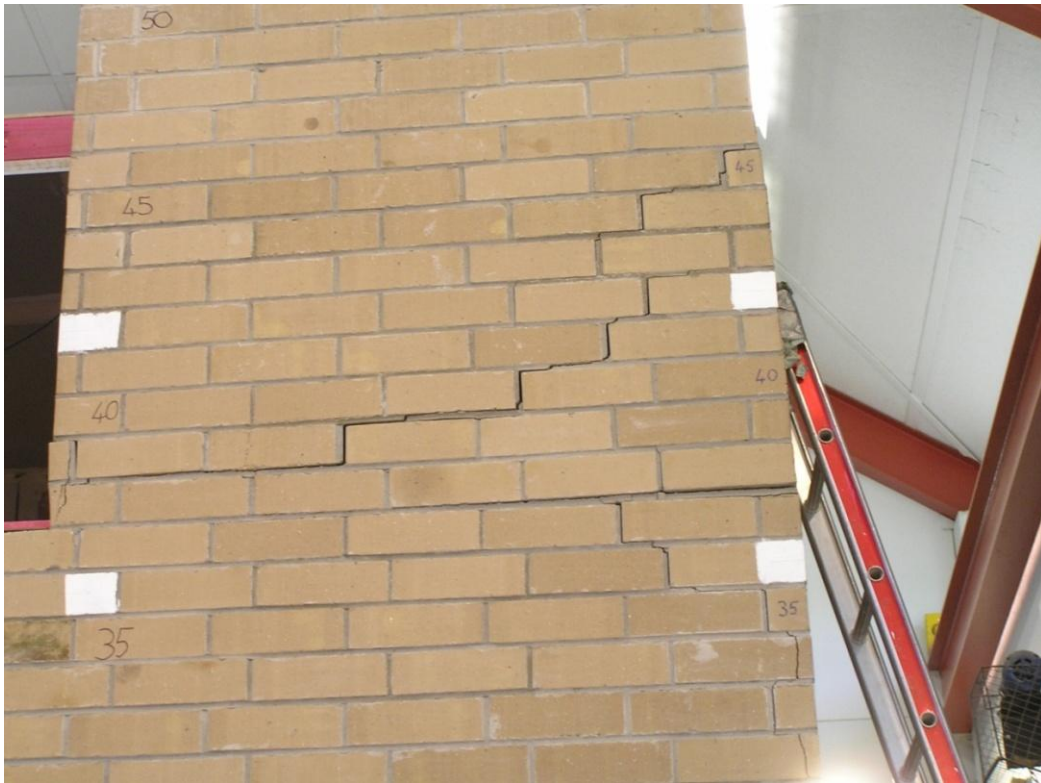
Figure 87. Cracking in Side 2 upper-storey veneer at Panel H at peak push in Stage F

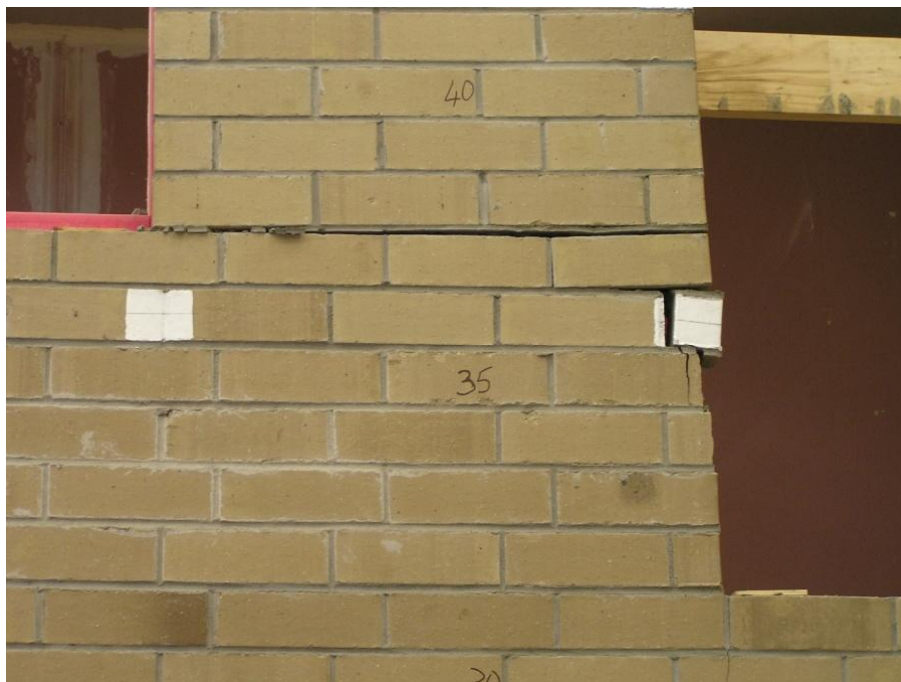
Figure 88. Cracking in Side 2 upper-storey veneer at Panel G at peak push in Stage F

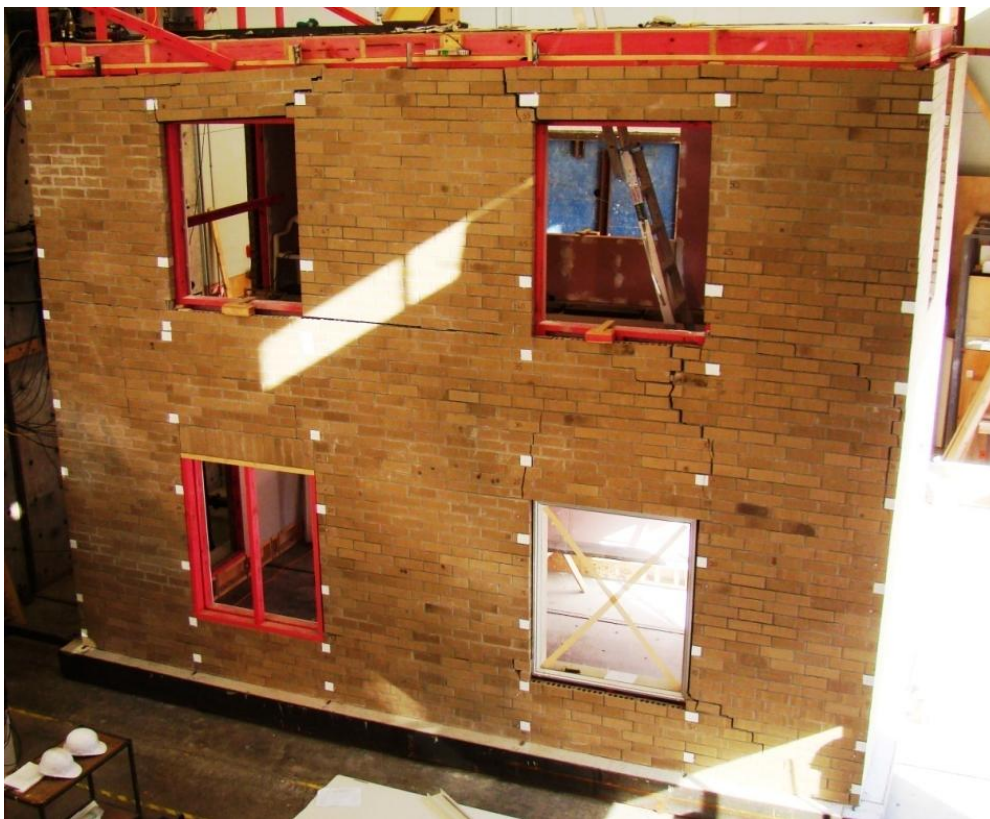
Figure 90. Cracking in Side 1 veneer at peak push in Stage G

In Stage G the test regime changed to deflection control to enable greater lower-storey deflections to be imposed. Figure 90 and Figure 91 show the cracking in Side 1 at peak push and pull loads respectively. Major cracks occurred mainly in the middle spandrel, as shown in Figure 92 and Figure 93. Crushing at the bottom window corners occurred as shown in Figure 94 and Figure 95 due to the high axial stress at these locations as the panels above rocked and pivoted at these corners. Figure 96 and Figure 97 show the cracking in Side 2 at peak push and pull loads respectively. It can be seen that the most severe cracking is in the middle spandrels and the brickwork above pivot points on these spandrel cracks.

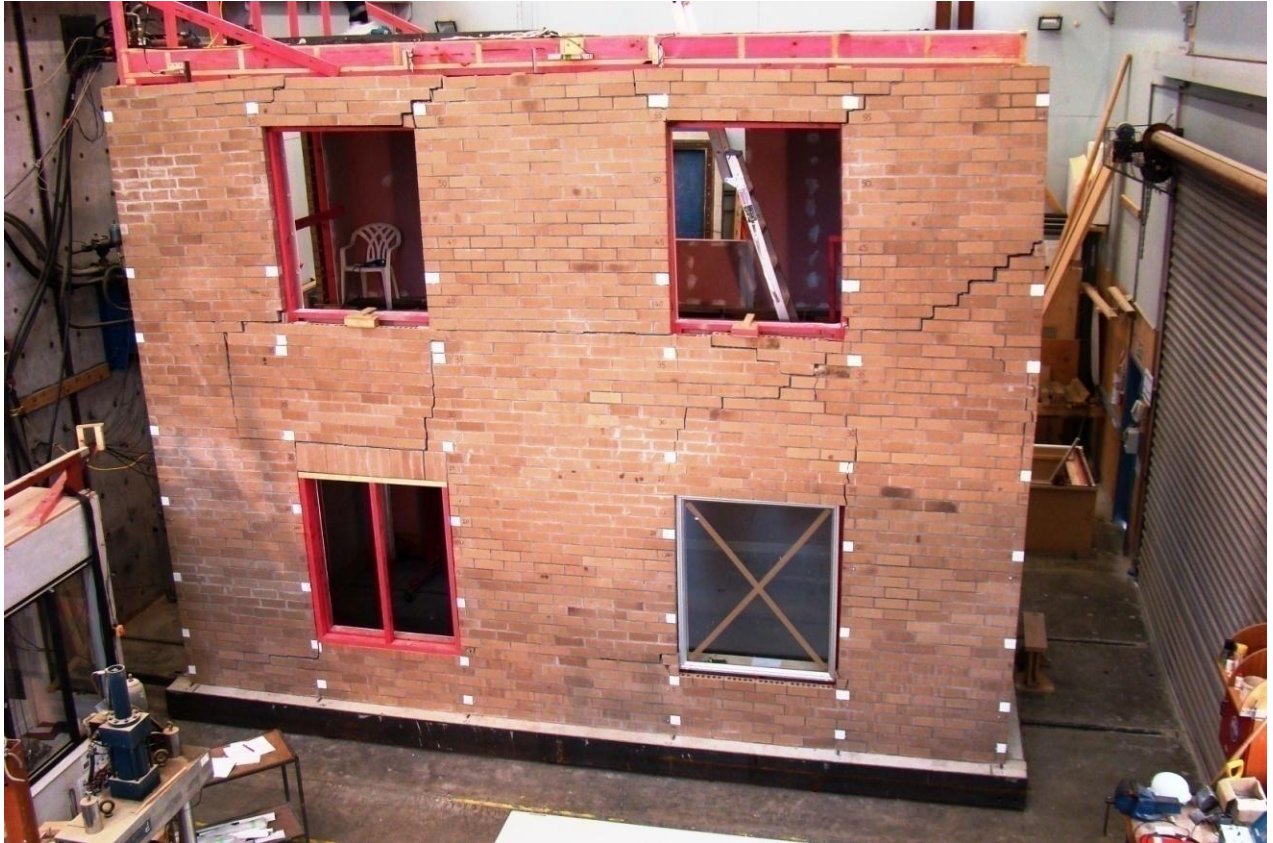
Figure 91. Cracking in Side 1 veneer at peak pull in Stage G

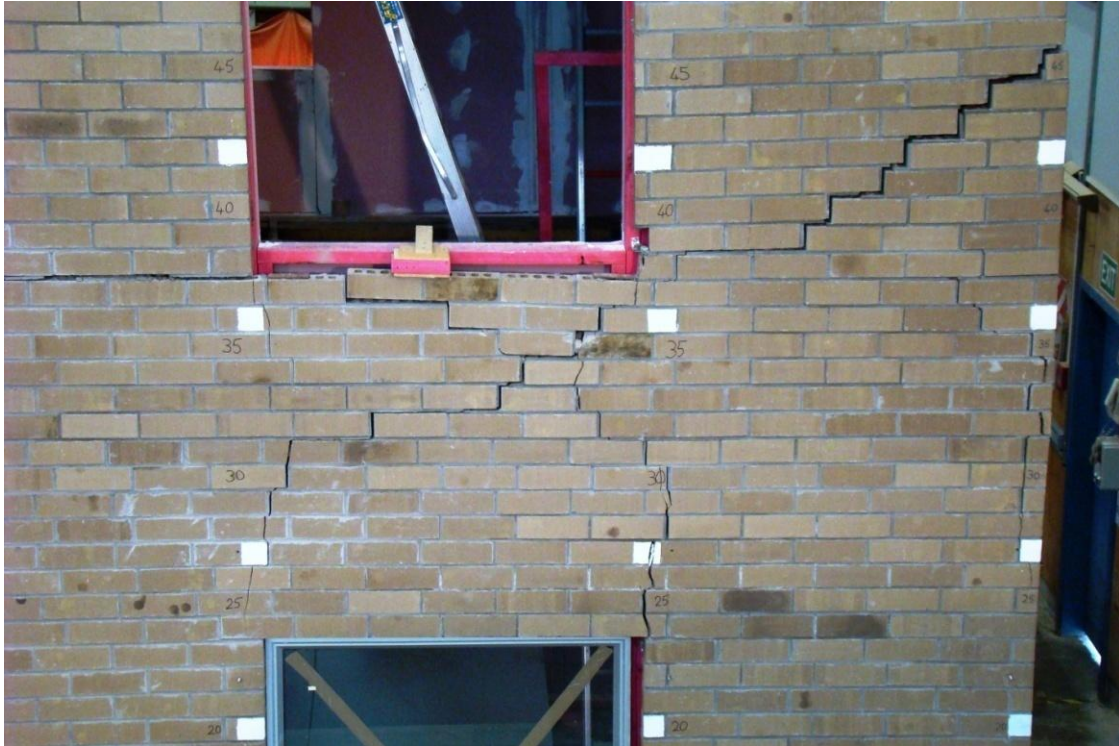
Figure 93. Cracking in Side 1 veneer at Corner 2 middle spandrel at peak pull in Stage G

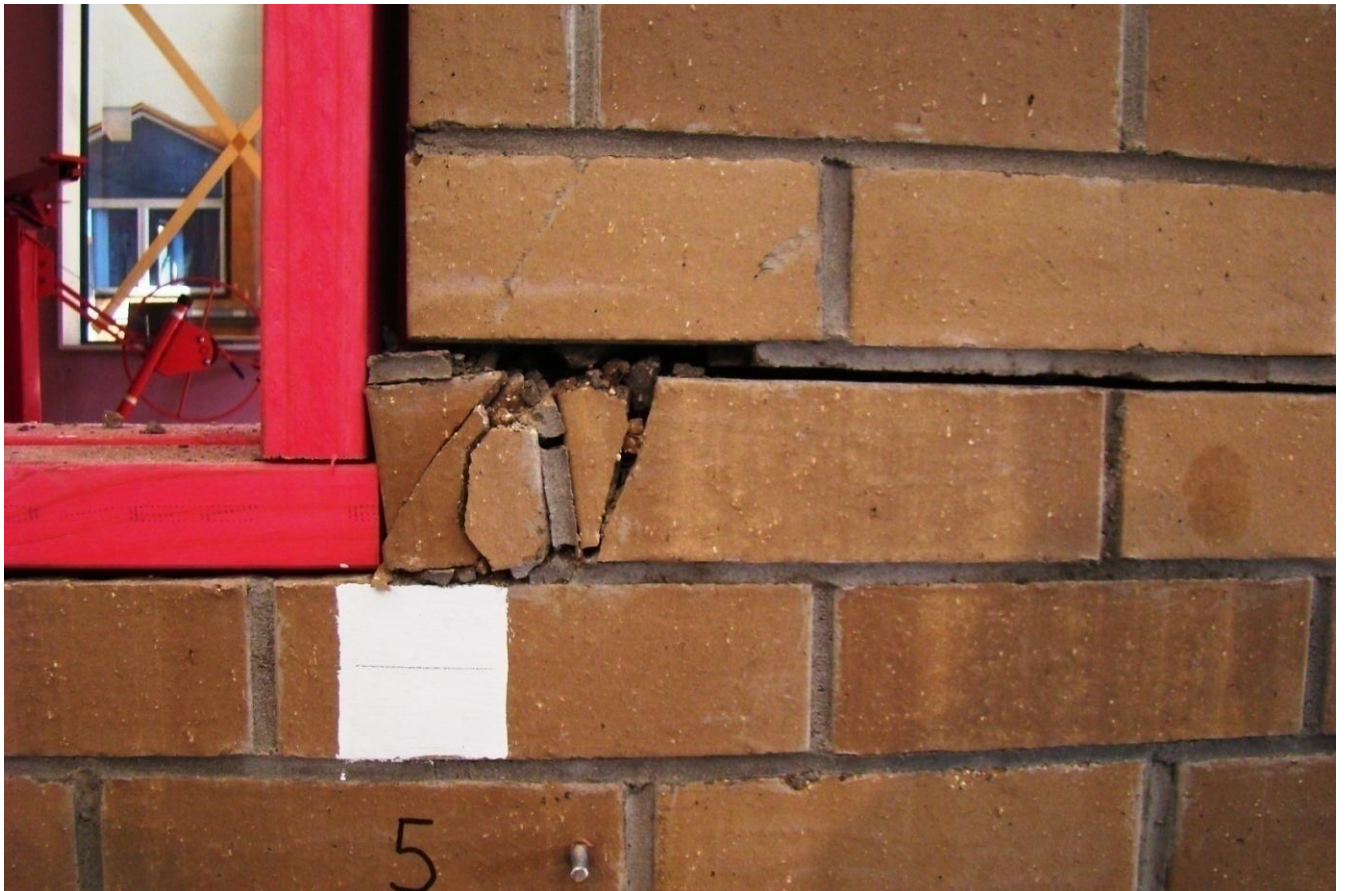
Figure 94. Brick crushing in Side 1 lower-storey veneer at Window S1B in Stage G

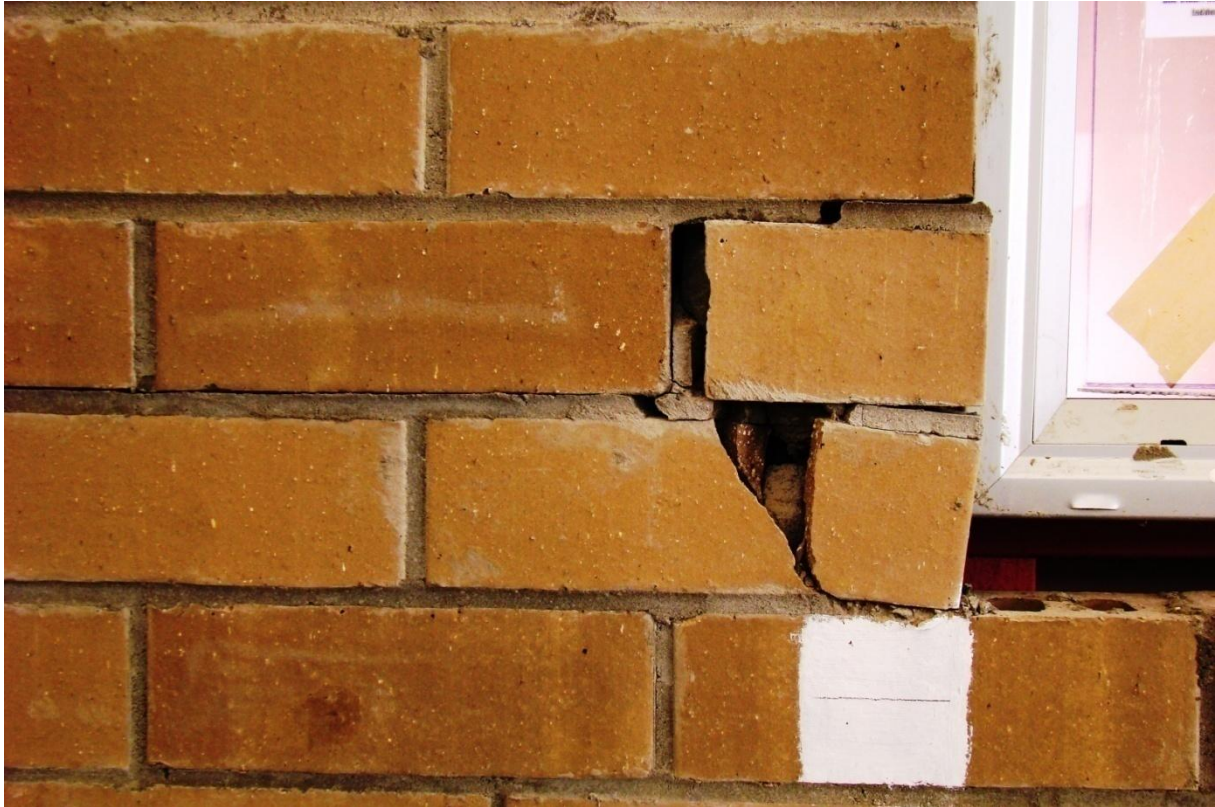
Figure 95. Brick damage in Side 1 lower-storey veneer at Window S1A in Stage G

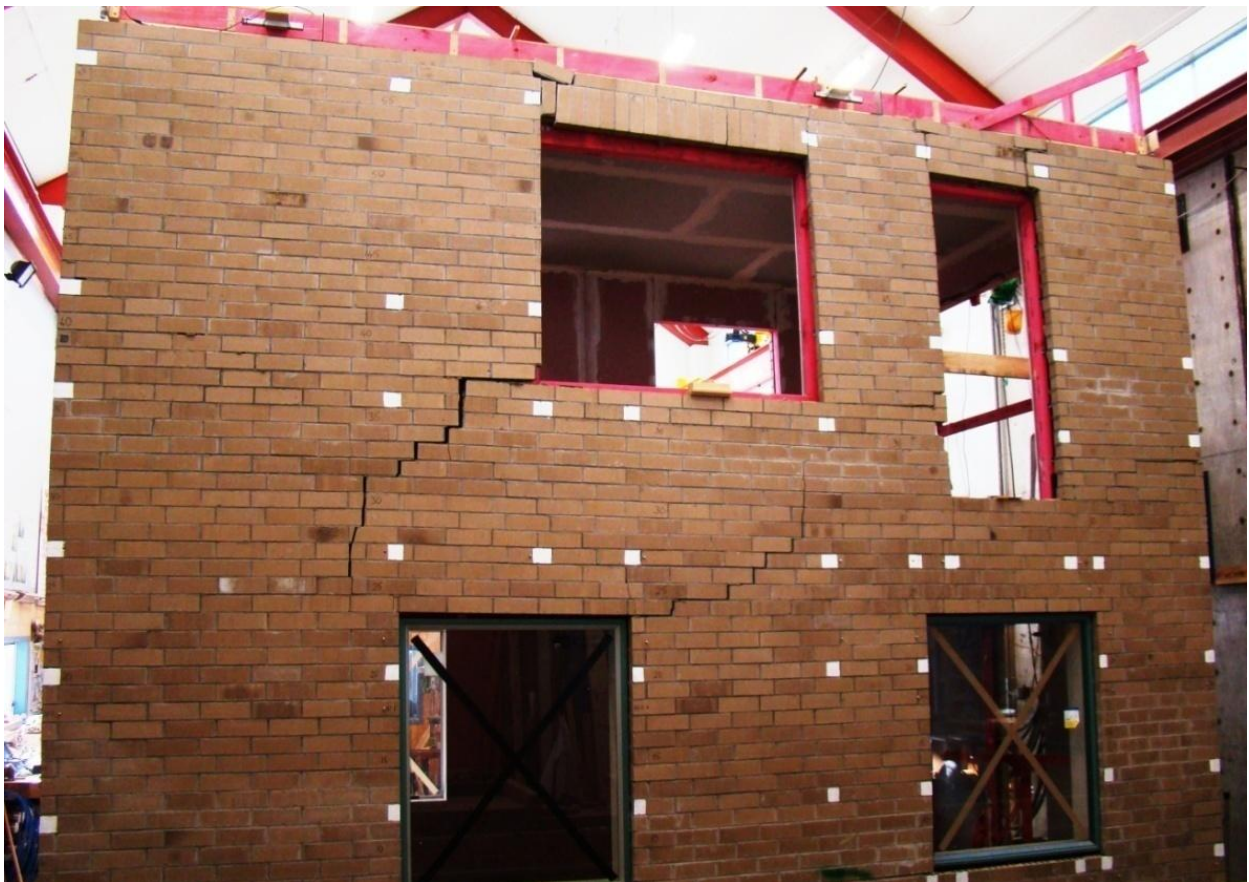
Figure 96. Cracking in Side 2 veneer at peak push in Stage G

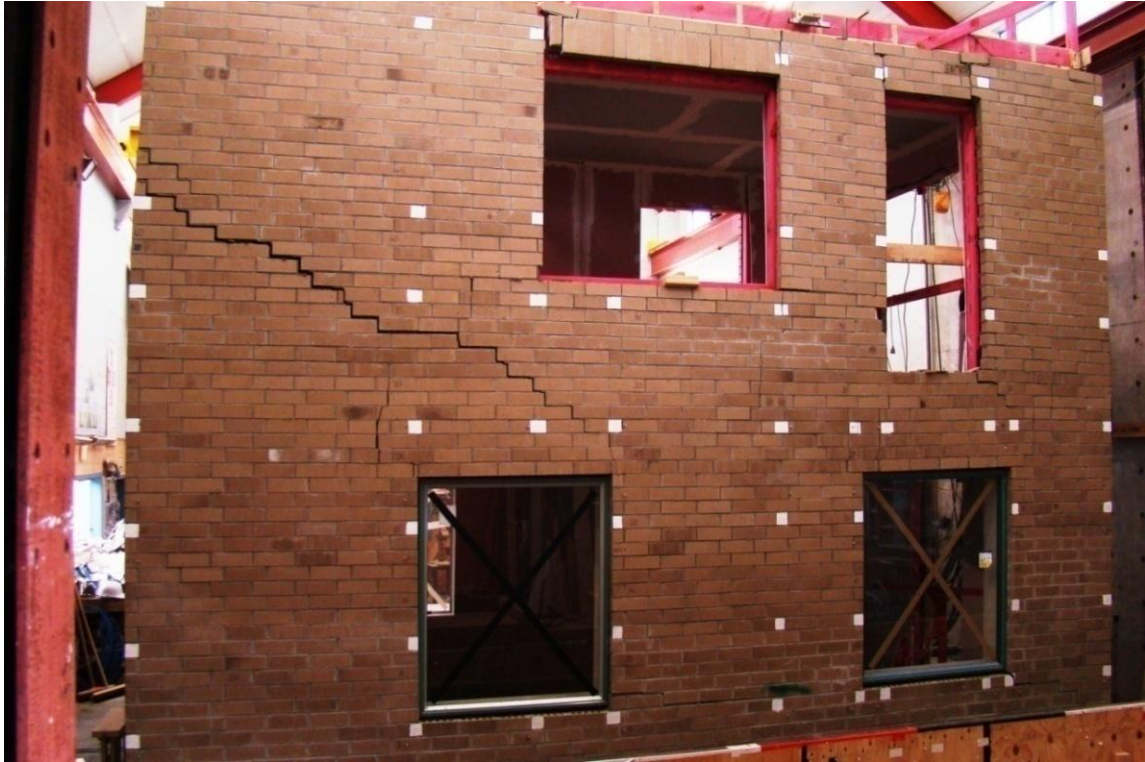
Figure 97. Cracking in Side 2 veneer at peak pull in Stage G

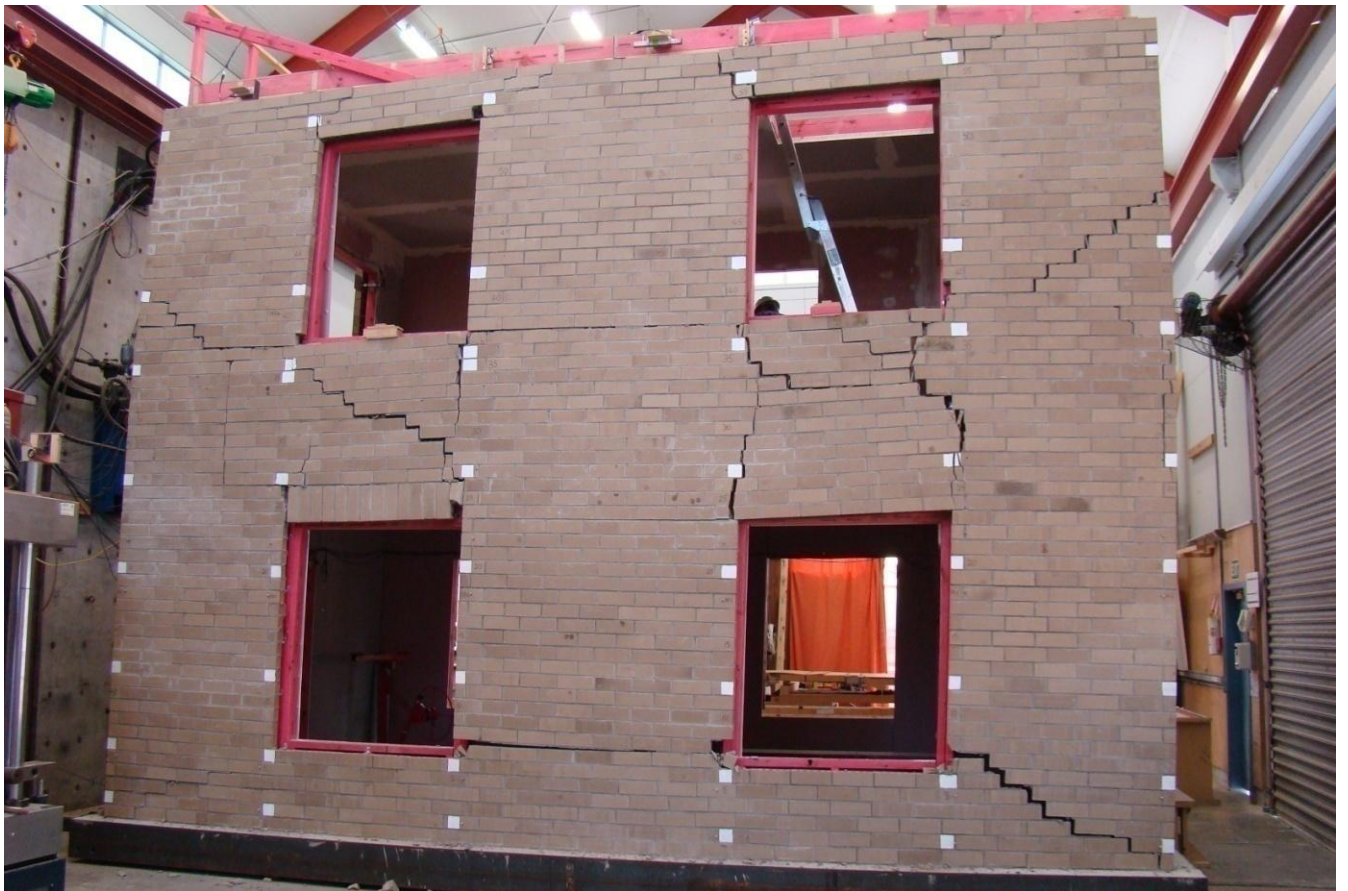
Figure 98. Cracking in Side 1 veneer at peak push in Stage I

Figure 98 and Figure 99 show the cracking in Side 1 and Figure 101 and Figure 103 show the cracking in Side 2 from Stage I loading. Damage is severe in all spandrels and from cracks emanating from all window corners. However, only a few isolated bricks fell and the panels showed little cracking over the depth of the windows.

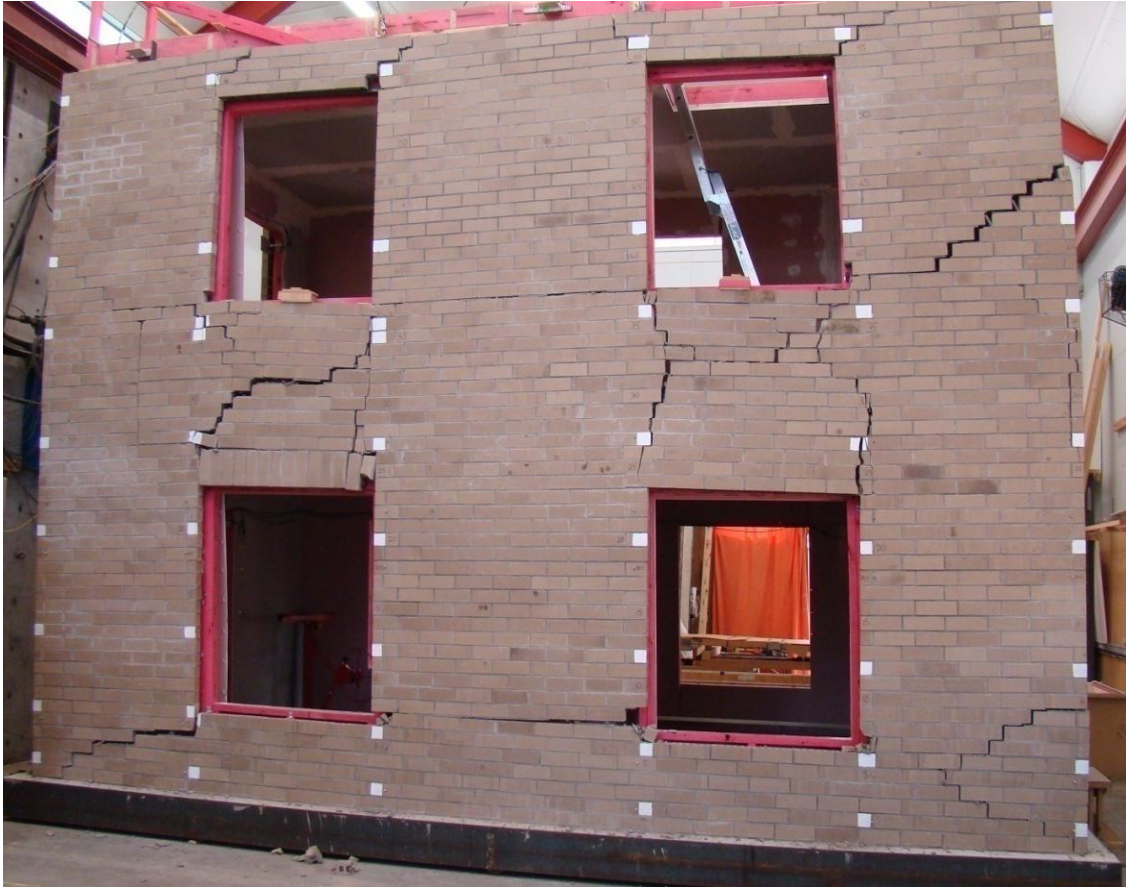
Figure 99. Cracking in Side 1 veneer at peak pull in Stage I

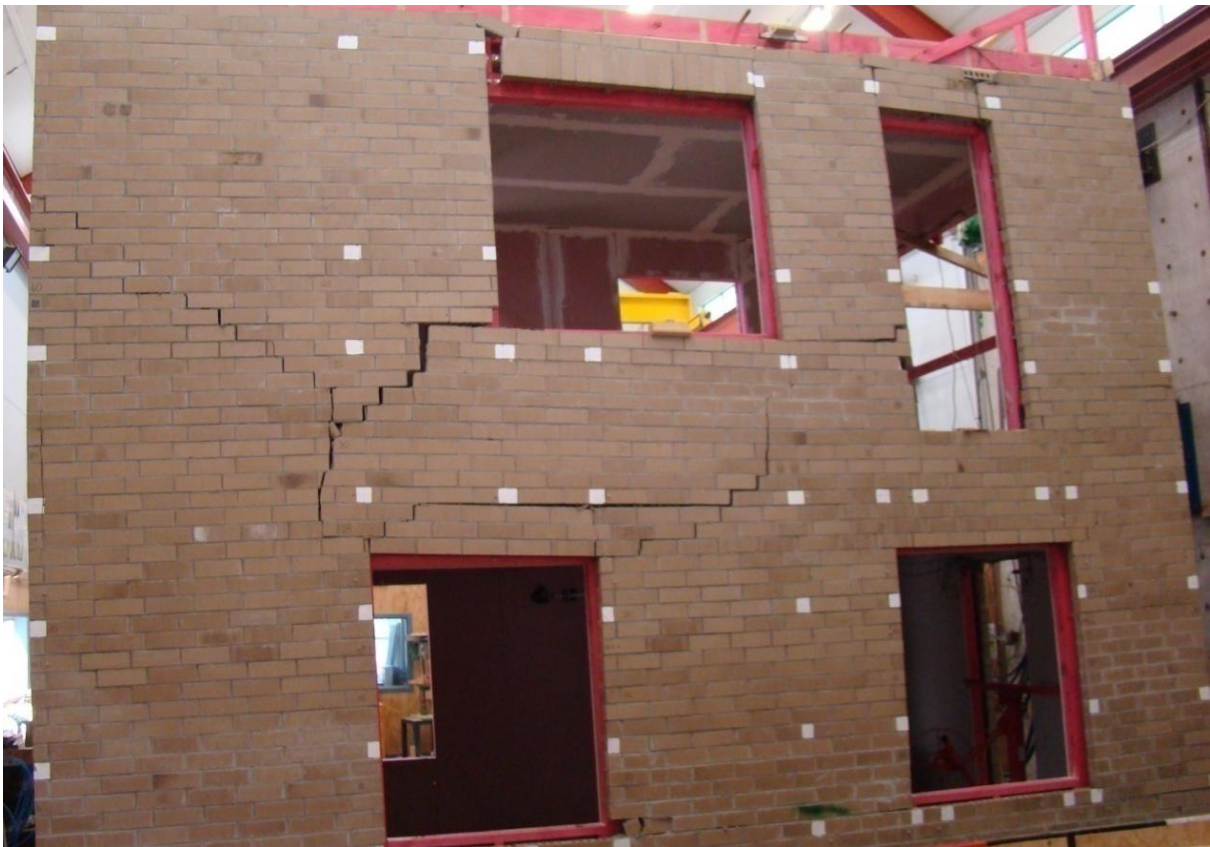
Figure 100. Cracking in Side 2 veneer at peak push in Stage I
