STUDY REPORT

SR No. 204 (2009)

Seismic performance of brick veneer houses

Phase 4. Cyclic racking of a two-storey clay-brick veneer building

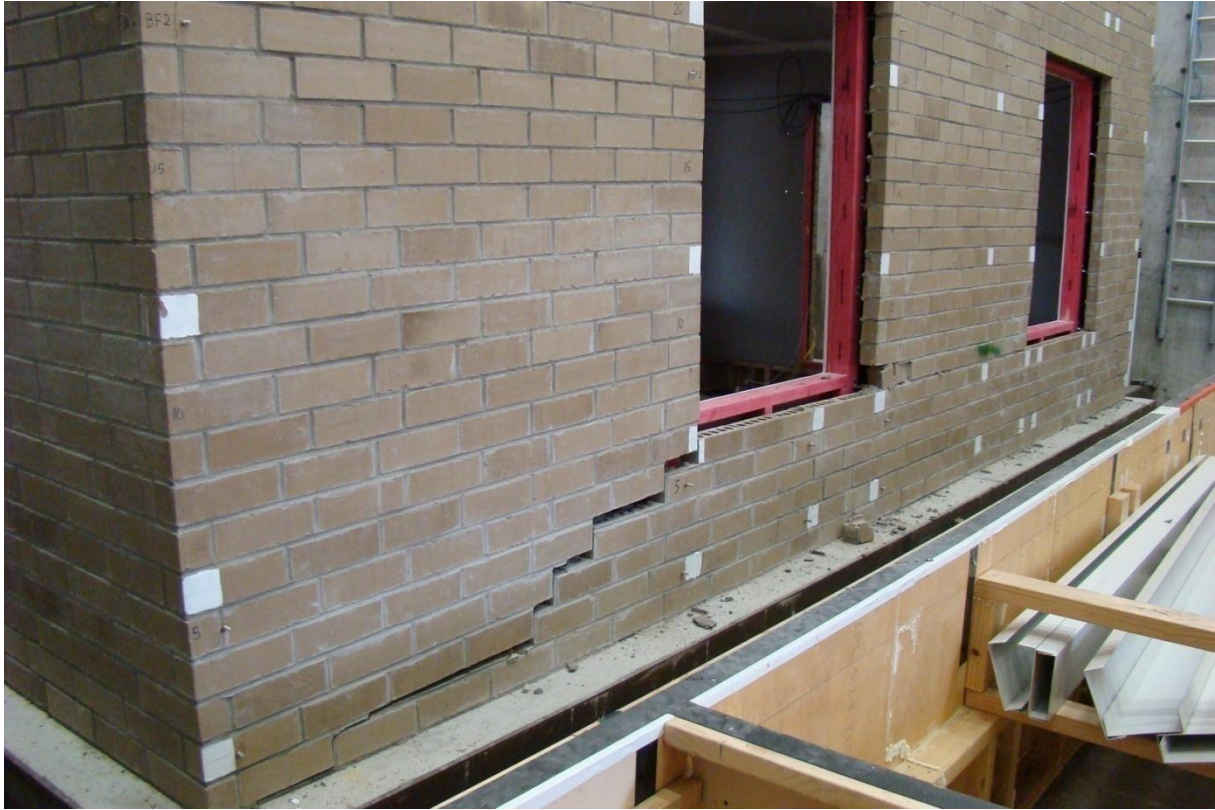
Figure 101. Cracking in Side 2 bottom spandrel at peak push in Stage I

Figure 98 and Figure 99 show the cracking in Side 1 and Figure 101 and Figure 103 show the cracking in Side 2 from Stage I loading. Damage is severe in all spandrels and from cracks emanating from all window corners. However, only a few isolated bricks fell and the panels showed little cracking over the depth of the windows.

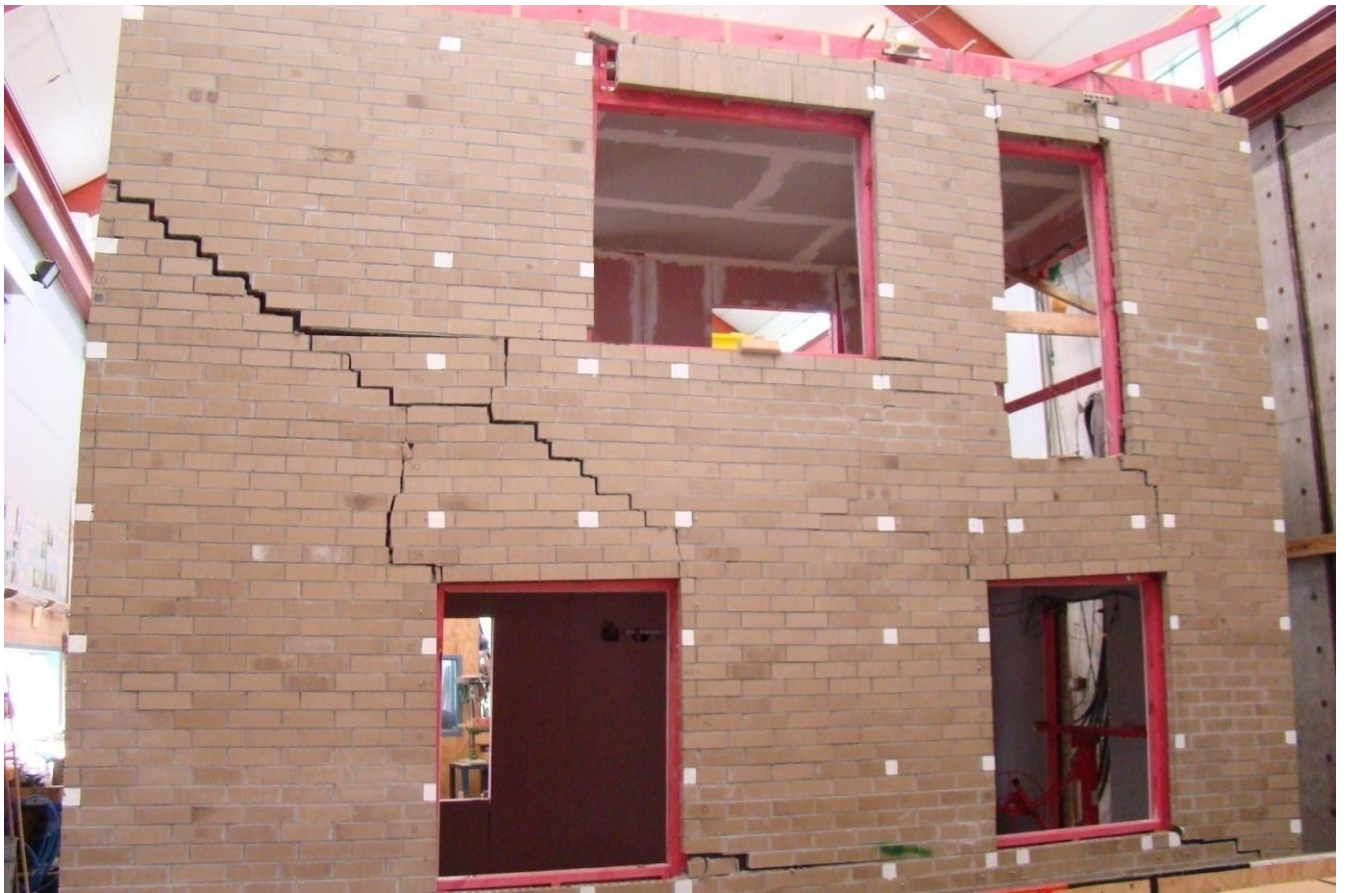
Figure 102. Cracking in Side 2 veneer at peak pull in Stage I

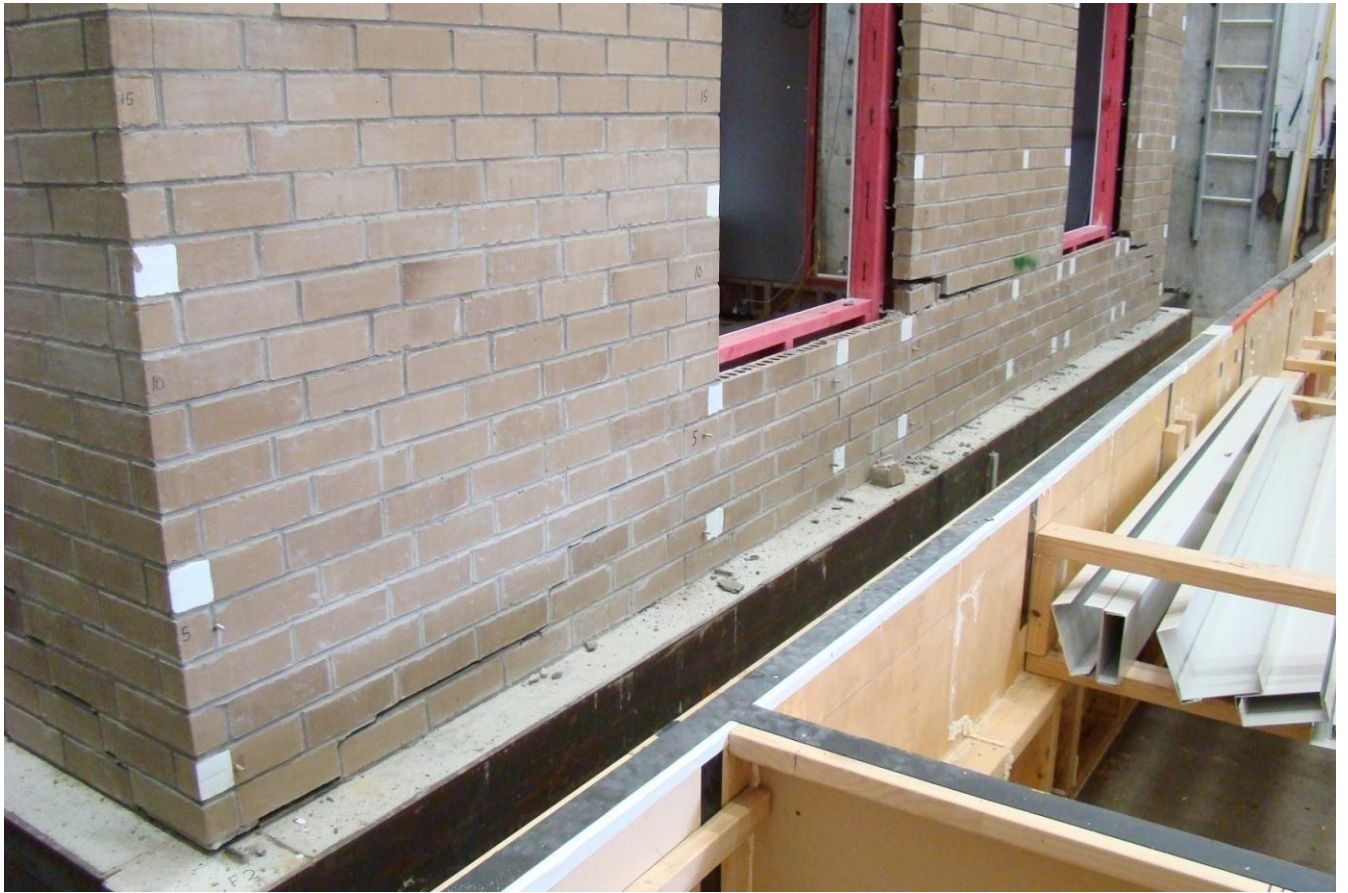
Figure 103. Cracking in Side 2 bottom spandrel at peak pull in Stage I

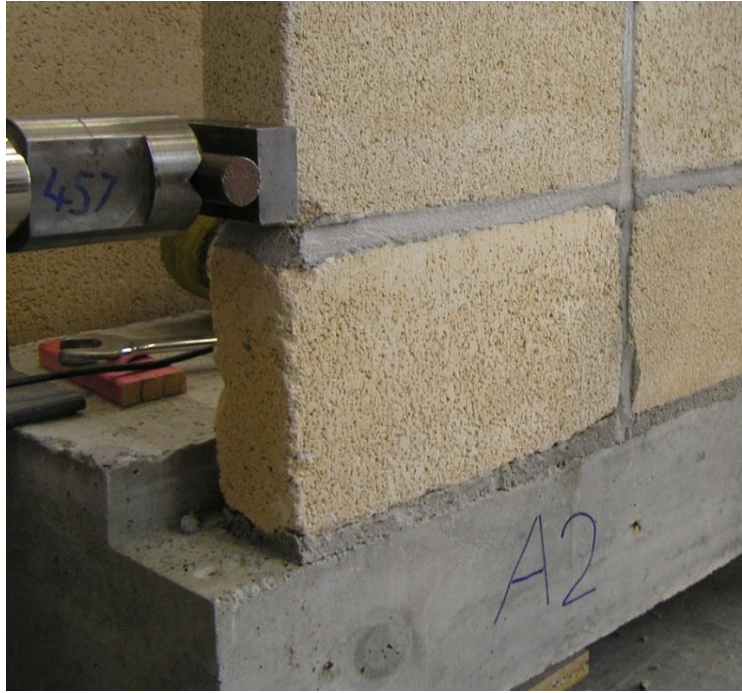
Figure 104. Concrete beam used as a foundation to fix bricks and application of shear load

Three concrete foundations were constructed. Details are given in Figure 104. The top surface of one of these was painted with two coats of Mulseal (a bitumen impregnated liquid which dried to give a surface texture and appearance much like tar). The foundation top edge was rebated 45 mm deep by 90 mm by using lengths of timber having the same cross-section dimensions on the two upper long edges of the mould. Such construction methods are typical on building sites. The concrete needed to flow under the timber which resulted in the surface of the rebate having some voids and lack of smoothness due to entrapped air.

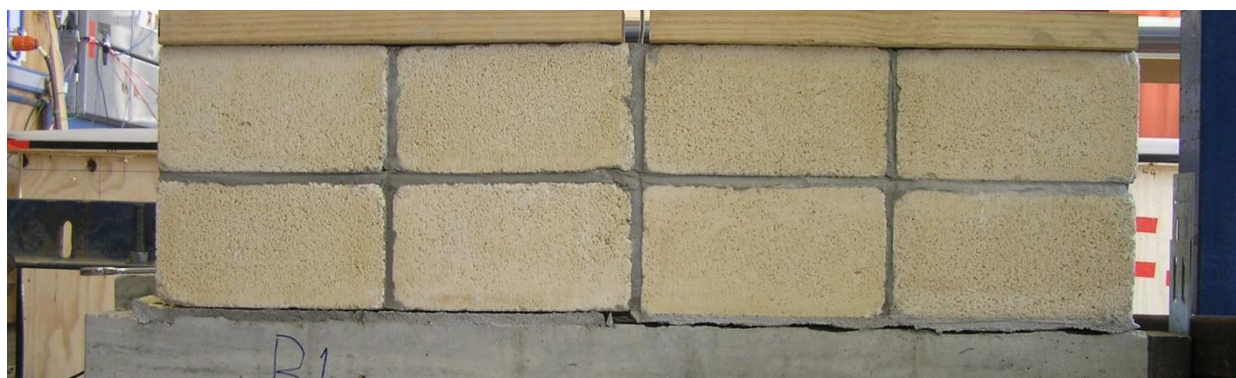
Figure 107. Typical shear failure

In this test on each wall a horizontal load was applied to the bottom layer of bricks and a reaction applied at the bottom of the foundation beam at the opposite end of the specimen, thus measuring the brick-to-foundation shear strength. Results are summarised in Table 11 for concrete brick mortared to a bare concrete foundation and Table 12 for brick mortared to Mulseal-coated concrete foundation. The axial load used in the calculation included the applied load as measured by the load cell, the weight of equipment which loaded the joint which was not measured by the load cell and also the weight of brick above the joint. In all cases failure was between the mortar and brick for part of the foundation length and mortar and substrate for the remainder of the length, as shown in Figure 107.

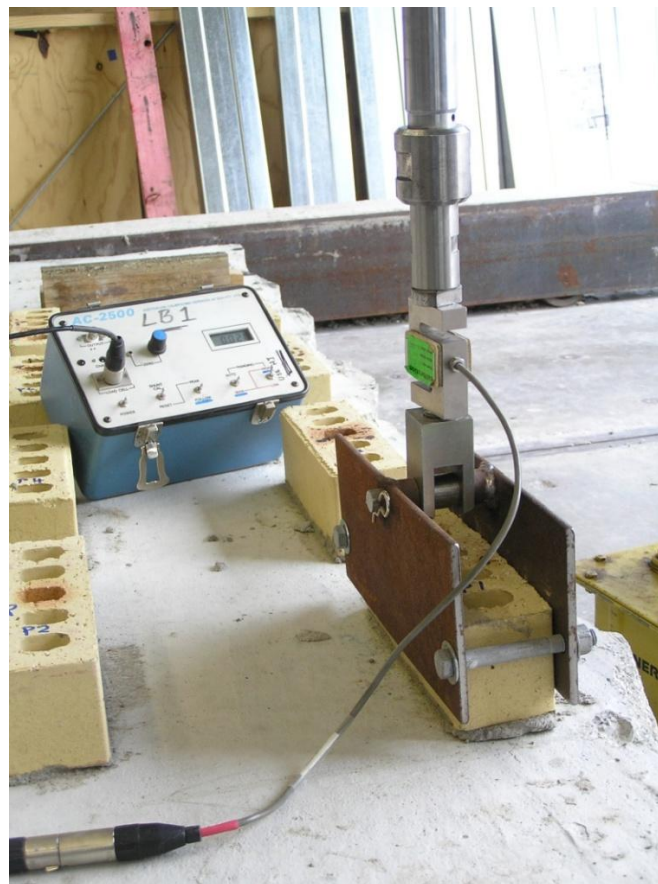
Plucking tests were performed as shown in Figure 110 with the results summarised in Table 14. Plates were bolted together each side of the bricks, thus effectively clamping the brick to the plates. These were mechanically lifted off and the peak load measured by a load cell and strain indicator.

Figure 110. Plucking test set-up

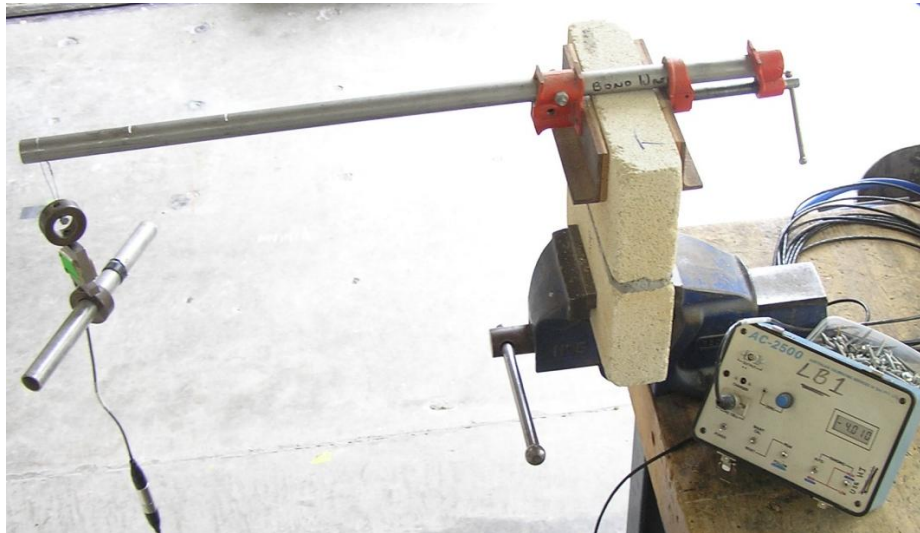
Figure 111. Bond wrench test arrangement

Tests were performed in accordance with NZS 4210 (NZS 2001). A view of the test set-up is shown in Figure 111. Results are given in Table 15. There is a significant scatter of results, but the mean value of 859 kPa is far higher than the 118 kPa obtained from the plucking tests from a concrete foundation (Table 14).
