STUDY REPORT

SR 244 (2011)

Timber Corrosion Test Methodology

BRANZ Study Report SR 244

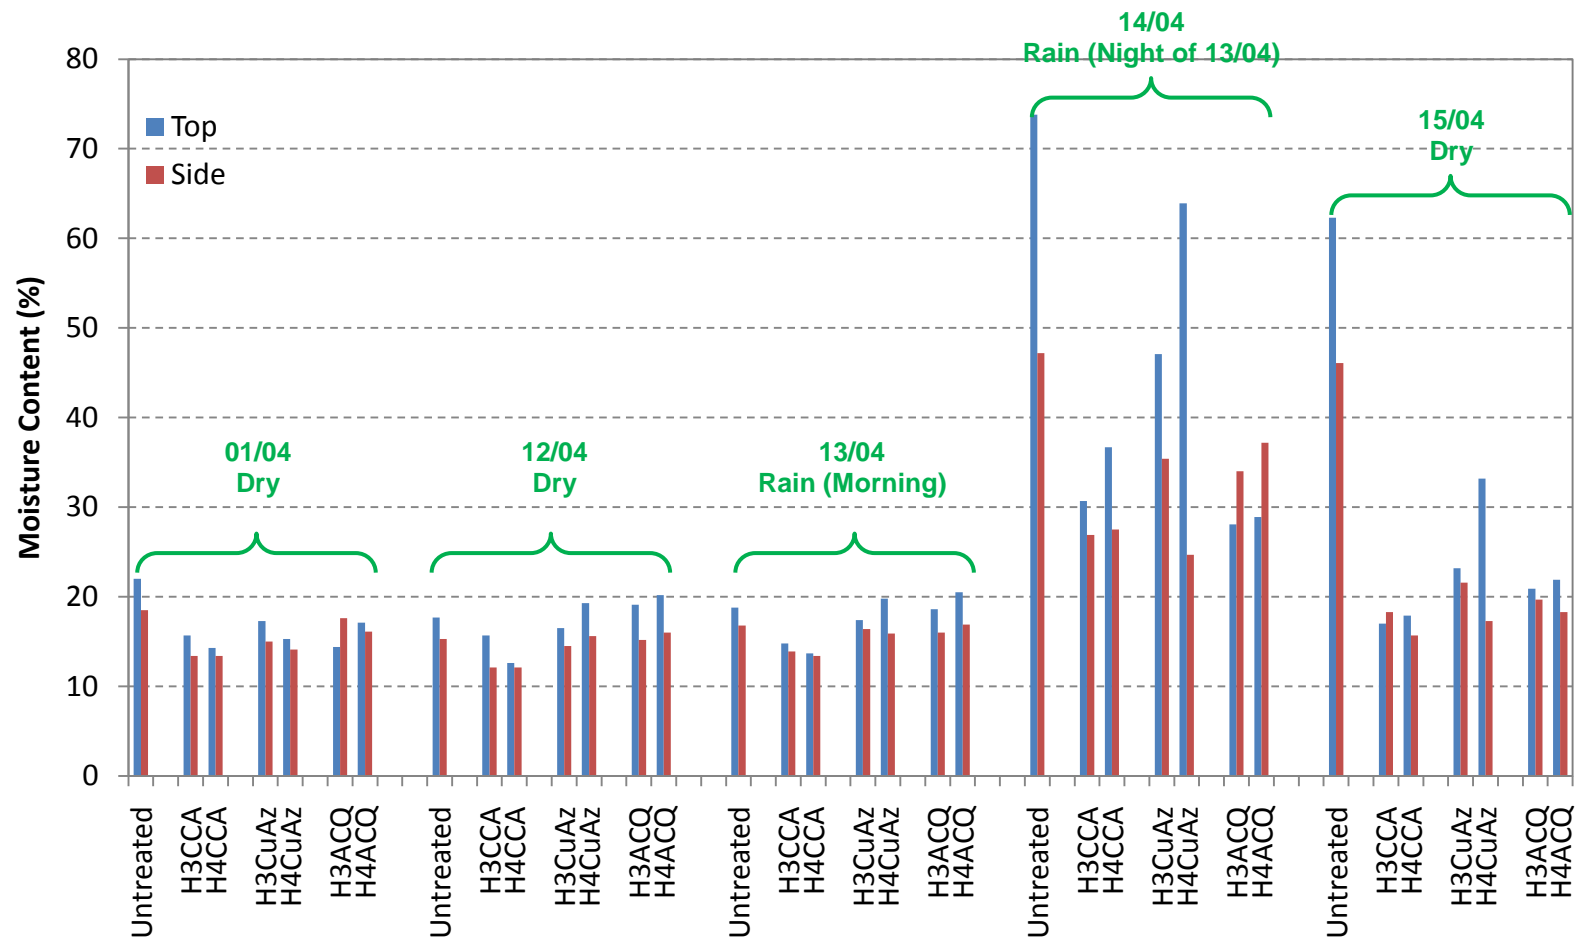
Figure 1. Variation of the moisture content of timbers exposed to the atmosphere at BRANZ's Judgeford campus from 01 April to 15 April 2010.

The weather conditions of New Zealand can be roughly divided into two seasons, wet and dry. The wet season has a relatively low ambient temperature and higher rainfall, therefore a higher moisture content develops in timbers directly exposed to the atmosphere. This can be clearly seen from Figures 1 and 2. For example, in April, the moisture content of the timber after a relatively long dry period could be as low as 15-20%, while in June and July, this value could be as high as 20-40%. The timber moisture contents after rain were similar, typically ranging from 30% to 70%.

However, it should be noted that NIWA's climate database indicates that the highest mean temperatures normally occur between December and March. Therefore, timber moisture contents in summer might be lower than those measured in this study which commenced in April (as noted in Figure 1).

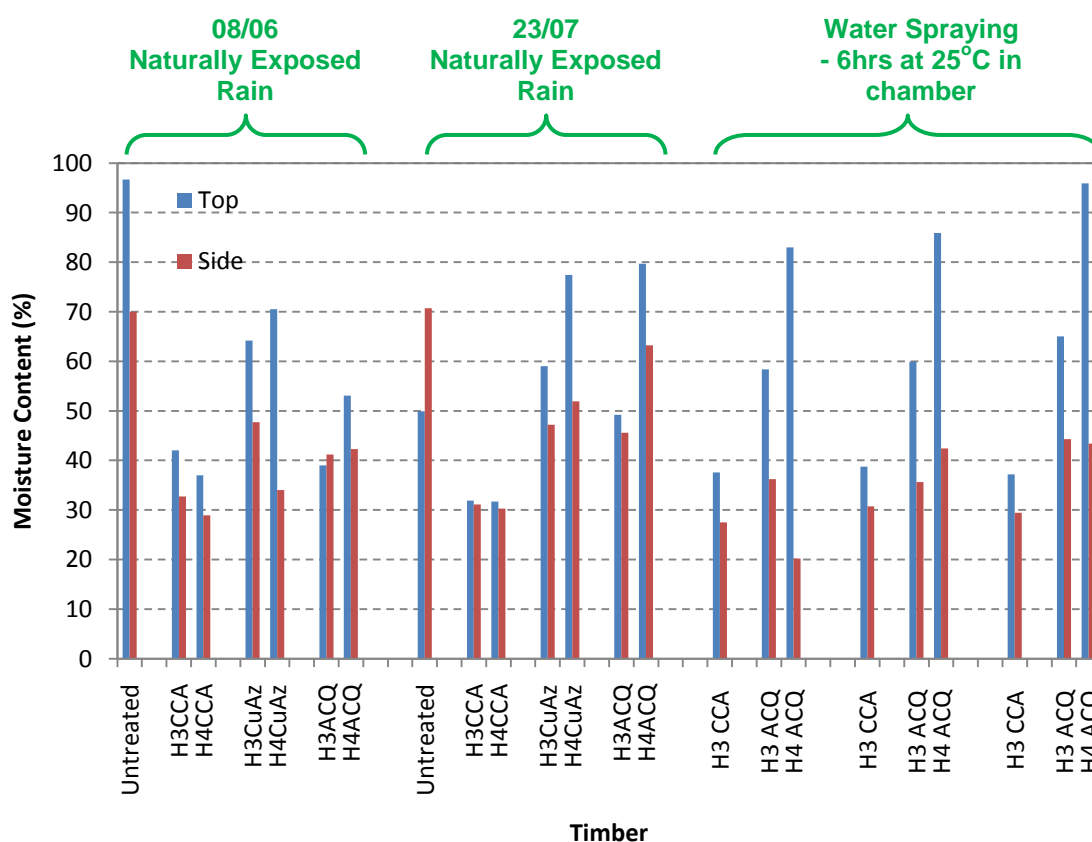
Figure 3. Comparison between the moisture contents of timbers exposed to natural and artificial environments (natural precipitation vs. artificial water spray at 25°C).

A series of preliminary tests were carried out using the above parameters. The volume of water sprayed was collected by funnels evenly distributed in the chamber to calculate hourly water spray. The moisture contents of the timber blocks installed in the fog chamber were measured during the artificial wetting-drying cycles. Comparisons between the timber moisture contents in natural and artificial wetting-drying cycles are given in Figures 3-5.

From the results shown above, it can be seen that the artificial cycles containing water spraying and air heating could reasonably simulate the natural wetting-drying behaviour (the moisture content level and variation) of the timbers exposed to the environment at the Judgeford site.

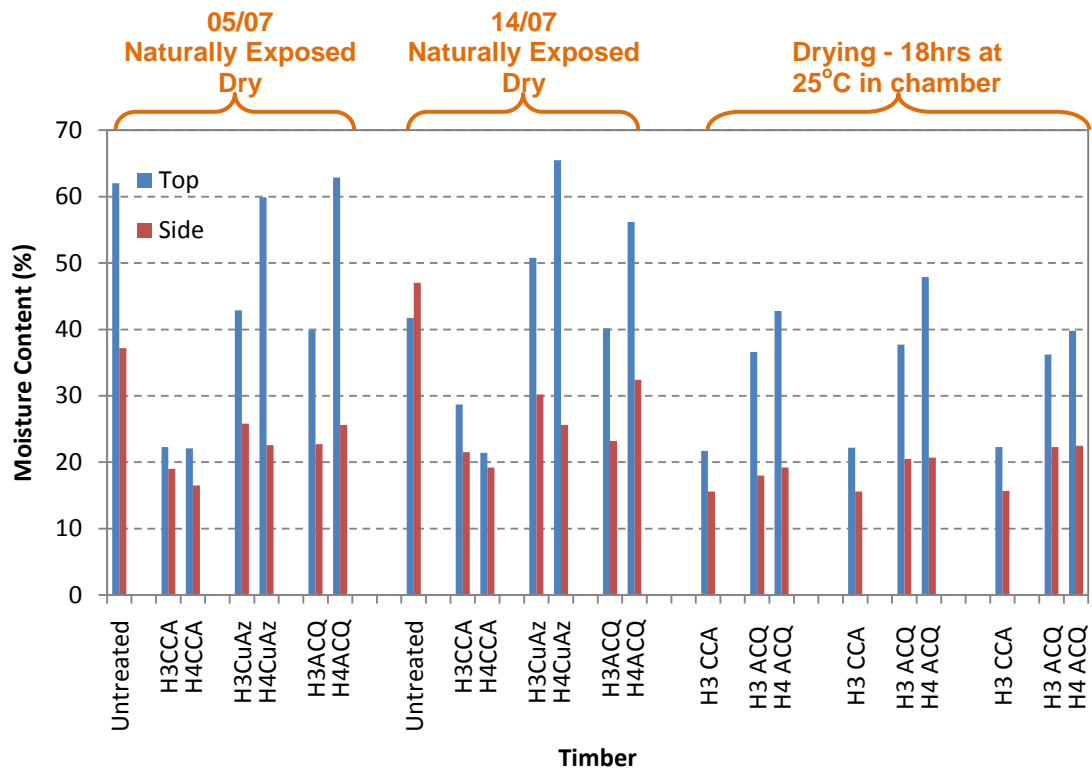
Figure 4. Comparison between the moisture contents of timbers exposed to natural and artificial environments (natural drying vs. artificial drying at 25°C).

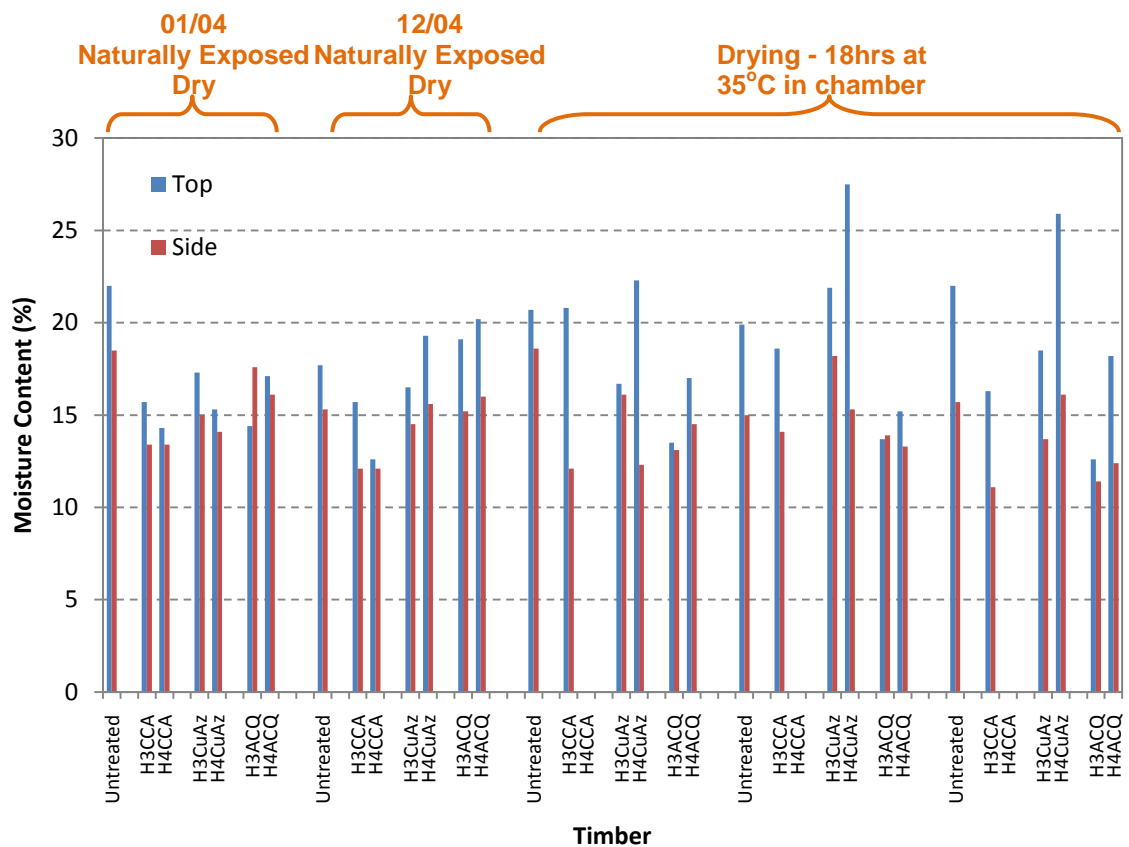
Figure 5. Comparison between the moisture contents of timbers exposed to natural and artificial environments (natural drying vs. artificial drying at a high temperature of 35°C).

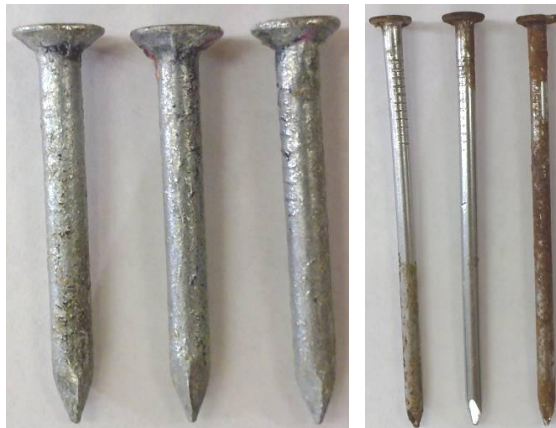
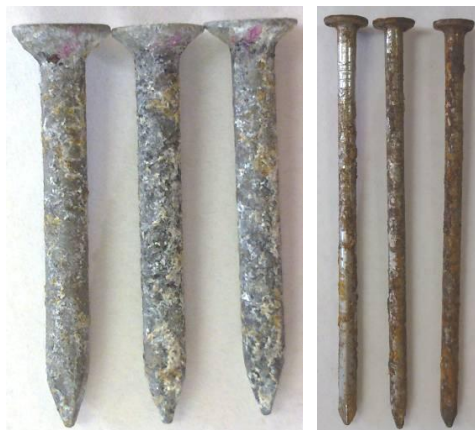
H3 ACQ / Top

H4 ACQ / Top

Figure 10. Surface morphologies of the nails retrieved from ACQ treated timbers (nails inserted into top surface of the timber block).

The most severe corrosion occurred on both mild steel and hot dip galvanised steel nails in timber treated with ACQ to an H4 level (see Figures 9-10). This was consistent with the findings of previous studies. However, all nails inserted into H3 ACQ treated timbers showed very low corrosion rates. The corrosion rates of mild steel and hot dip galvanised steel nails in H3 ACQ treated timbers were only ~15% of those in H4 ACQ

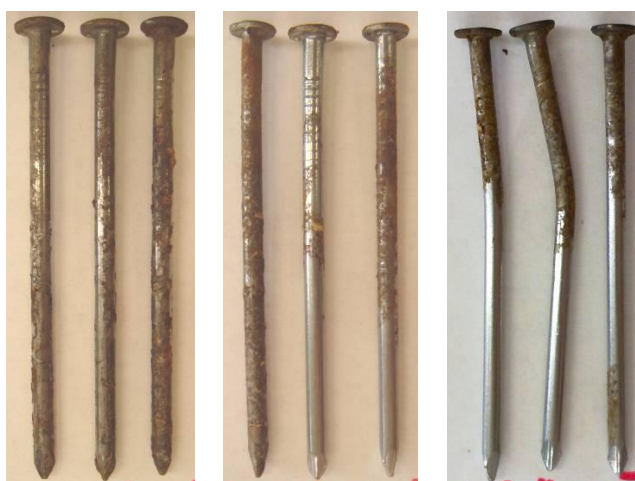
H3 CCA / Top H3 CuAz / Top H4 CuAz / Top

Figure 11. Surface morphologies of the nails retrieved from H3 CCA, H3 and H4 CuAz treated timbers (nails inserted into top surface of the timber block).

In general, timbers treated with CuAz were more corrosive than those treated with CCA under identical testing conditions. However, this behaviour was not reflected by the results of this first test (see Figure 11).

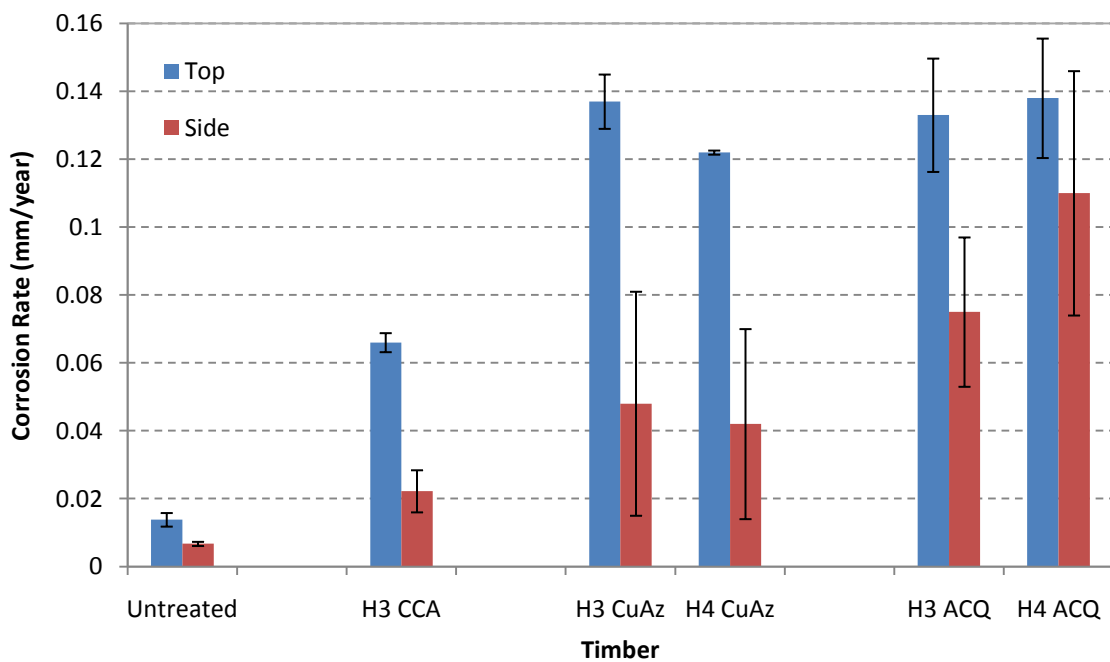
Figure 14. Corrosion rate of hot dip galvanised nails (Trial 2).

The corrosion rates of the mild steel and hot dip galvanised steel nails calculated from their weight losses after the two-stage exposure are presented in Figures 13 and 14.

The correlation between timber corrosivity and preservation treatment given by the corrosion rates of the hot dip galvanised nails also agreed well with that of the mild steel nails. The only difference was the untreated and CCA treated timbers had a much lower aggressivity when compared with the CuAz and ACQ treated timbers (see Figure 14). The nails inserted into the timber from the top and the side also showed an almost identical trend between corrosion rate and timber treatment.

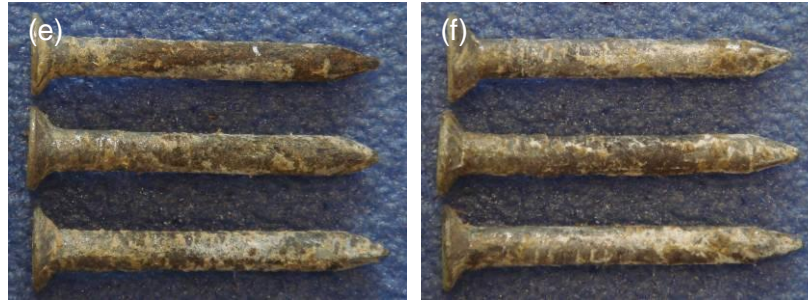
Figure 16. Surface morphologies of hot dip galvanised nails inserted into timber blocks from the top: (a) untreated, (b) H3 CCA, (c) H3 CuAz, (d) H4 CuAz, (e) H3 ACQ and (f) H4 ACQ.

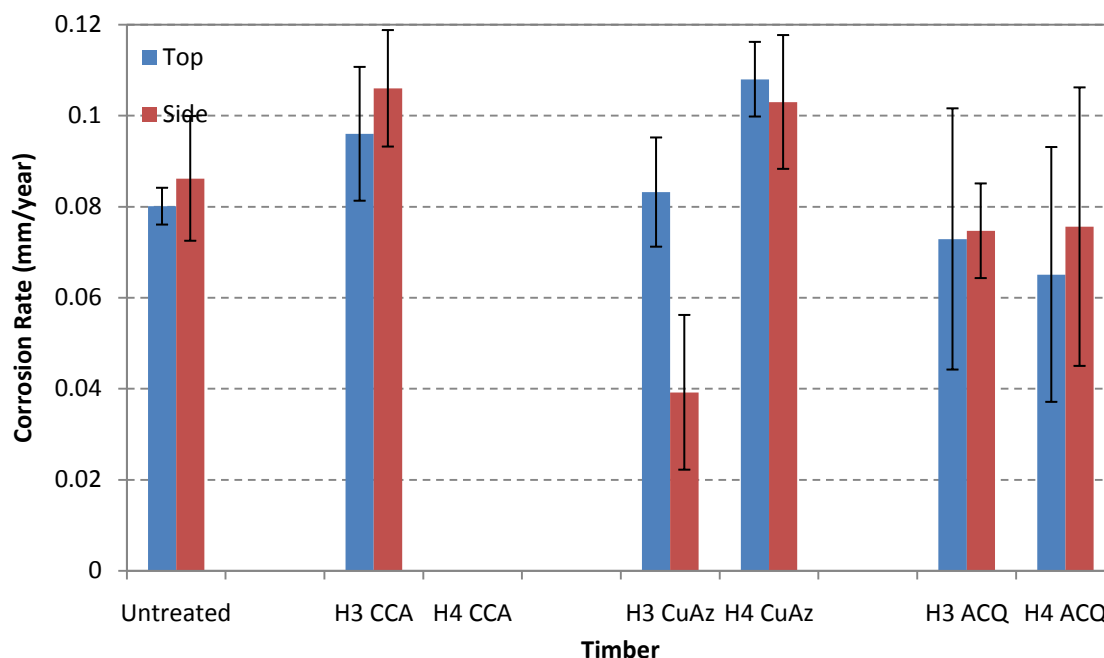
Figure 19. Corrosion rate of mild steel nails (Trial 3).

The corrosion rates of the mild steel nails derived from this modified two-stage exposure are presented in Figure 19.

It was found that the timbers treated with CCA and CuAz had a very similar aggressivity towards mild steel nails. Also, their aggressivity was only slightly higher than the untreated timber. This correlation between timber aggressivity and

preservation treatment is very similar to that observed in the second trial. However, Figure 19 implies that the timbers treated with H3 and H4 ACQ were less corrosive when compared with timbers treated with other preservatives (see Figure 20 for a morphological comparison). This result does not agree with the results obtained in the second trial or in the field exposure tests.

Figure 19 also demonstrates that the nails inserted into the side surface of the timber block corroded at a slightly higher rate than those inserted into the top surface (see Figure 21 for a surface morphological comparison), the exception was for those in CuAz treated timbers (see Figure 22). This phenomenon is unusual and differs from the results from the second trial and from the field exposure.

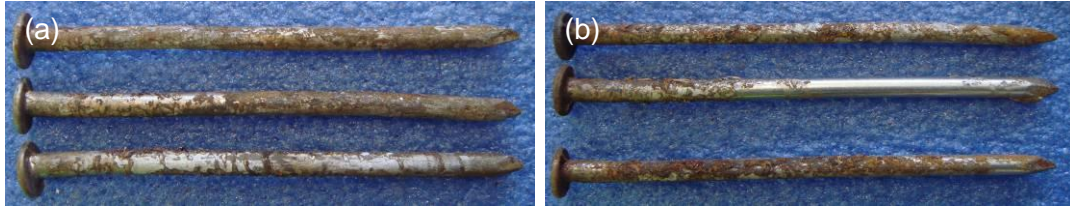
Figure 20. Surface morphologies of mild steel nails embedded into the H4 CuAz (a) and H4 ACQ (b) treated timber top surfaces.

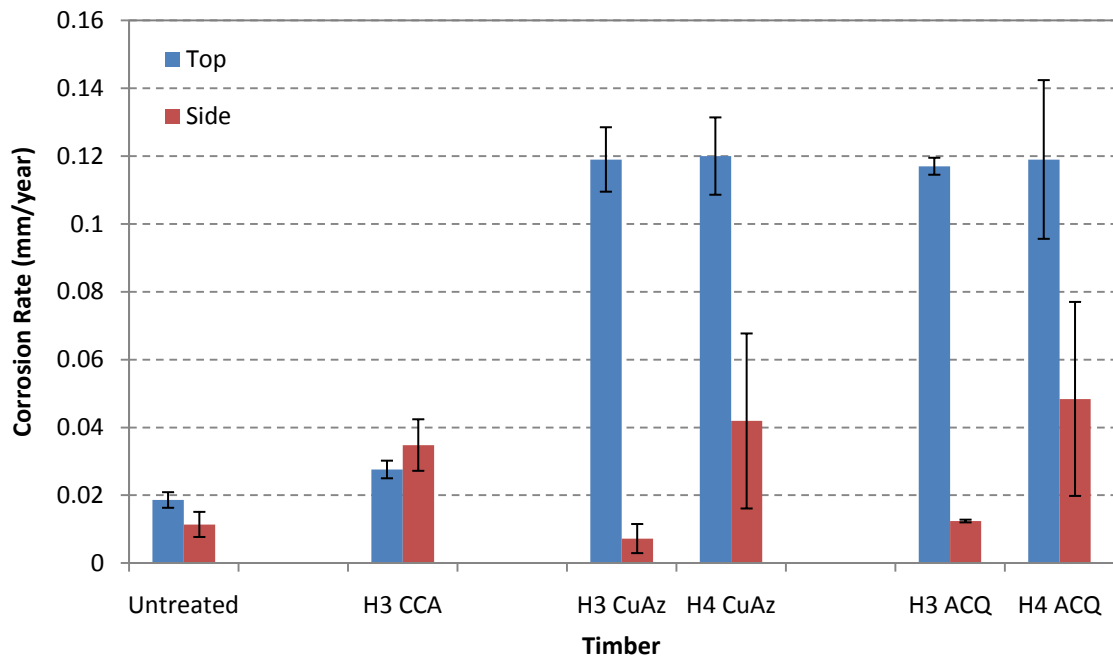
Figure 23. Corrosion rate of hot dip galvanised nails (Trial 3).

Corrosion of hot dip galvanised steel nails showed a different trend with respect to timber preservation treatment when compared with mild steel nails (see Figure 23). The untreated and H3 CCA treated timbers exhibited a similar aggressivity towards HDG nails. The timbers treated with CuAz and ACQ attacked the HDG nails at very similar rates and these rates were much higher than those observed in the timbers treated with CCA. These observations are similar with those obtained in the second trial and are supported by surface morphological characterisations (see Figure 24). In

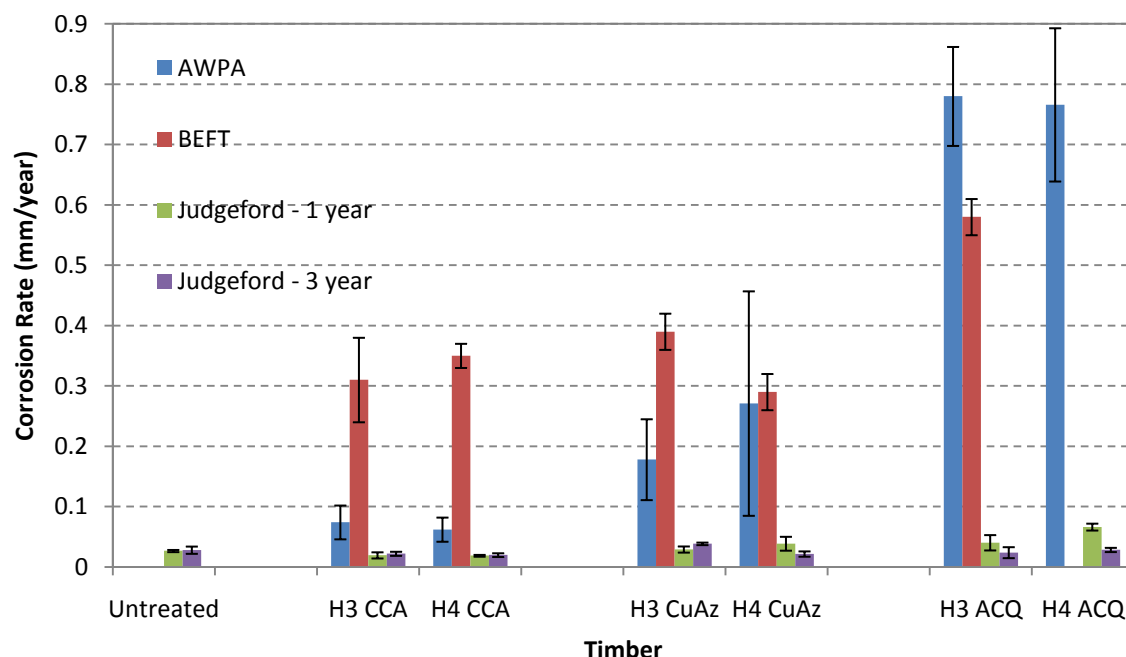
Figure 28. Corrosion rates of mild steel nails measured by accelerated and field exposure tests.

From Figure 28, it can be seen that after one year exposure at BRANZ's Judgeford site, the comparative corrosivity of timber treatment follows a clear trend:

$$H3\ CCA \approx H4\ CCA < H3\ CuAz < H4\ CuAz < H3\ ACQ < H4\ ACQ.$$

Corrosion in H4 ACQ treated timber was 3.5 times higher than that in H4 CCA treated timber. After three years of exposure, this trend slight changed to:

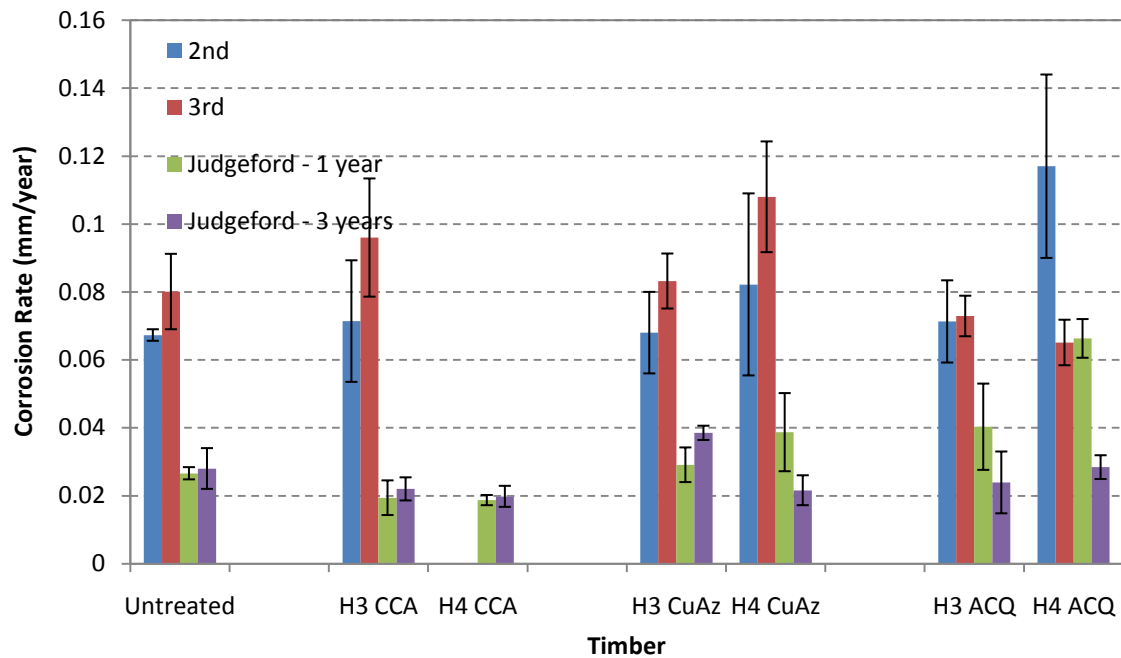
Figure 30. Corrosion rates of mild steel nails measured by accelerated two-stage and field exposure tests.

The corrosion rates derived from the accelerated two-stage tests used in this study indicate that ACQ and CuAz treated timbers could be more aggressive than CCA treated and untreated timbers. However, the corrosivity enhancement by these two preservation treatments over CCA treatment was not as significant as those observed with the AWWA or BEFT methodologies.

The third trial produced a different outcome with mild steel nails having a slightly lower corrosion rate in H3 ACQ treatment than in other treatments. This finding is somewhat similar to the observations obtained from the nails after three years of exposure at Judgeford. In the Judgeford field test, H4 ACQ and H4 CuAz treatments were only 1.4 and 1.1 times more corrosive than H4 CCA treatment. These enhancement levels are very similar with those calculated from the results of the second and third trials. However, it must be noted that corrosivity enhancement by ACQ and CuAz when compared with CCA treatment is more obvious based on the results derived from the one-year field exposure.

One encouraging observation is that the corrosion rates of mild steel nails derived from these two-stage accelerated tests were, in general, two to four times higher than those obtained from the field exposures. This indicates that the corrosion processes occurring under the present experimental conditions are more representative of those occurring on nails embedded into timbers exposed in the field.
