Managing subfloor moisture, corrosion and insulation performance

BRANZ Study Report SR354

Abstract

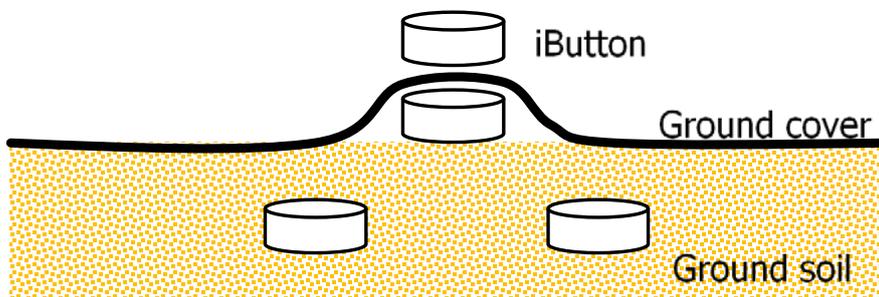
Figure 1. Schematic of sensor (iButton) arrangement for monitoring moisture transfer/evaporation from covered ground in subfloor.

- **Surrounding atmospheric environment:** A portable weatherstation was installed to collect climatic factors including ambient temperature, humidity, rainfall, wind speed and wind direction. The data was recorded every hour.
- **Subfloor environment:** iButton (DS1923) sensors were installed at different locations of a subfloor space to monitor temperature and humidity. Several sensors were also specially arranged to monitor moisture transfer/evaporation from ground soil to subfloor atmosphere (Figure 1). The data was collected every hour. Stainless steel pins were inserted into H3.2 CCA-treated timber blocks (150 × 90 × 45 mm) to measure moisture content of timbers used in subfloor space through an electrical resistance measurement approach. This data was collected every 15 minutes.

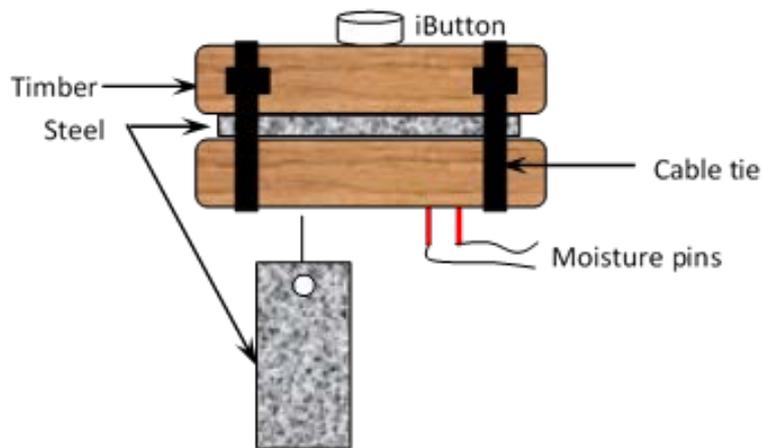
Figure 2. Sample arrangement for subfloor corrosivity measurement.

- **Indoor environment:** Two sensors were placed in either the living room or kitchen to monitor changes in indoor temperature and humidity. Two were used for a measure of redundancy. The console of the weatherstation also recorded indoor temperature and humidity every hour where it was installed and was then placed in the kitchen.
- **Corrosivity of subfloor atmosphere:** Precleaned mild steel samples were installed to investigate the aggressiveness of the subfloor environment. This included one set of samples directly exposed to subfloor air and another set sandwiched between the two H3.2 CCA-treated timber blocks where the moisture content was measured (Figure 2).

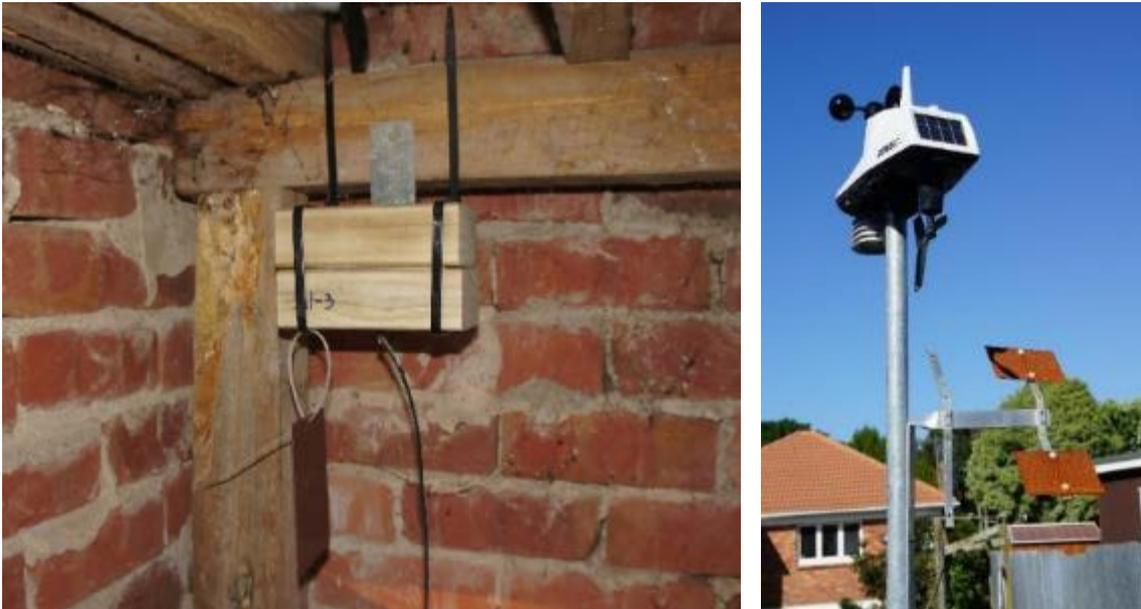
Figure 3. A typical sample set for subfloor (left) and open atmosphere (right) corrosivity measurement.

Mild steel samples with a dimension of $\sim 120 \times 80 \times 0.95$ mm were cut from cold-rolled sheets. The surface was as originally rolled without further treatment. To measure the corrosivity of the subfloor environment, one set of steel samples was directly exposed to subfloor atmosphere at several (6–7) locations, typically at four corners, two close to vents and one in the centre. The mass loss after 12 months of exposure was measured to calculate mean corrosion rate. Another set of steel samples was placed between two H3.2 CCA-treated timber blocks ($\sim 150 \times 90 \times 45$ mm) tightened with two cable ties (Figure 3). This sample configuration was used to simulate corrosion of metal fasteners in timbers. In addition, two steel samples were exposed to the atmosphere directly surrounding the house being surveyed. Their mass losses after 12 months could be used to classify atmospheric corrosivity according to relevant ISO and national standards.

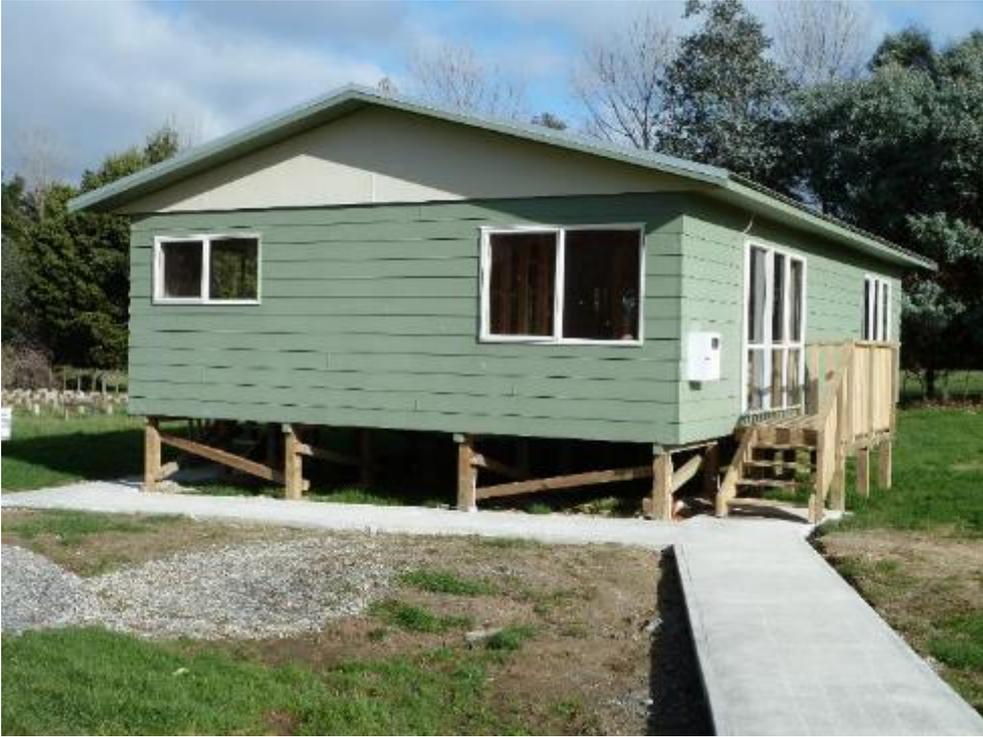
Figure 4. BRANZ ventilation research building – before enclosing subfloor.

The building shown in Figure 4 and Figure 5 was constructed as a prebuilt shell in 2007 and transported onto the research site for the Weathertightness, Air quality and Ventilation Engineering (WAVE) research programme. The single-storey building has a floor area of 91 m². The building is a traditional timber-framed construction that is clad with painted fibre-cement weatherboard directly fixed over a flexible wall underlay. The gable roof has corrugated steel cladding on timber trusses. The floor is made of particleboard, which is sealed with polyurethane. The walls and the ceiling are insulated to the requirements of the Building Code with fibreglass batts. All inner wall surfaces and the ceiling are lined with gypsum-based plasterboard, which received three coats of an acrylic paint.

The building was used for ventilation research for 2 years before the start of the subfloor research programme. Prior to this, the subfloor was exposed (Figure 4). It was enclosed in early 2013 (Figure 5) before the onsite measurements started later that year.

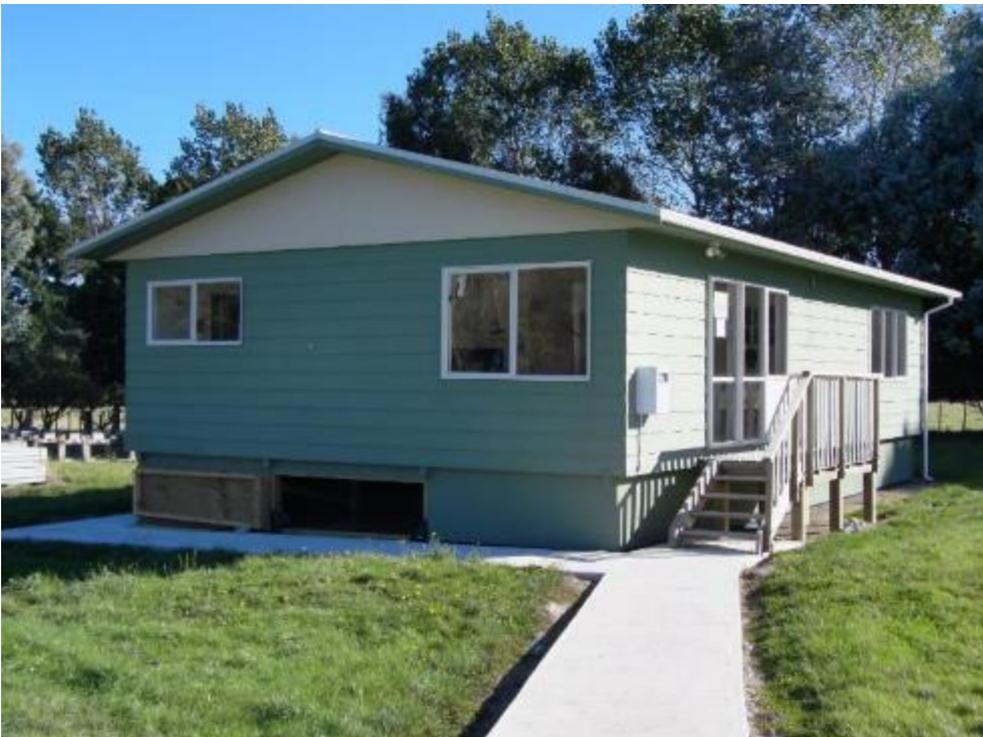
Figure 5. BRANZ ventilation research building – subfloor enclosed with access door open.

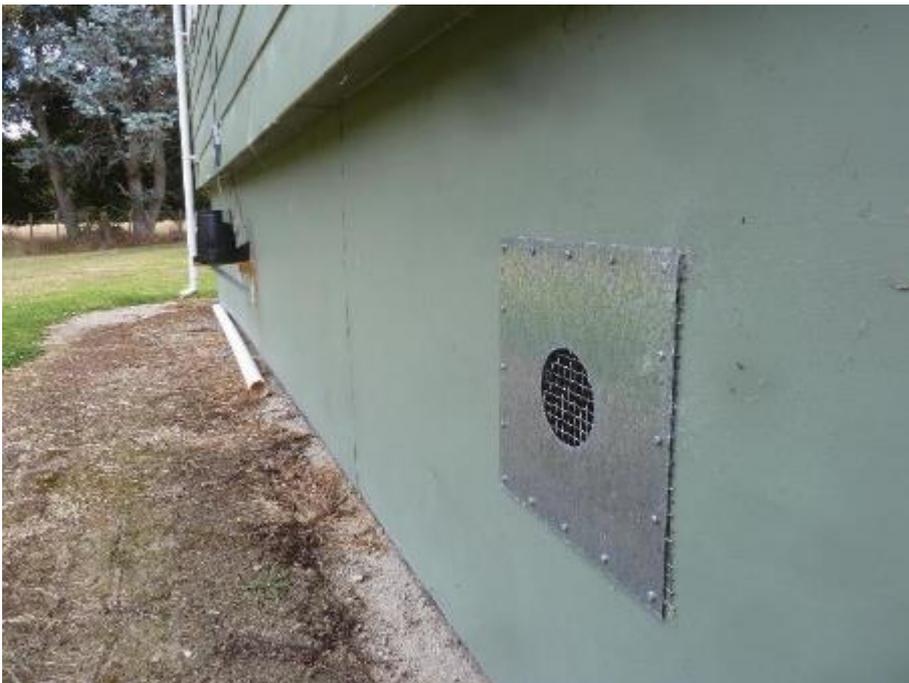
Figure 6. Subfloor vent.

The perimeter lining of the subfloor was fitted with a set of 10 steel plates covering penetrations in the plywood enclosure. These were gasketed with closed-cell foam rubber and were interchangeable, which enabled the installation of vents up to a maximum size of 200 mm diameter (Figure 6).

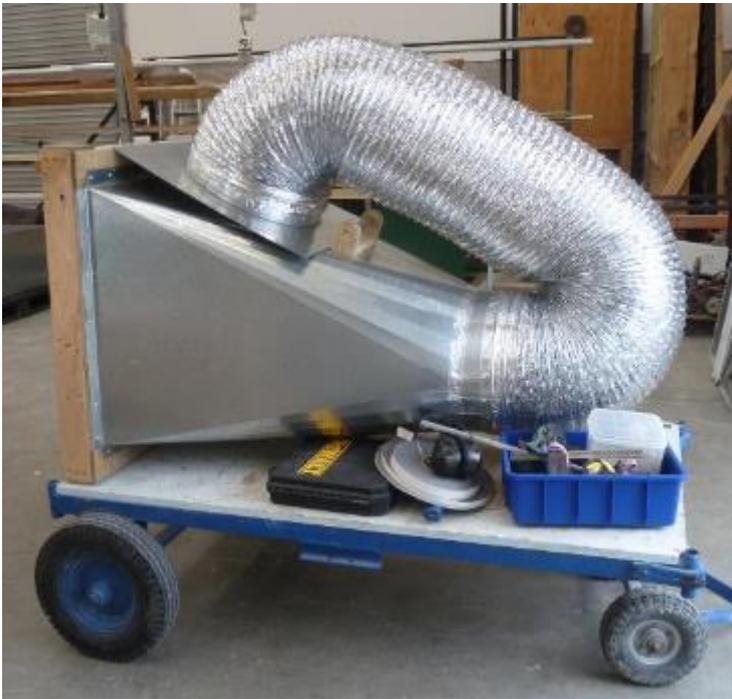
Figure 7. Blower door cowl and flange.

Airtightness of the subfloor space was tested using BRANZ's Retrotec blower door with the subfloor configured in its most airtight state. A custom cowl and flange (Figure 7) were made that enabled connection of the blower door to the side of the subfloor enclosure.

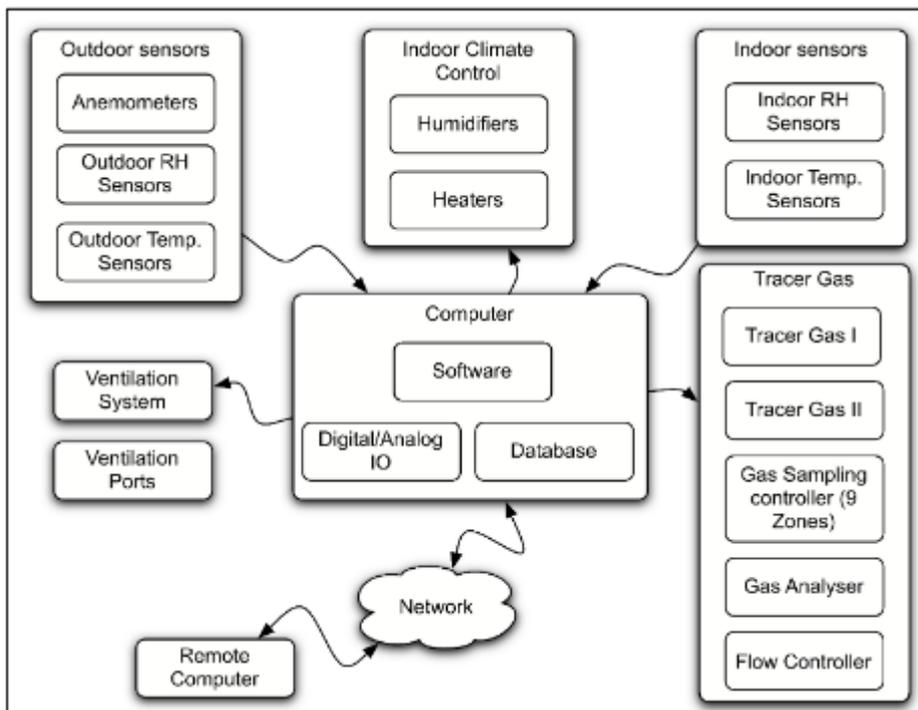
Figure 8. Typical instrumentation scheme using FlexiDAQ.

The equipment was controlled and data collected using the in-house BRANZ data acquisition software FlexiDAQ (Figure 8). FlexiDAQ is a modular system that allows multiple types of instrumentation to be controlled by the same computer using a plugin architecture. In the case of the subfloor research building (Figure 12), indoor sensors were replaced with sensors in the subfloor space. Also, indoor climate control or the ventilation system did not apply in this project.

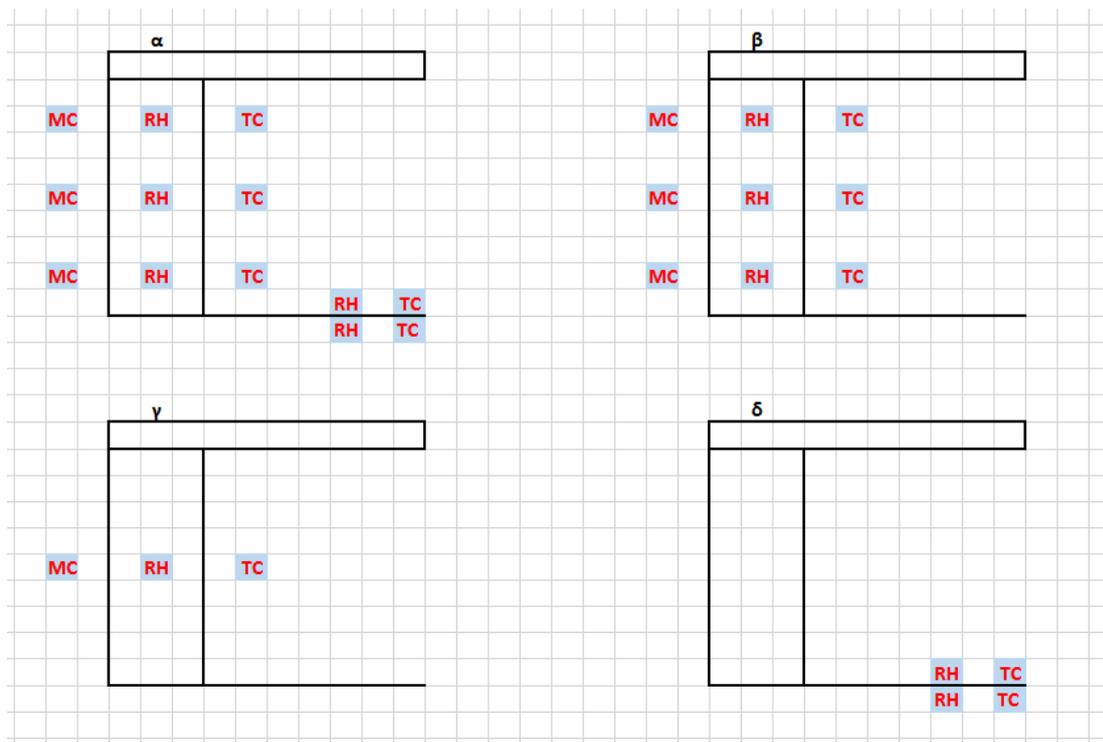
Figure 9 shows how these were configured in a vertical cross-section. The sensor types are indicated by a two-letter code:

- MC = moisture content pins
- TC = thermocouples
- RH = Honeywell RH probes.

Figure 9. Layout of sensors for each of the four different location types.

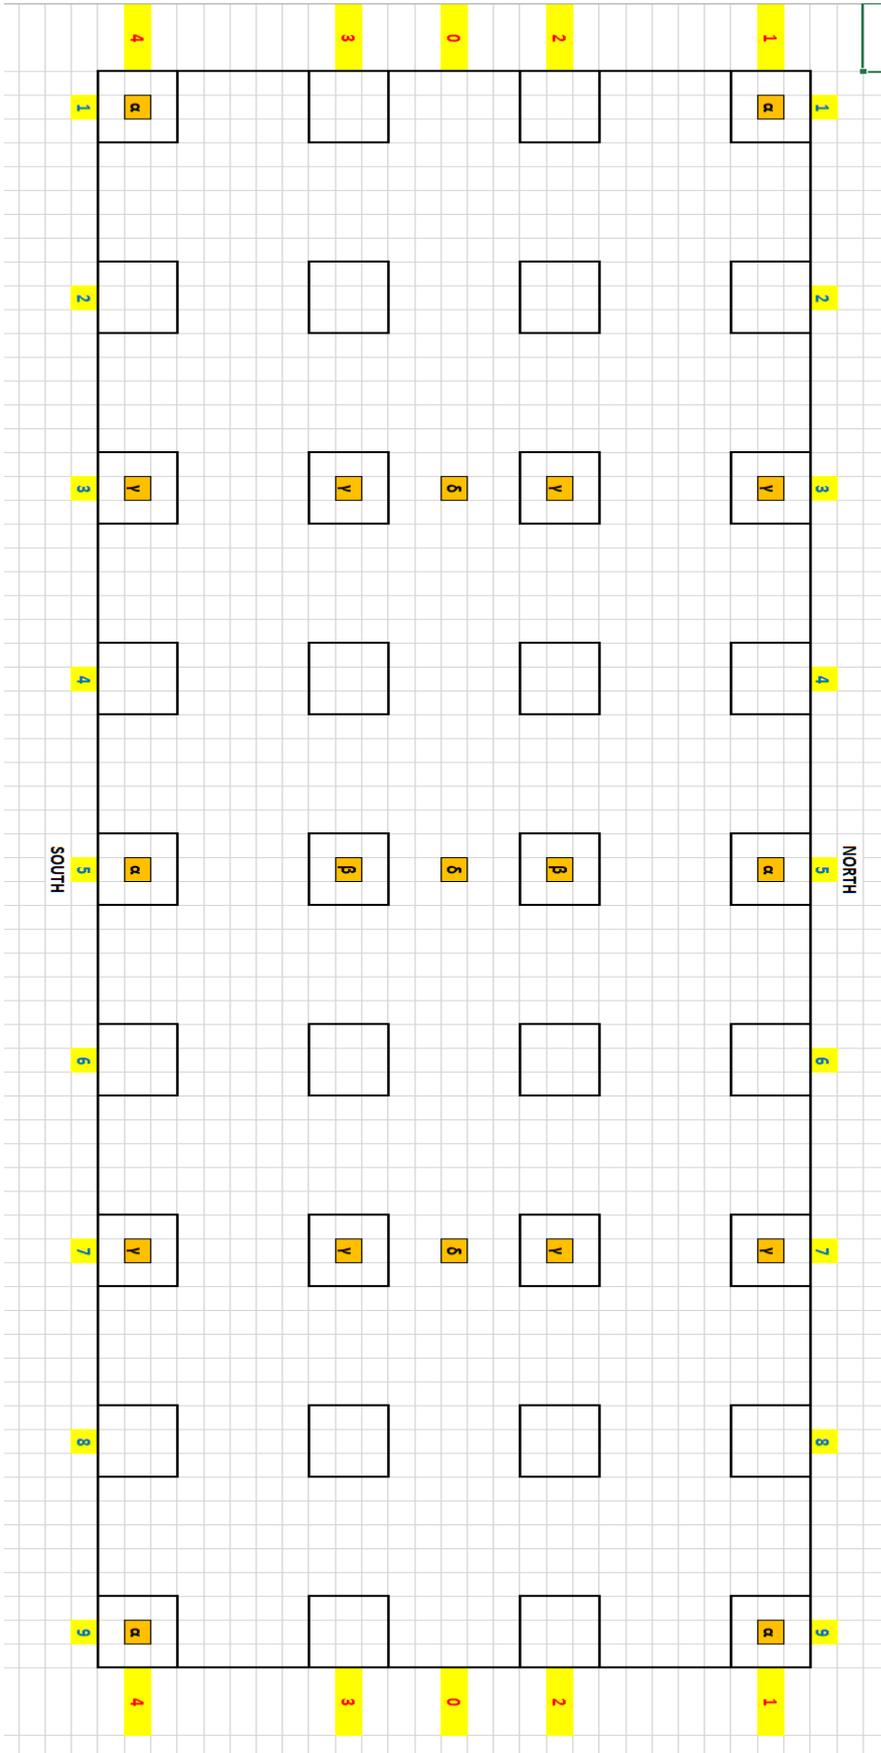
Figure 10 shows a plan view of the pile layout under the ventilation research building and the Greek letter associated with the particular sensor layout at each measurement location.

Figure 10. Pile layout and sensor distribution under the ventilation research building.

Prior to closing the door, the instrumentation was turned on and state of the subfloor captured. This is shown in Figure 25 via a heatmap of timber moisture content of the subfloor framing timber. This floor plan is rotated 90 degrees relative to Figure 10.

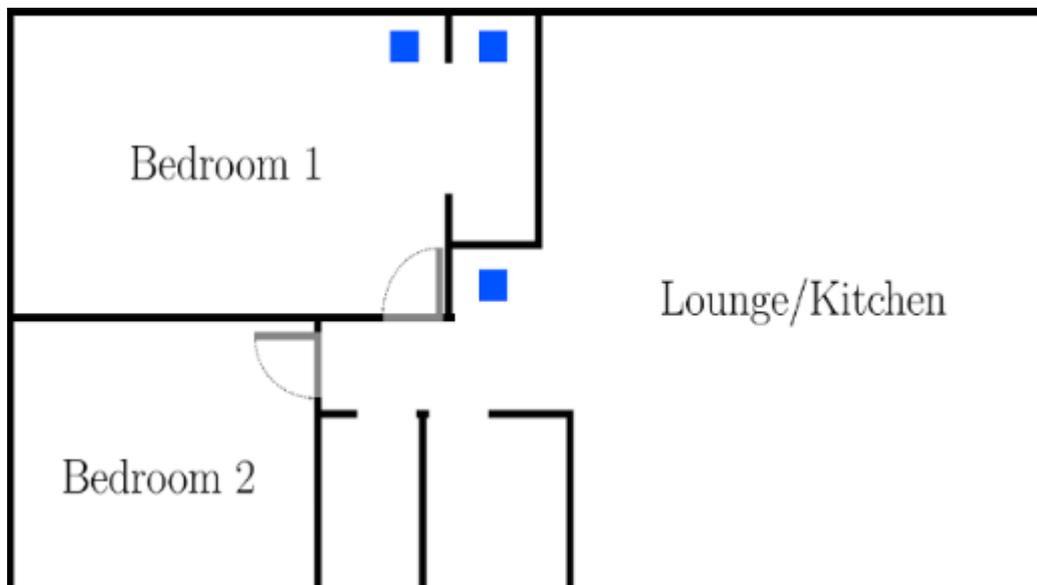
Figure 11 indicates where the heat flux sensors were placed on the floor plan of the ventilation research building.

Figure 11. Heat flux sensor locations (shaded blue) in the ventilation research building.

Heat flux sensors were installed on the top surface of the bare flooring at three locations – one near the south-facing wall, one near the centre of the floor and one near the north-facing wall (Figure 11). Further details of the technique can be found in BRANZ Study Report SR202 (Cox-Smith, 2008), which describes measurements of the thermal performance of draped foil floor insulation using an earlier version of the BRANZ heat flow sensors.

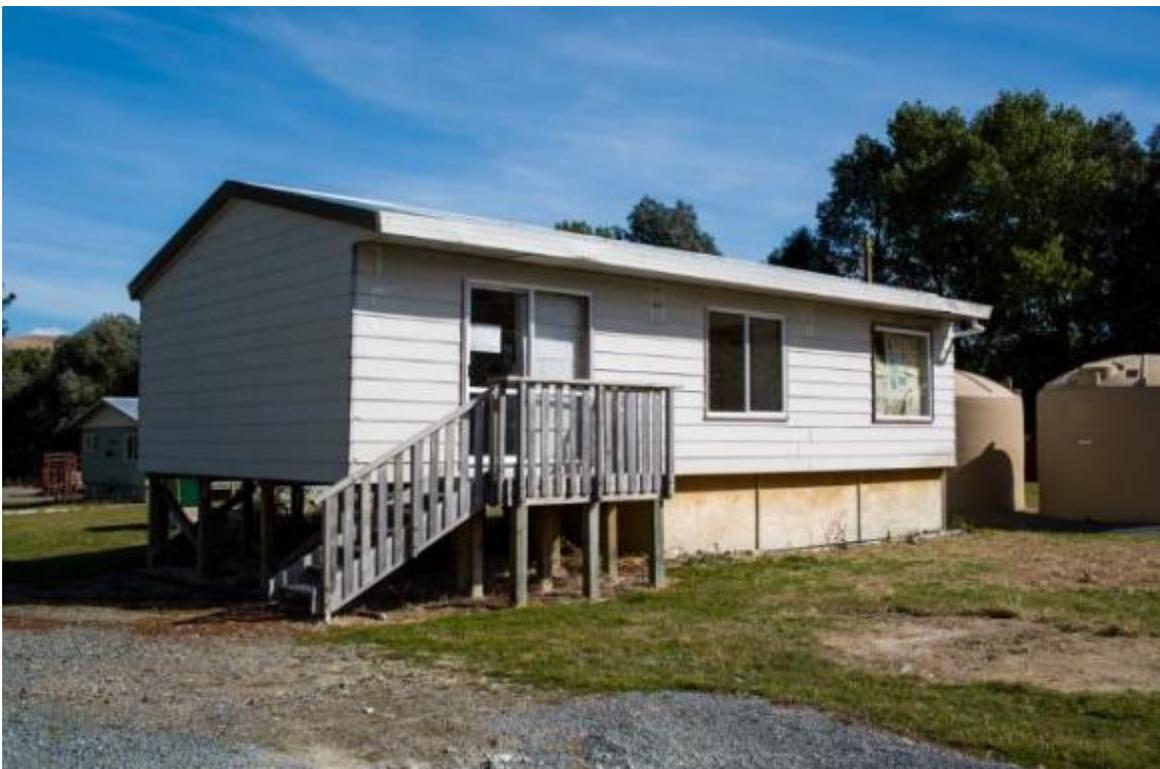
Figure 12. Subfloor research building.

The BRANZ fire research building was used to create a second research facility – the subfloor research building (Figure 12) – where the effects of wind wash could be studied more closely without the concern of affecting the ventilation programme measurements taking place in the other lab.

The building is of similar construction to the ventilation research building, with fibre-cement cladding, single-glazed windows and a corrugated steel roof. Where it differs, however, is that the airtightness of the building itself is much lower than the ventilation research building in the order of 10–12 ach @ 50 Pa.

At a height of 1.2 m, the subfloor research building is also considerably higher off the ground compared to the ventilation research building. The subfloor space has been divided in two, with one half closed in with a plywood cladding similar to the other building and the other half been left exposed.

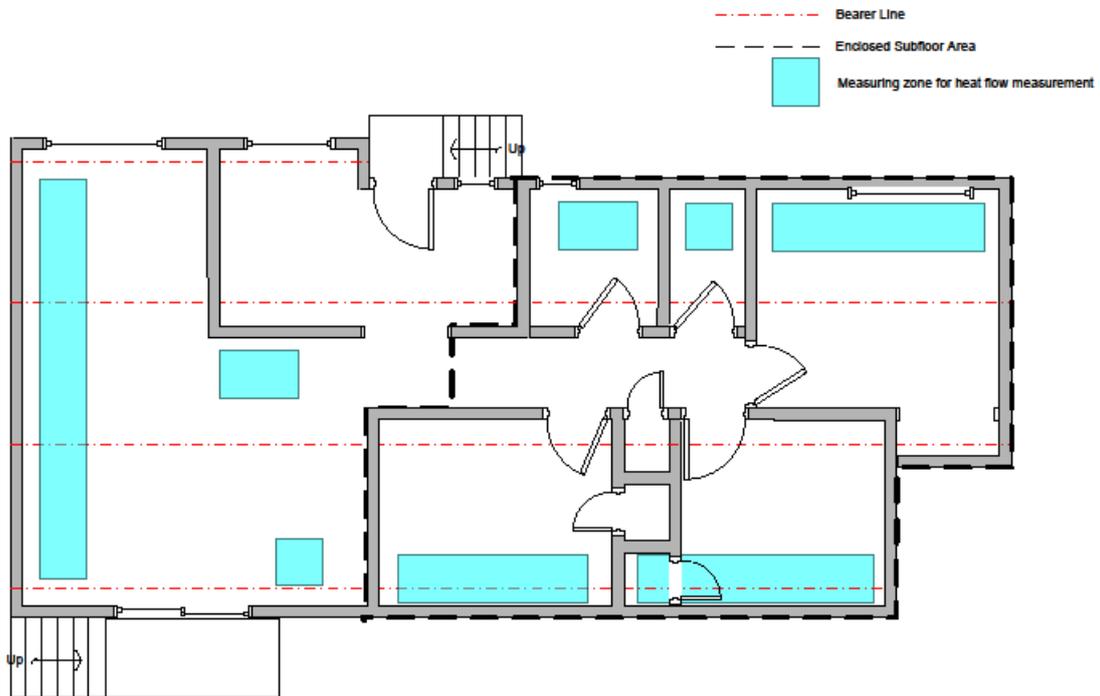
Figure 13 shows a floor plan of the subfloor research building, with the locations where heat flux sensors were located shaded.

Figure 13. Heat flux sensor locations – subfloor research building.

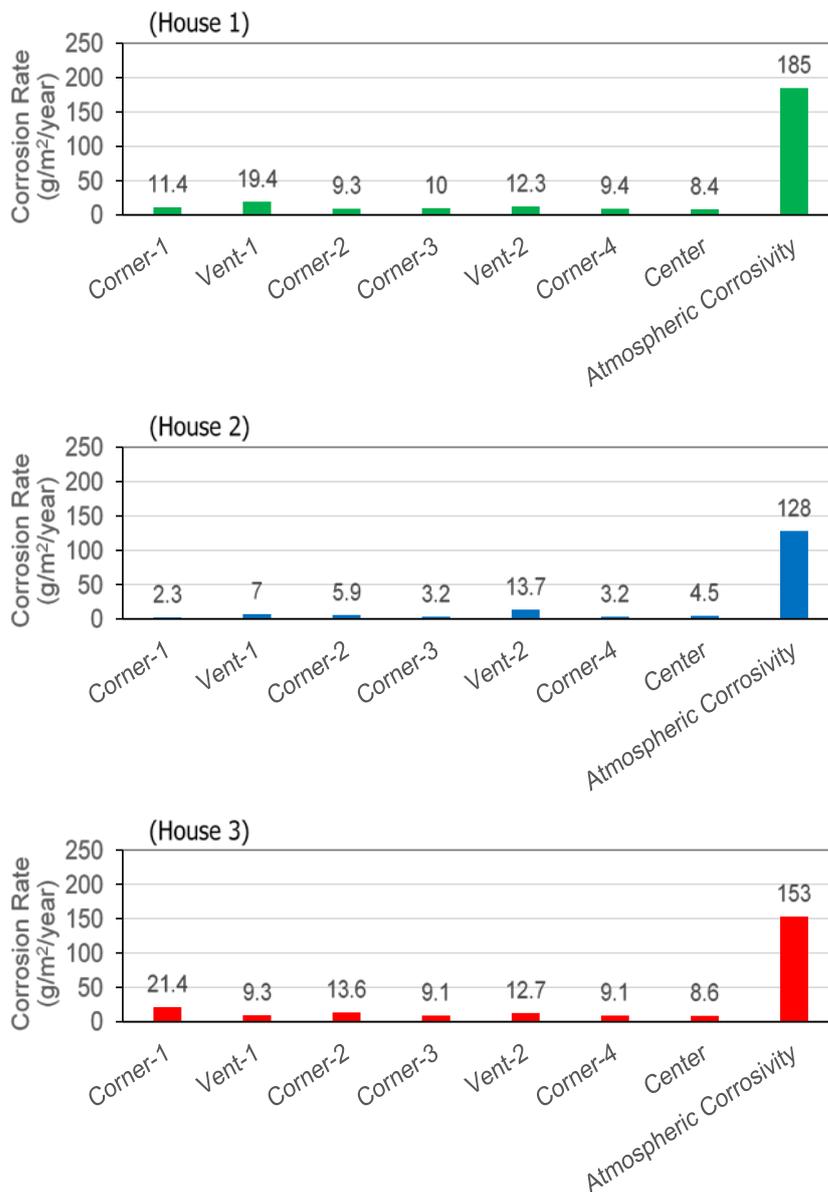
Figure 14. Corrosion rates of mild steel samples directly exposed to subfloor environments of houses surveyed in Auckland.

The annual mean corrosion rates of the steel samples exposed to the subfloor environments of the houses surveyed are presented in Figure 14 – Figure 16.

It can be seen from these results that the corrosion rates of steel samples installed at corners and the centre of the subfloor were much lower than that of the steel samples directly exposed to the atmosphere surrounding the house surveyed. Typically, the decrease could be 10 times or even more. Although variations could be observed with different corners, these are generally small. There is also no clear evidence that one corner located towards one specific direction would produce a local environment that is more aggressive towards metallic components.

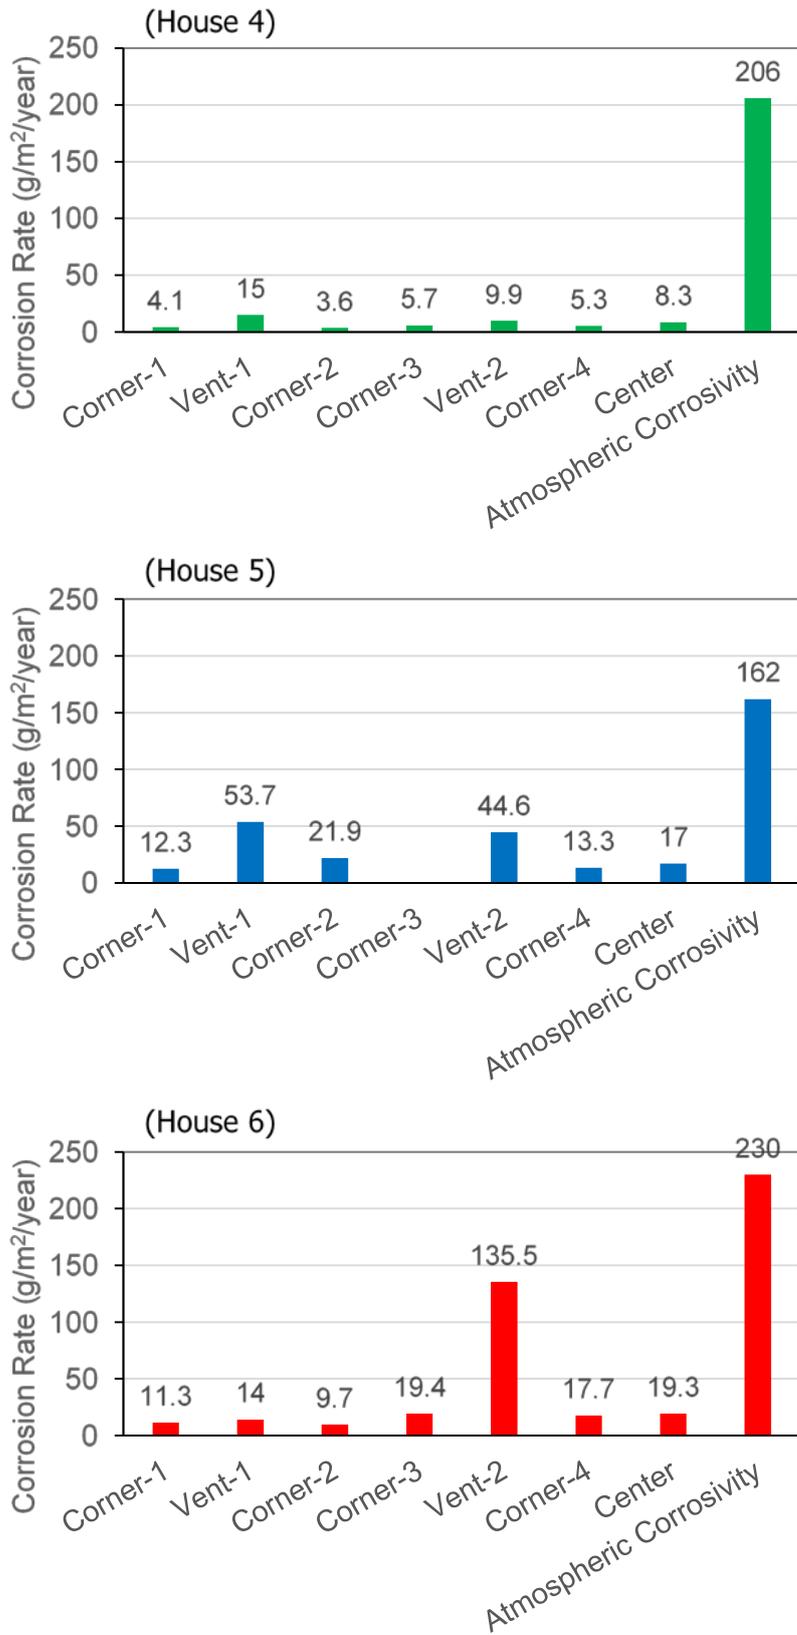
Figure 15. Corrosion rates of mild steel samples directly exposed to subfloor environments of houses surveyed in Wellington.

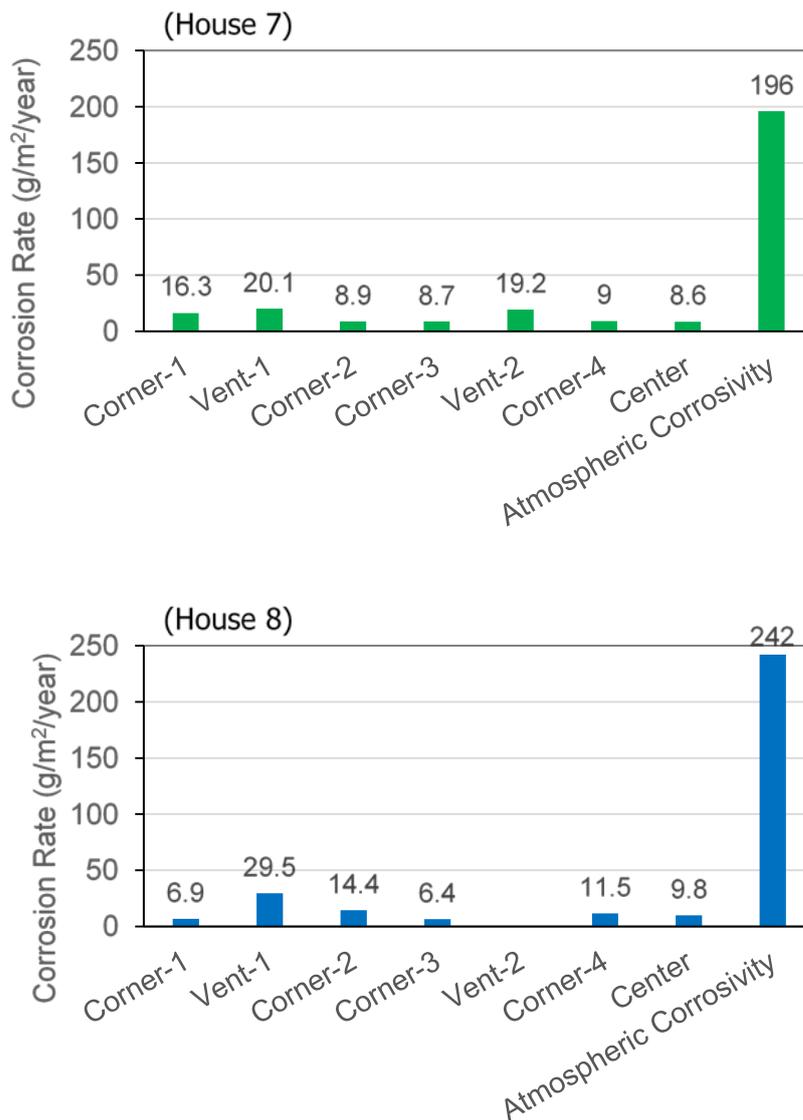
Figure 16. Corrosion rates of mild steel samples directly exposed to subfloor environments of houses surveyed in Invercargill.

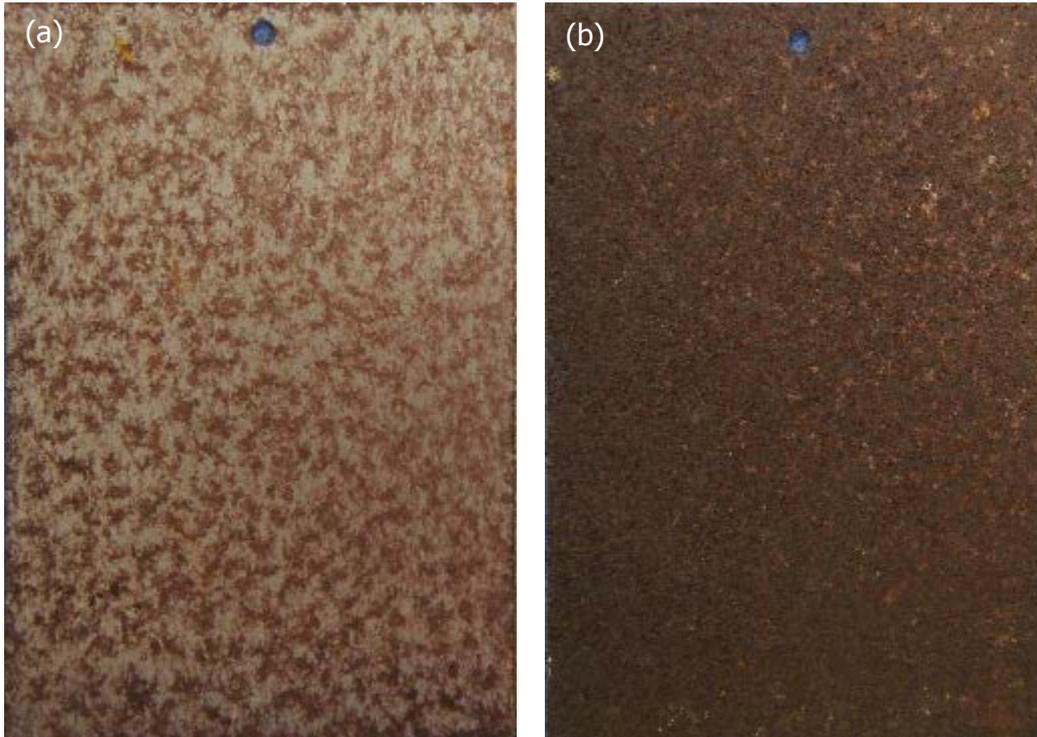
Figure 17. Surface morphologies of mild steel samples installed in corner-2 (a) and close to vent-2 (b) of the subfloor of house 6.

For house 6, it can be clearly seen in Figure 17 that the surface of the mild steel sample close to the vent-2 location was covered with a layer of rust much thicker than that on the sample installed in corners. The difference in corrosion rates between those two samples (corner-2 and vent-2) was 14 times. This phenomenon was not observed with the sample close to the vent-1 location of the same house. This is because the vent-1 location is actually not a vent due to the physical construction. It was only used in this study because it is directly opposite to the vent-2 location.

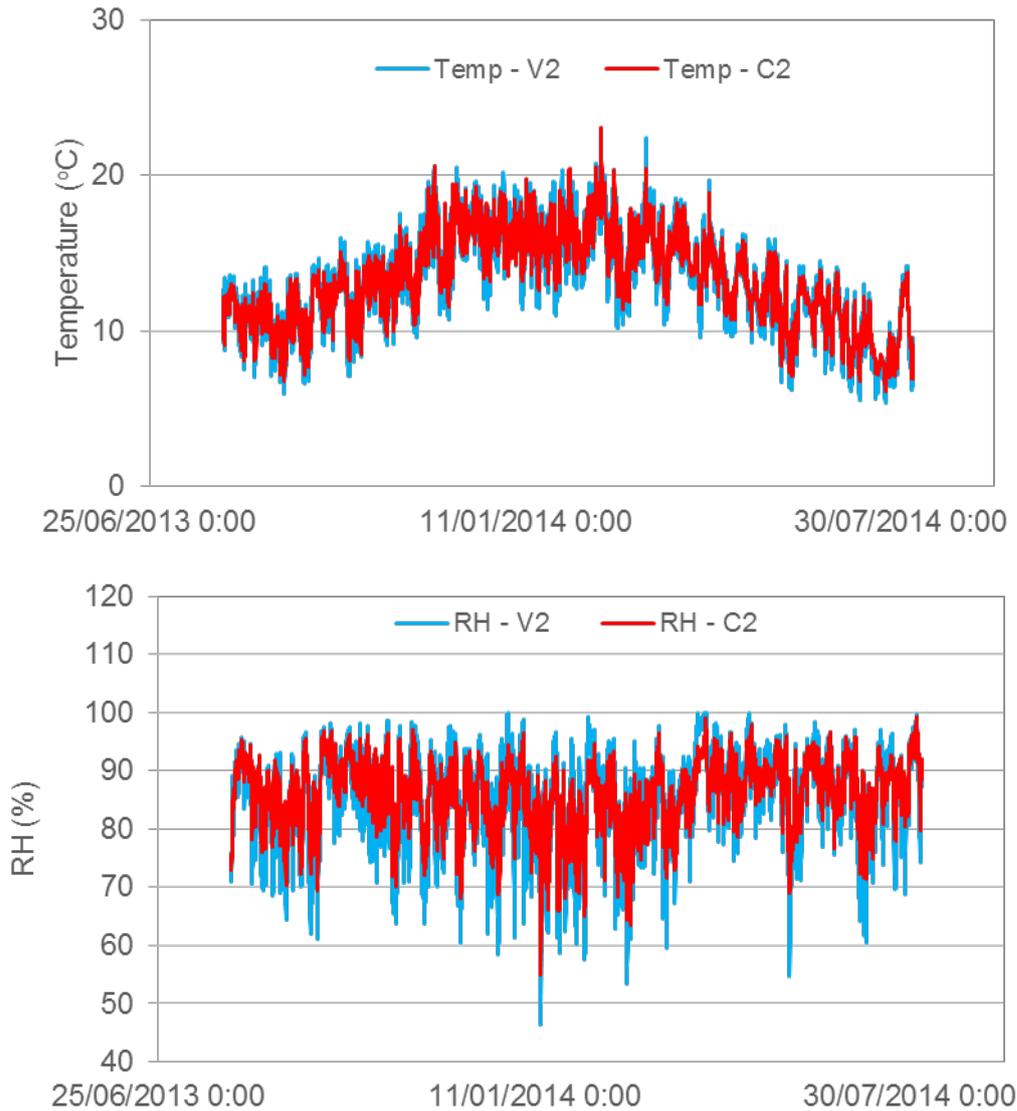
Figure 18. Variations of temperature and relative humidity at corner-2 and vent-2 locations in the subfloor of house 6.

The variations in temperature and relative humidity for corner-2 and vent-2 locations in the subfloor of house 6 are presented in Figure 18. The average values of these two environmental factors were very similar at these two locations. However, the standard deviation of temperature and humidity for the vent-2 location are greater than the corner-2 location. These were 3.1°C and 7.8% RH versus 2.8°C and 5.8% RH for the vent-2 and corner-2 locations respectively. This could lead to higher chance of moisture condensation on the steel surface, i.e. a larger time of wetness, therefore promoting corrosion through a longer period of electrolyte presence. Additionally, the vents on the timber plank subfloor enclosure could also permit ingress of rainwater splash through gaps, resulting in physical water on the steel surface and a longer period of high humidity in the ground nearby and underneath

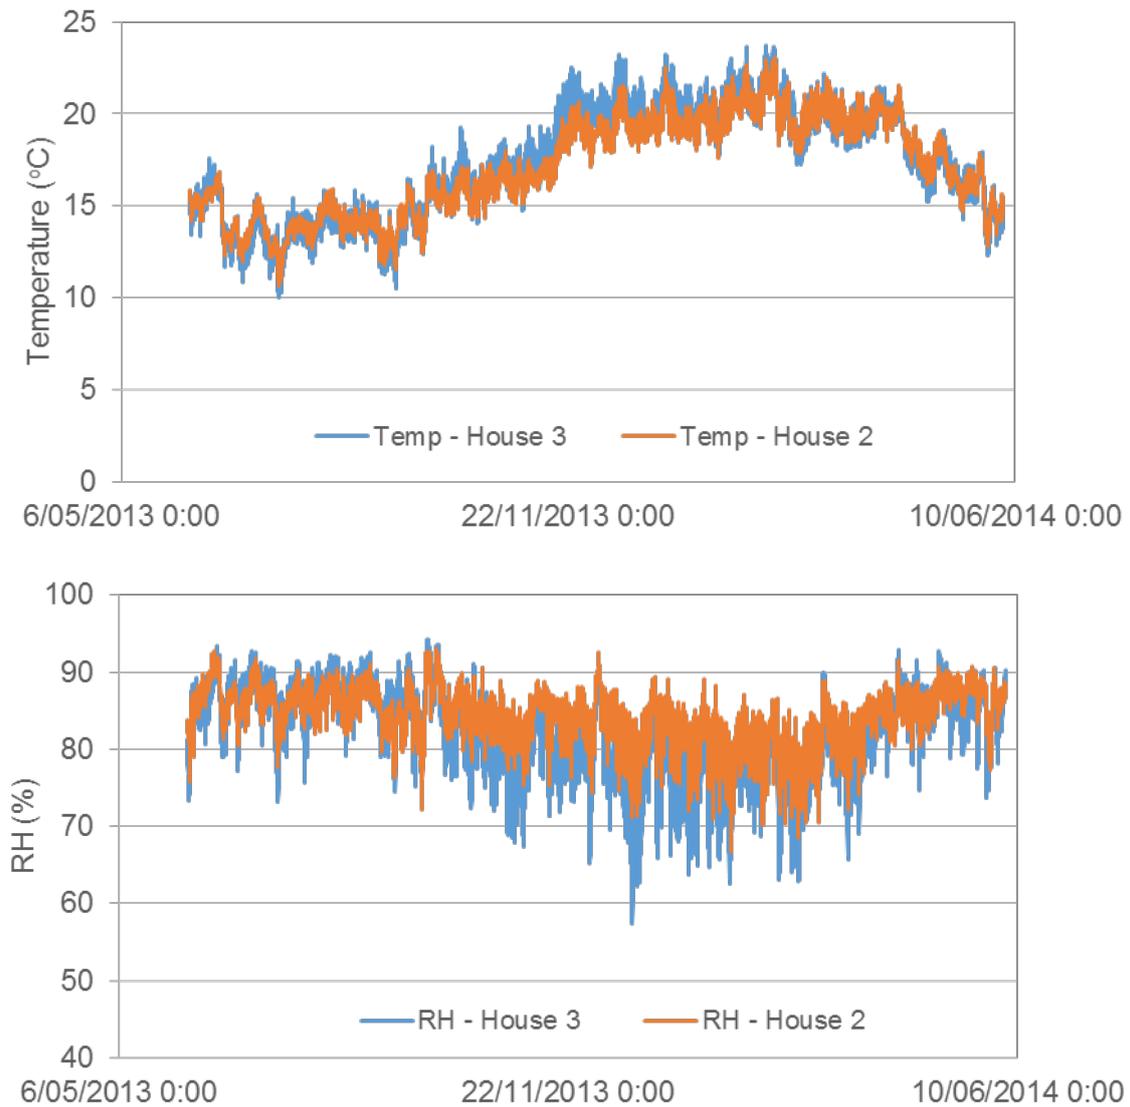
Figure 19. Variations of temperature and relative humidity at corner-1 locations in the subfloors of house 3 and house 2.

A comparison was then made between the subfloor temperature and relative humidity for houses 2 and 3, mainly for the corner-1 (Figure 19) and centre (Figure 20) locations to explore how this difference happens.

Summary statistics from Figure 19 and Figure 20 are presented in Table 1 and Table 2. At the corner-1 locations, in winter, temperature and relative humidity of these two houses were similar although house 3 had a slightly larger variation in RH but only by 1.1%. In summer, house 3 had a higher mean temperature by 0.6°C and a 5.3% lower mean RH.

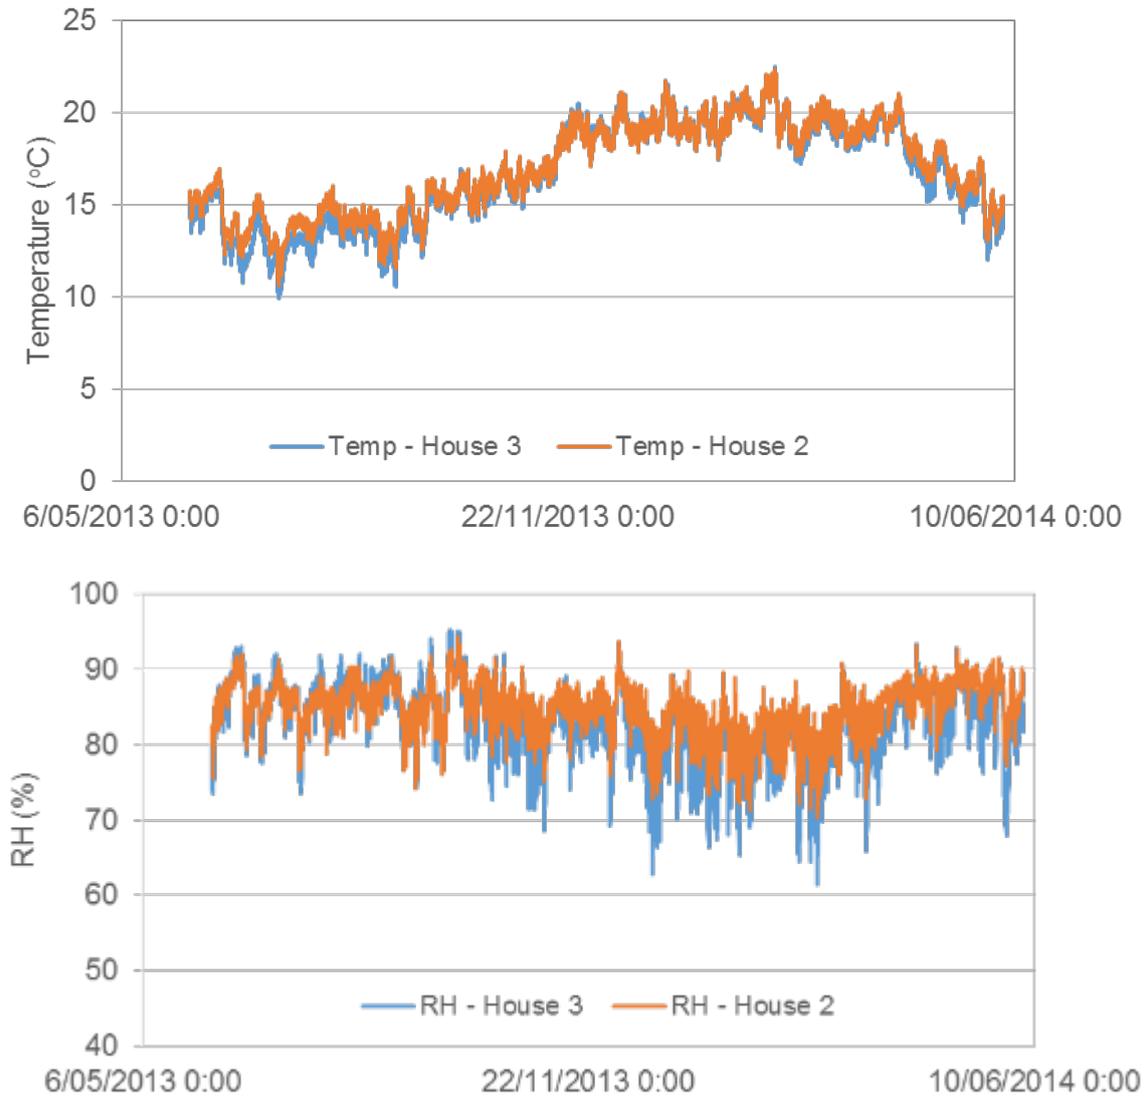
Figure 20. Variations of temperature and relative humidity at centre locations in the subfloors of house 3 and house 2.

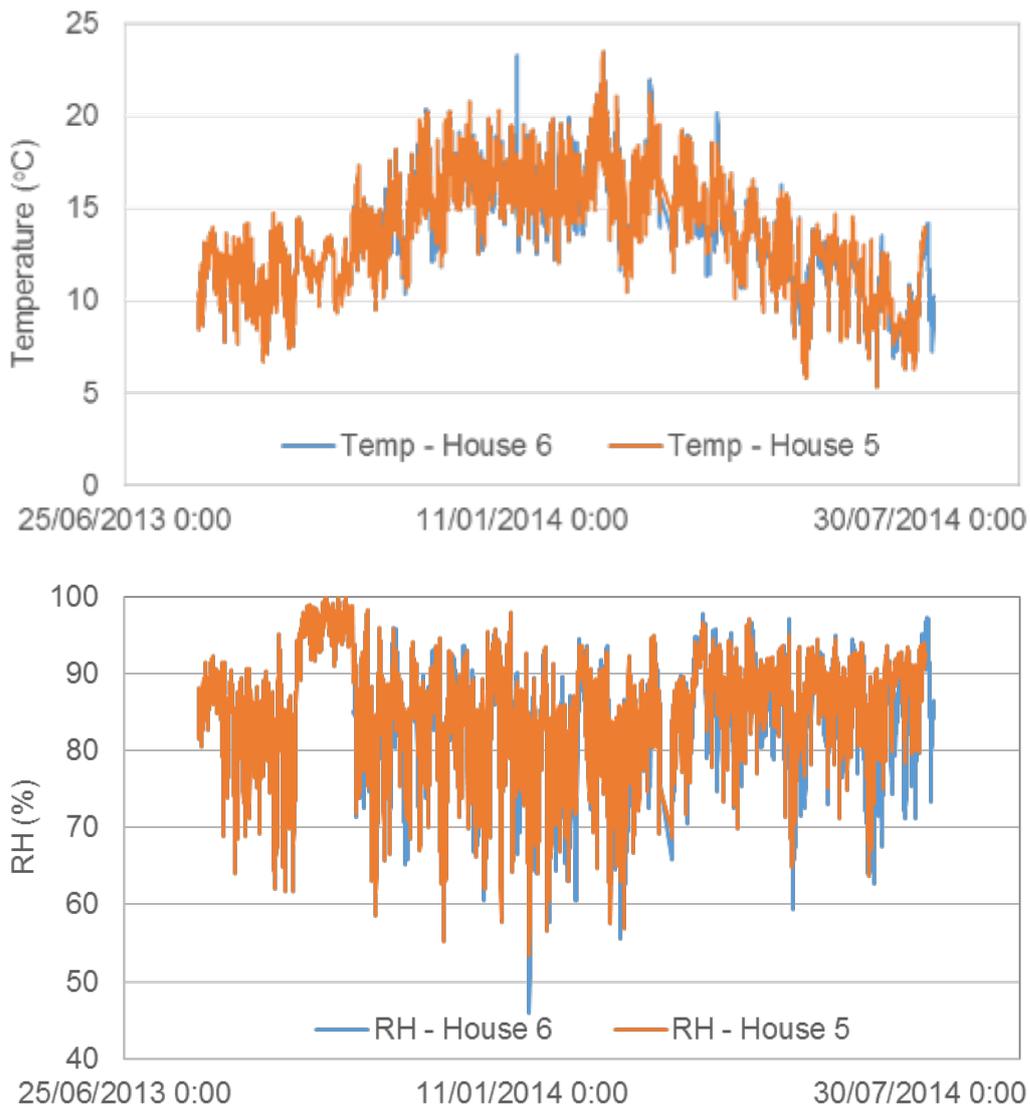
Figure 21. Variations of temperature and relative humidity at centre locations in the subfloors of houses 6 and 5.

As shown in Figure 21, both temperature and relative humidity in the centre locations of these two houses were exhibiting no significant difference. This could then explain why metals tended to corrode similarly in these two subfloors with significantly different ground soil conditions.

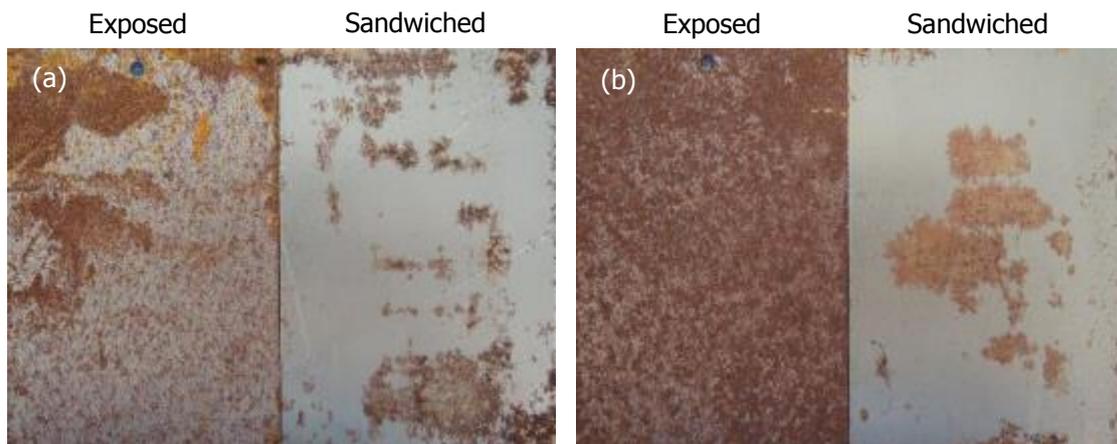
Figure 22. Surface morphology of mild steel samples exposed to subfloor of house 7 (a) in the corner of the house, (b) close to vent 2.

In comparison with the metals directly exposed to subfloor atmospheres, these samples corroded even slower. Only limited patches with very thin rust could be observed after 12 months of exposure (Figure 22).

From Figure 22(a) and (b), it appears that the sample close to the vent suffered slightly more corrosive attack than that installed in the corner. The chance of moisture condensation on the steel surface could be higher due to larger variations of temperature and humidity close to the subfloor vent.

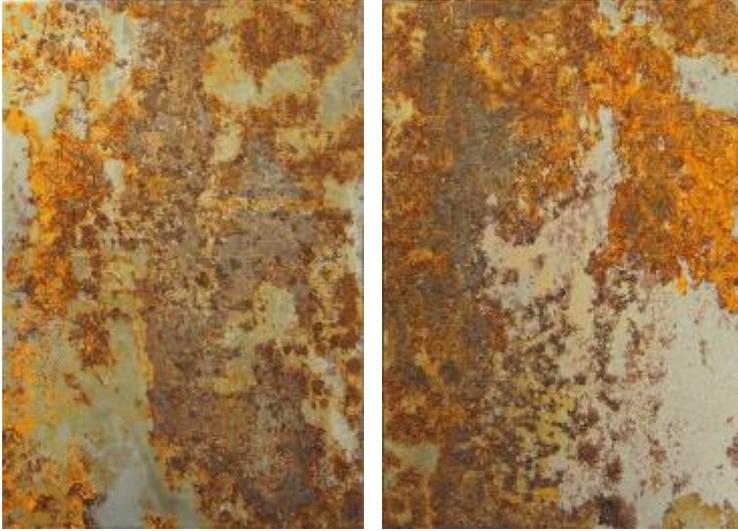
Figure 23. Surface morphology of sandwiched mild steel sample installed close to the vent-1 location in the subfloor of house 7.

The sample sandwiched into the timber blocks installed at the vent-1 location of the subfloor of house 7 had a high corrosion rate, 93.2g/m²/year. An examination of the steel surface and timber revealed that this sample had been wetted by water for a relatively long period (see Figure 23). A check of the foundation wall arrangement showed that the external concrete pavement close to this vent was high. Consequently, rainwater could flow into the subfloor through this vent and make the timber block wet.
