Managing subfloor moisture, corrosion and insulation performance

BRANZ Study Report SR354

Abstract

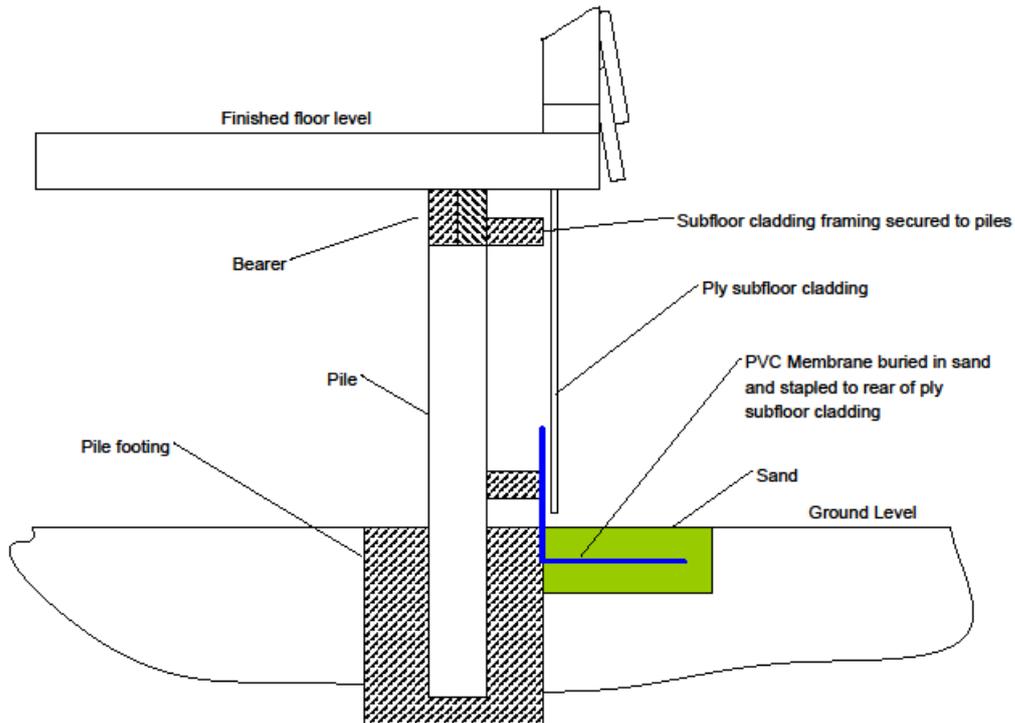
Figure 24. Subfloor footing detail.

The ventilation research building was relocated to the BRANZ site in Judgeford in 2010. The subfloor space to this building remained completely exposed to the environment until the beginning of the subfloor research programme. In early 2013, a plywood cladding in combination with a sand and polythene-based footing (Figure 24) were added to enclose the space. Large doors were fitted at either end of the building to enable access.

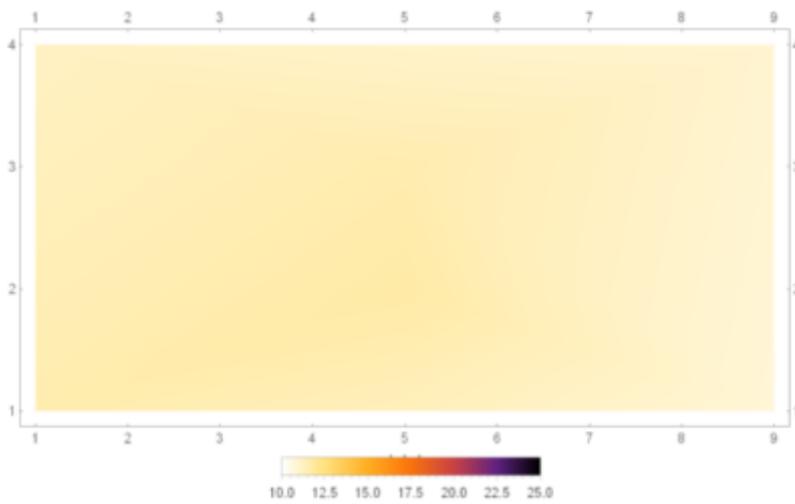
Figure 25. Heatmap of timber moisture content prior to enclosing the space.

Prior to closing the door, the instrumentation was turned on and state of the subfloor captured. This is shown in Figure 25 via a heatmap of timber moisture content of the subfloor framing timber. This floor plan is rotated 90 degrees relative to Figure 10.

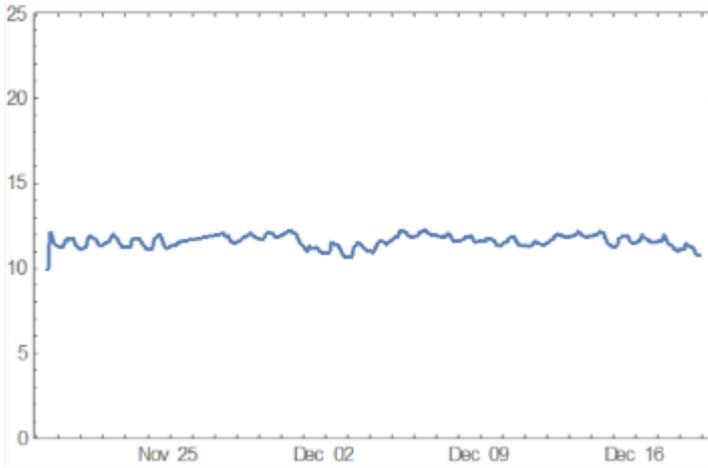
Figure 26. Mean moisture content for the 3 weeks prior to enclosing the space.

Figure 26 is a plot of the mean timber moisture content prior to the doors being closed. The timber was in a consistently dry state around 12% across the entire space.

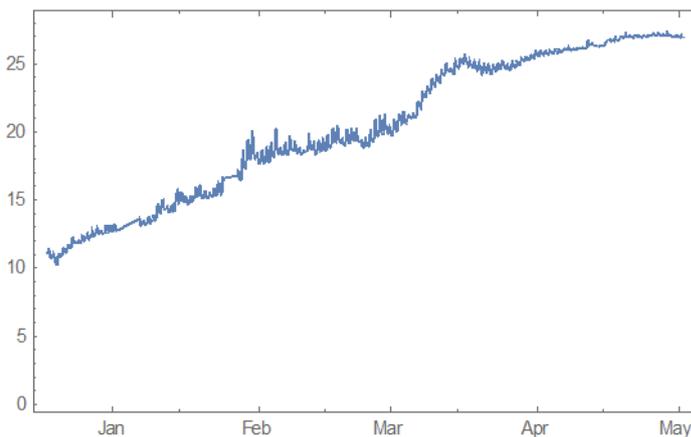
Figure 27. Moisture accumulation in southern subfloor framing timber.

Figure 27 is a plot of the moisture content in a timber bearer along the south face of the building. Figure 28(a) shows a heatmap of timber moisture content just prior to additional ventilation being added. It is clear that the southern side of the subfloor space has accumulated considerably more moisture, mainly due to the lack of solar gain on the plywood lining of the subfloor and the floor surfaces of the rooms above.

As Figure 27 shows, the accumulation of moisture in the framing once the doors were closed is rapid, taking 4 months to build up from a dry state to reach fibre saturation, purely from absorption from moisture in the air. Using the equipment mentioned in section 3.2.3, the leakage area of the entire subfloor space to outside was measured to be roughly equivalent to a single pipe of 150 mm diameter. Figure 27 and Figure 28 clearly show that the amount of infiltration this provides is insufficient to dilute the moisture evaporating from the exposed soil in the space.

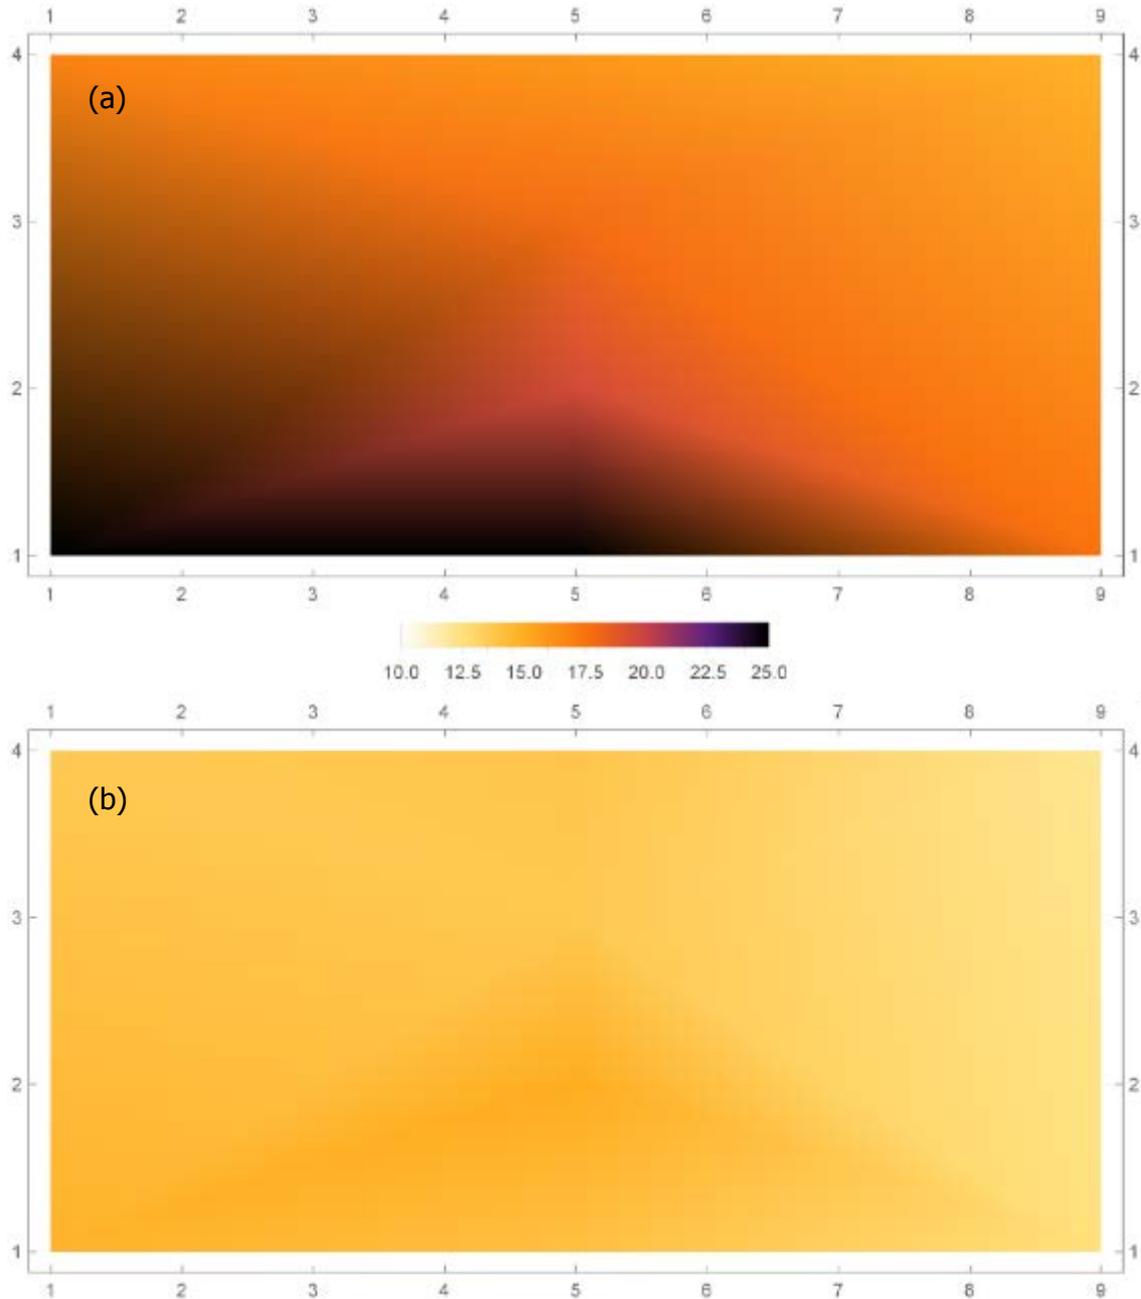
Figure 28. Heatmaps of framing moisture content – (a) in May 2014 and (b) in December 2014, some time after vents were added.

In May 2014, the steel plates covering the vents in the subfloor walls were exchanged for a set of vents at 90 mm diameter. These were chosen as they represented what had been found was in use in practice over numerous BRANZ houses condition surveys and the field survey. The drying of moisture after this occurred can be seen in Figure 29. Figure 28(b) shows a heatmap of the subfloor framing timber in December of 2014, where it is clear the subfloor space has recovered to a large extent, with a mean of 13.5%.

Figure 28 and Figure 29 clearly demonstrate that the addition of ventilation openings is beneficial to the amount of moisture retained in the subfloor. The remaining question is how much ventilation those vents provided. Given that this building is in a well exposed location, we cannot be sure that similar openings will be sufficient in built up areas or where site conditions of other works may limit the effectiveness of the vents provided.

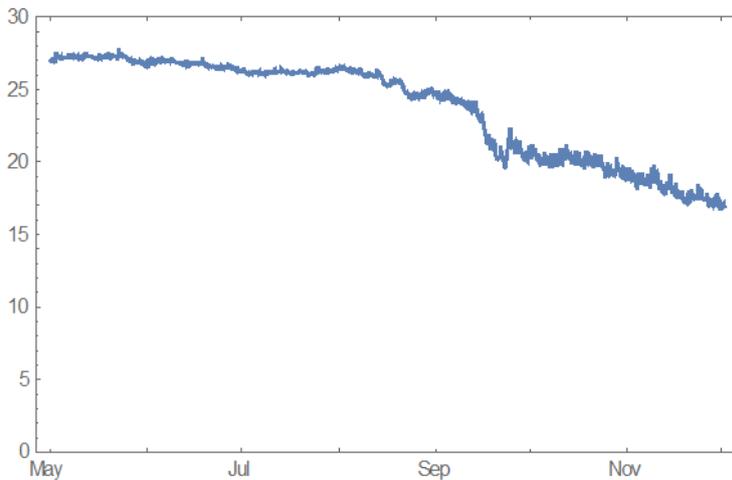
Figure 29. Drying of framing timber after the addition of 20% of Building Code level ventilation openings.

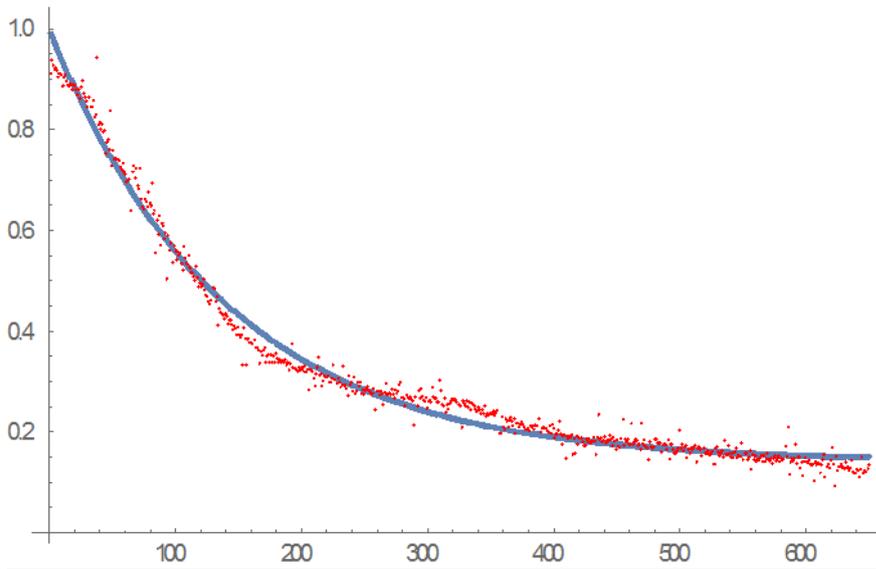
Figure 30. Tracer decay – 90 mm vents.

Results are plotted in Figure 30 and Figure 31. Ventilation rates for the 90 mm and 200 mm vents were 25.9 and 32.6 ach respectively.

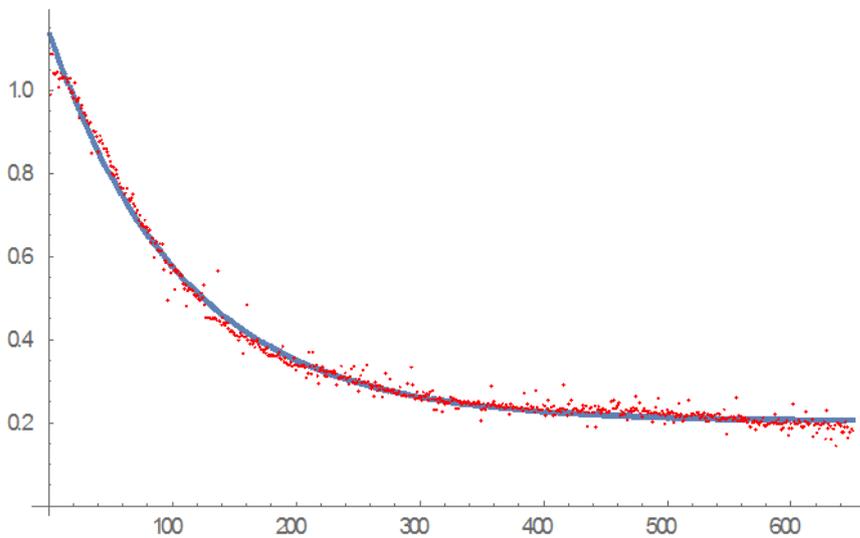
Figure 31. Tracer decay – 200 mm vents.

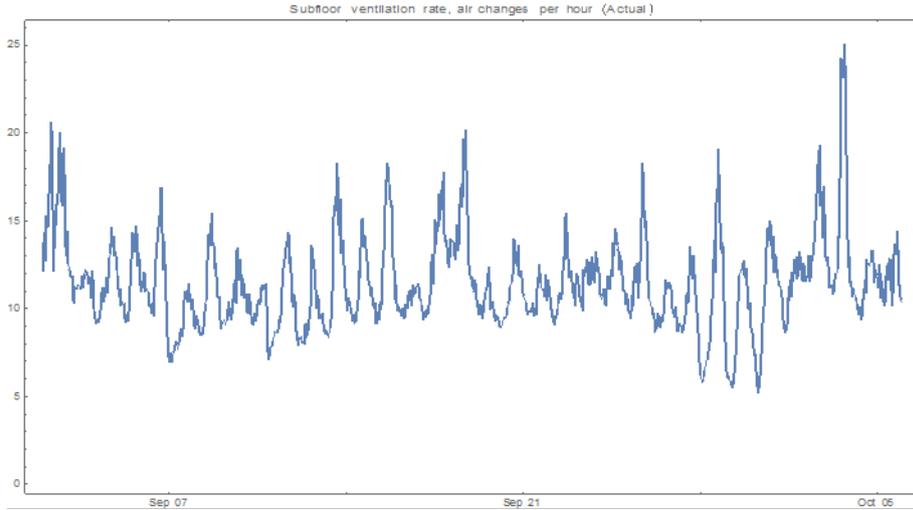
Figure 32. Hourly average ventilation rates measured in the subfloor – all vents closed and polythene laid on the soil.

Hourly average ventilation rates are plotted for the measurement period in Figure 32. The mean measured ventilation rate was 11.5 ach.

The range wind speed is fairly similar in both plots, and the mean speeds are close enough to give confidence that the infiltration rates in Figure 32 are typical for the enclosed subfloor with no ventilation provisions.

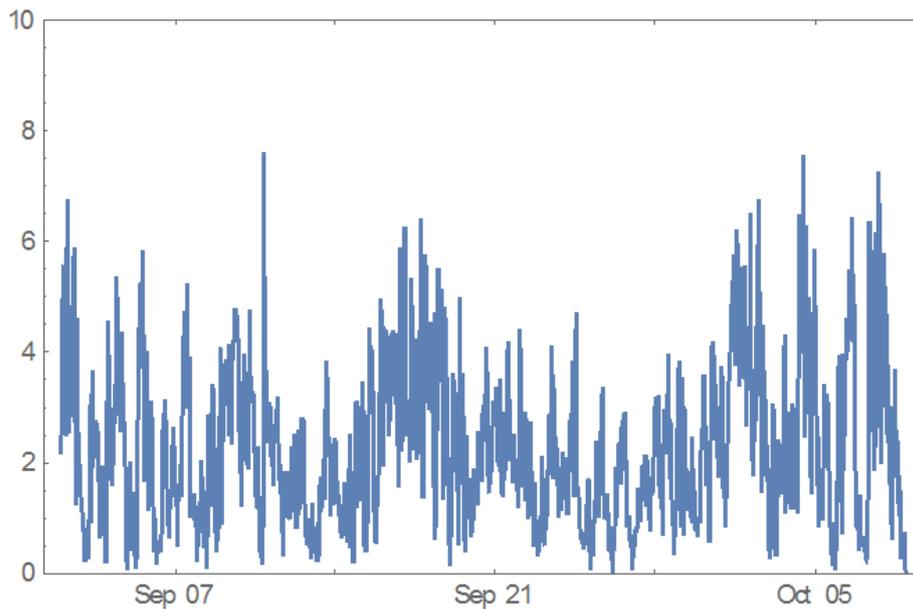
Figure 33. Hourly mean wind speed during constant dosing tracer experiment.

Figure 33 and Figure 34 are plots of the hourly average wind speed (measured at a height of 10 m) for the period of the measurements shown in Figure 32 and the rest of the project respectively. The mean in Figure 33 was 2.27 m/s, and in Figure 34, this was 2.11 m/s.

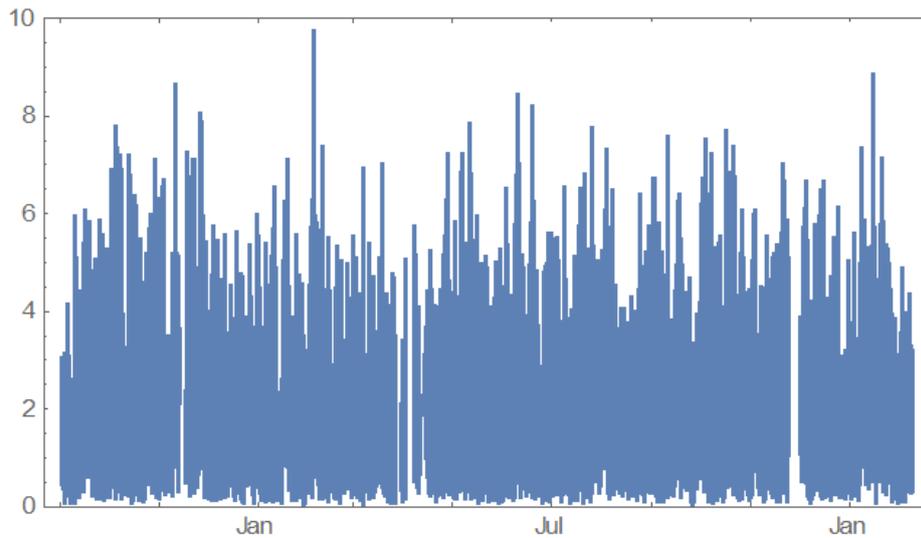
Figure 34. Hourly mean wind speed over the project.

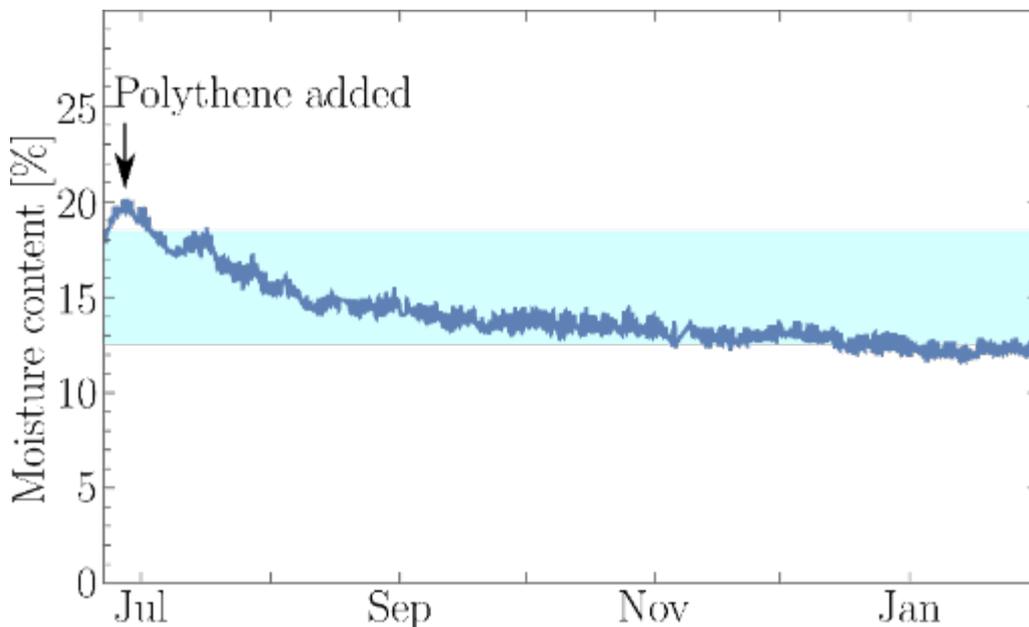
Figure 35. Moisture content of south bearer after polythene laid and all vents of the space are closed.

As seen in Table 7, the subfloor was sealed again in June 2015, and a polythene moisture barrier was laid on the ground. The moisture content of the bearer on the south face (where the highest moisture contents were previously measured) is shown in Figure 35.

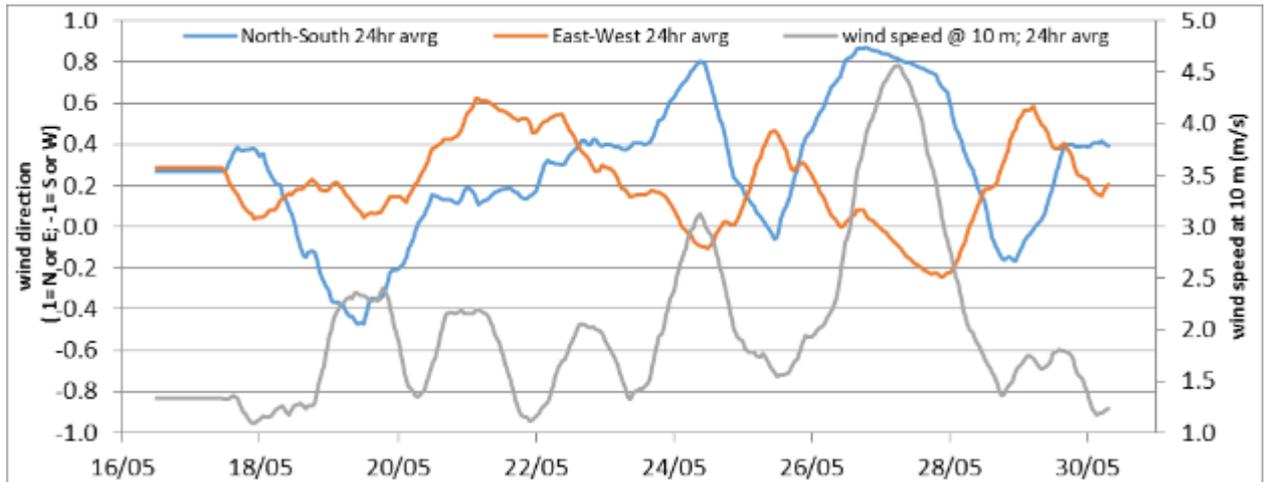
Figure 36. Moving average of wind speed and direction for the period where foil performance was monitored.

Figure 36 shows a summary of the wind speed and direction over the measurement period. The data has been summarised as a 24-hour moving average of wind speed and direction with the direction split into two components – north to south and east to west. Data points are at 1-hour intervals. It can be seen from the chart that strong northerly winds were experienced on 27 and 28 May, moderate southerlies on 20 May and moderate easterlies on 20 and 24 May.

Comparing the two charts in Figure 36 and Figure 37 reveals that, although the R-values, when averaged over a period of a week or more, are consistent with the assumed performance of this type of floor system (under NZS 4214:2006 *Methods of determining the total thermal resistance of parts of buildings*), the performance over a period of 1 or 2 days can deviate significantly from those longer-term values.

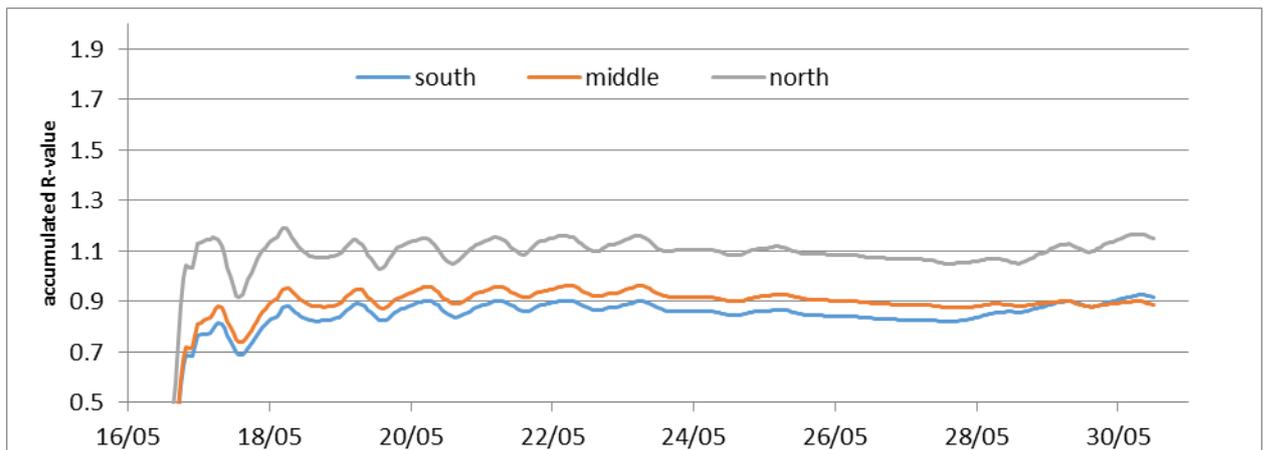
Figure 37. Accumulated R-value of foil insulation in three locations.

Figure 37 shows the accumulated R-values at the three positions. The accumulated R-values are similar to what was measured as part of SR202.

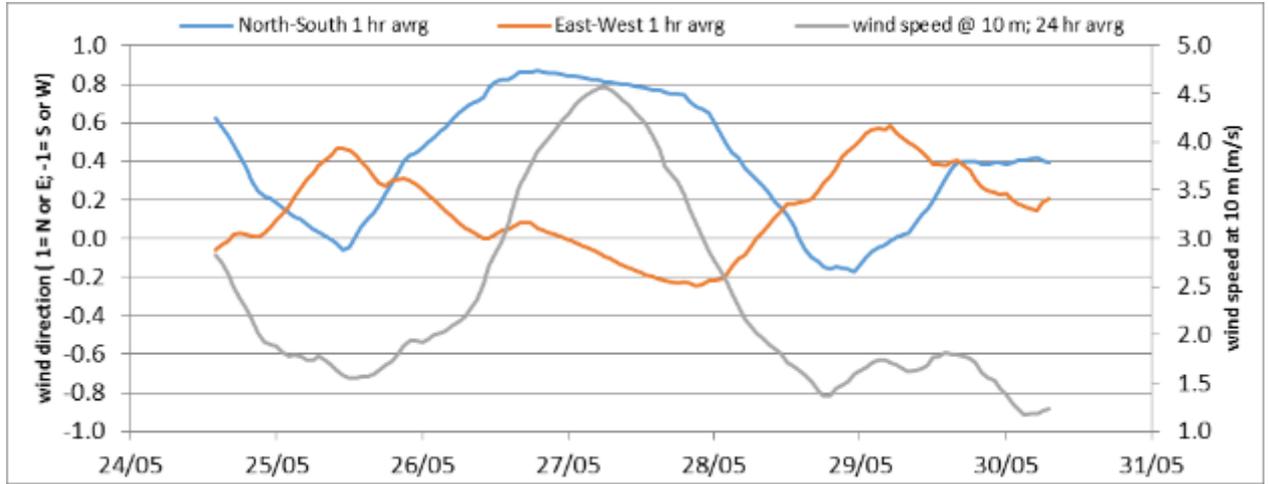
Figure 38. 24-hour average wind speed and direction for second week of monitoring foil insulation performance.

Figure 38 and Figure 39 relate to the second week of data, with Figure 40–Figure 42 showing the data as a more detailed 1-hour moving average instead of the 1-day moving average in and for the wind data and R-value.

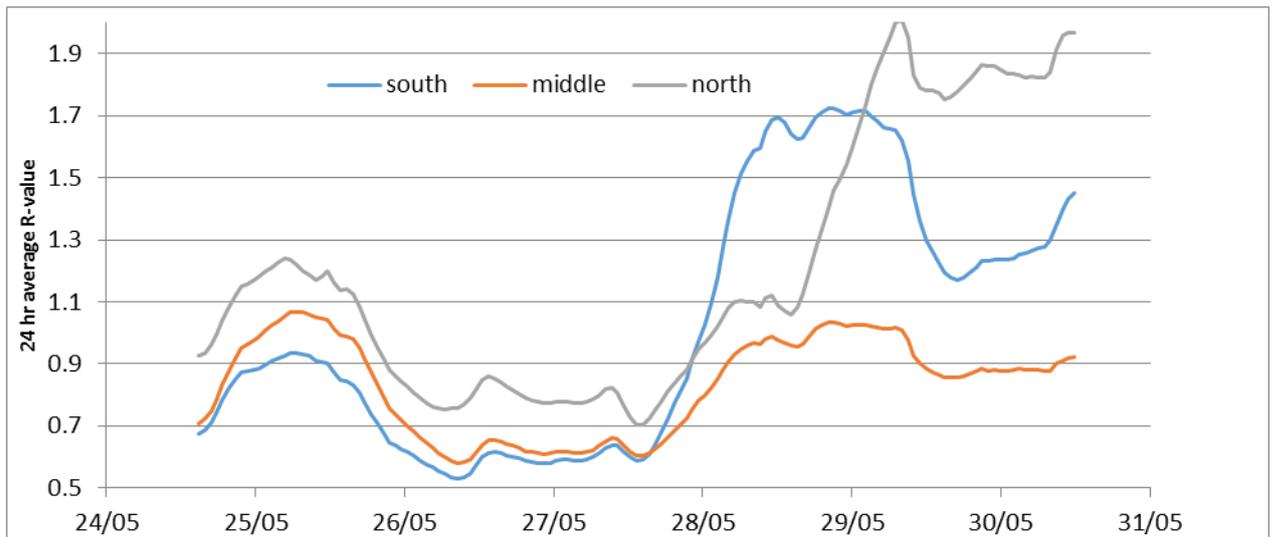
Figure 39. 24-hour average R-value of foil insulation in three locations – week 2.

Over the period 29–31 May, the wind velocity was only moderate, but there were significant changes in wind direction. The overall impact was that the R-value trend for the centre of the floor was a continuation of the data over the previous 2 weeks whereas there was an unusual increase in R-value at the two perimeter locations, first for the south and then for the north. The wind during that period swung around from north to the south then back again.

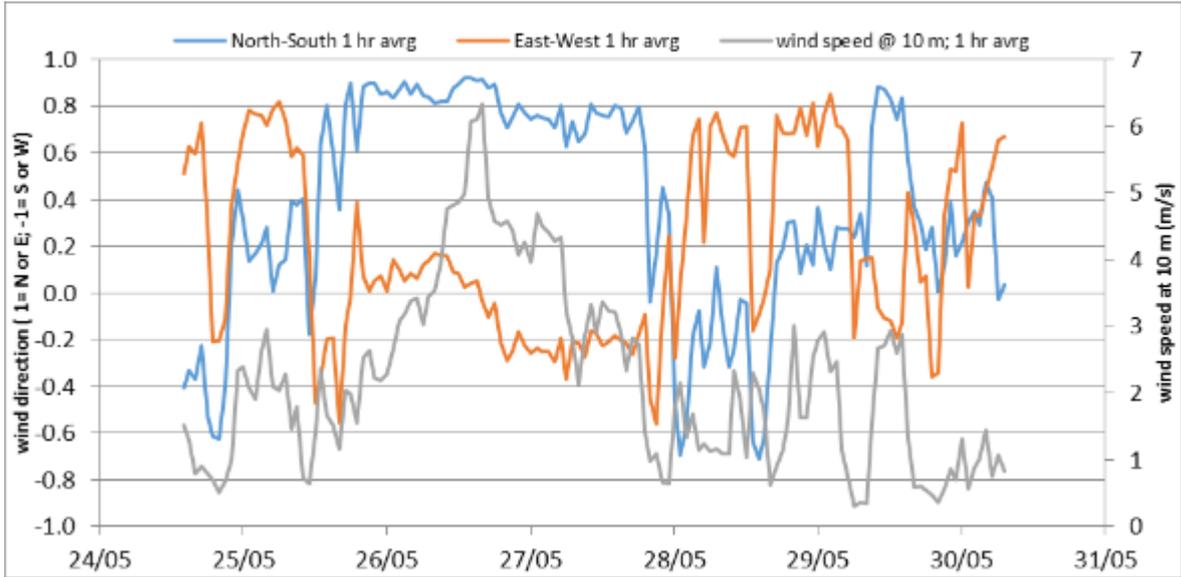
Figure 40. 1-hour average wind speed and direction for week 2 – foil insulation performance measurements.

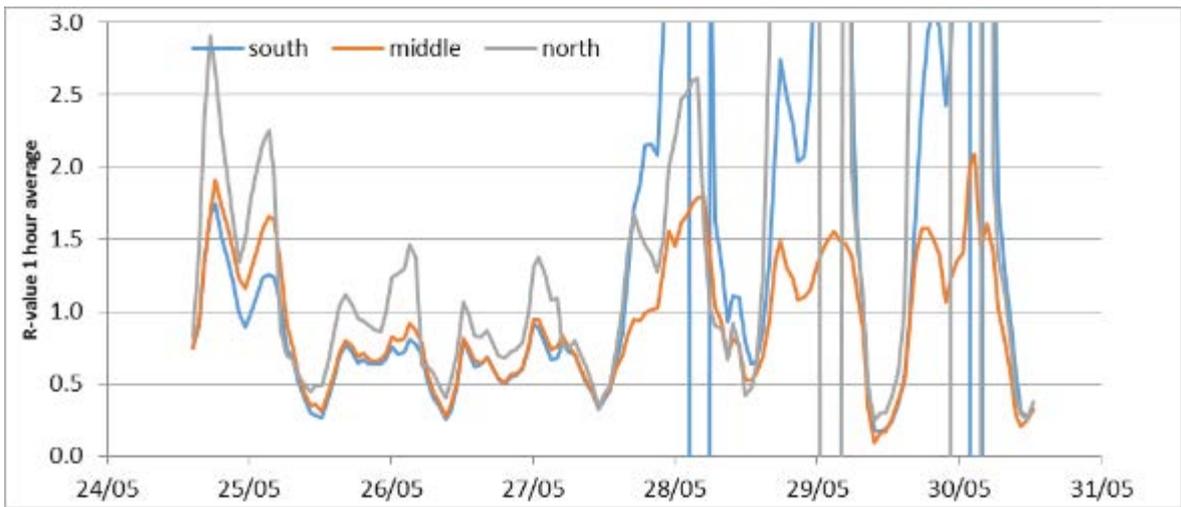
Figure 41. 1-hour average R-Value for three locations – foil insulation.

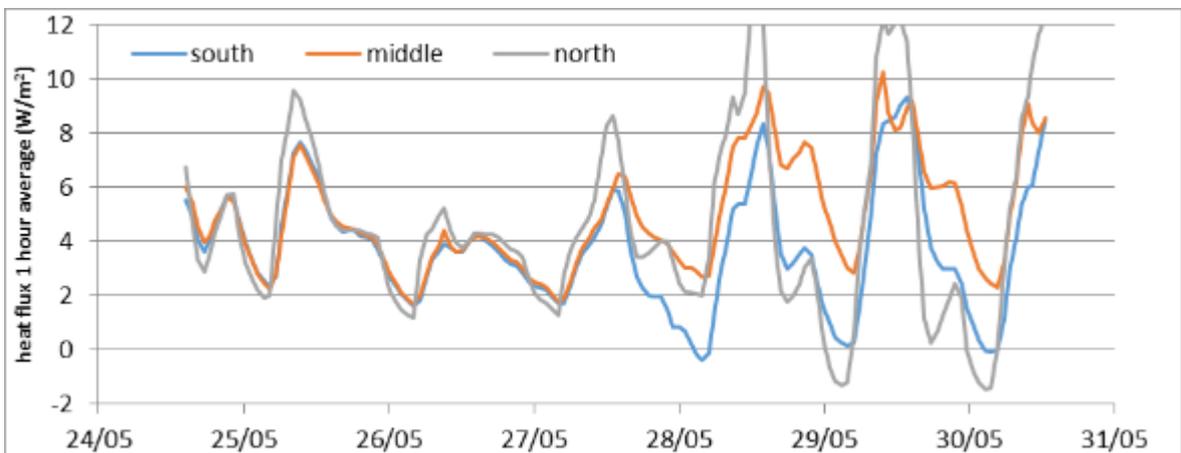
Figure 42. 1-hour average heat flux for three locations.

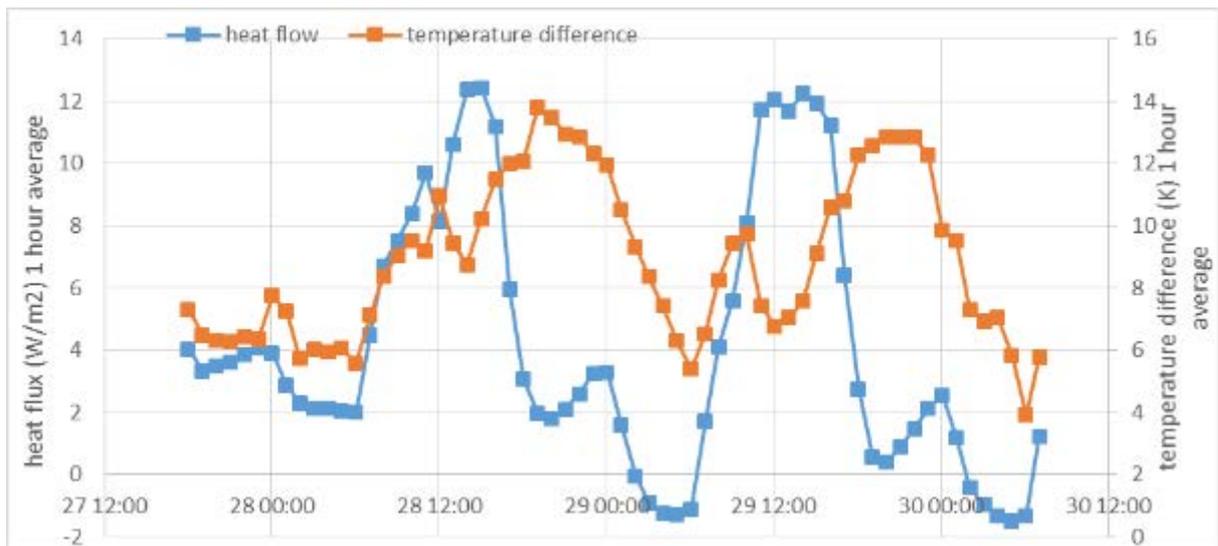
Figure 43. Heat flux and temperature difference in the middle of floor sensor location from 29–31 May.

Figure 43 displays in detail the heat flow and temperature difference data for the sensor in the middle of the floor over the period 29–31 May. In the middle of the day on both 29 and 30 May, the heat flow gets out of sync with the temperature difference. After cold morning temperatures, the house begins to heat up. The heat flow responds almost immediately with the increase in temperature difference until midday when, for a few hours, the temperature difference begins to decrease without any change in the rate that the heat flow is increasing. After a couple of hours of decreasing temperature, the temperature difference starts increasing again.

At that point, the heat flow starts to decrease until around dusk when the trends reverse, temperature difference decreases and heat flow increases. At midnight, the heat flow starts to increase again and is in sync with temperature difference as external temperature drops until dawn and then increases again with the start of the next day.

A possible explanation for this behaviour is moisture condensing for a period on the surface of the foil then evaporating off again. It would also explain why the R-value increased more at the south and north locations than in the middle after the wind swung around from the north to the south and possibly cleared excess moisture from the airspace between the floor and the foil.

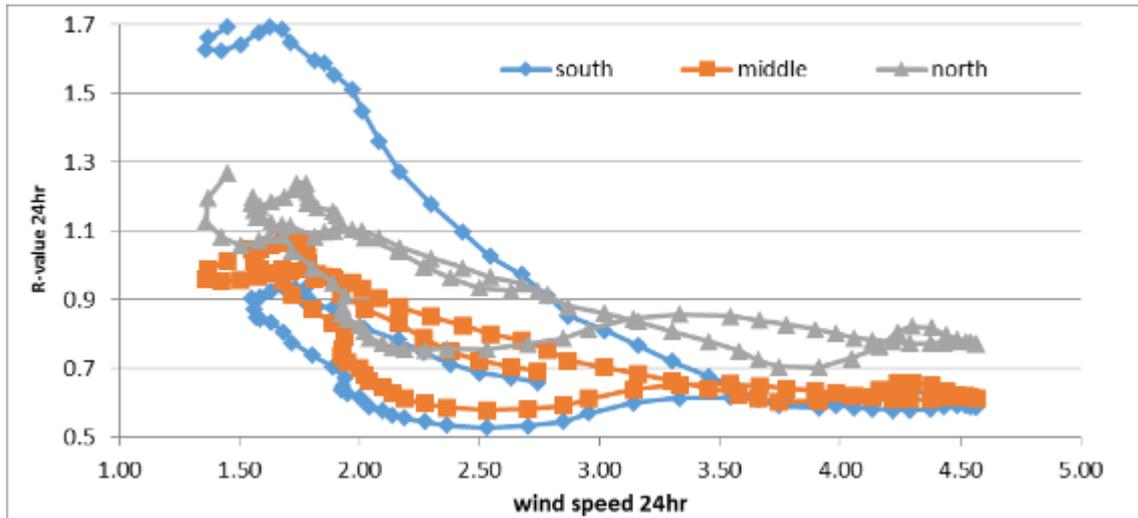
Figure 44. Progression of 24-hour moving average R-value of foil insulation from 29–31 May for three locations.

Figure 44 shows the moving 24-hour average R-values at 1-hour intervals over the period 29–31 May. The R-value is plotted against air speed at 10 m. Air speed begins at 2.7 m/s with the R-values increasing as the air speed decreases to 1.5 m/s. The R-values then decrease as the air speed increases again to 2 m/s. The R-values do not decrease further as the air speed continues to increase to 4.5 m/s. The R-values start to increase again as the air speed drops below 3 m/s. Whilst the R-values at the north and middle locations return to the same values they were previously when the wind was at 1.5 m/s, the R-value for the south location is significantly higher.

Given that the air speed in the subfloor space is expected to be one-tenth of the value at 10 m, this result shows how sensitive the performance of draped foil is to wind speed.

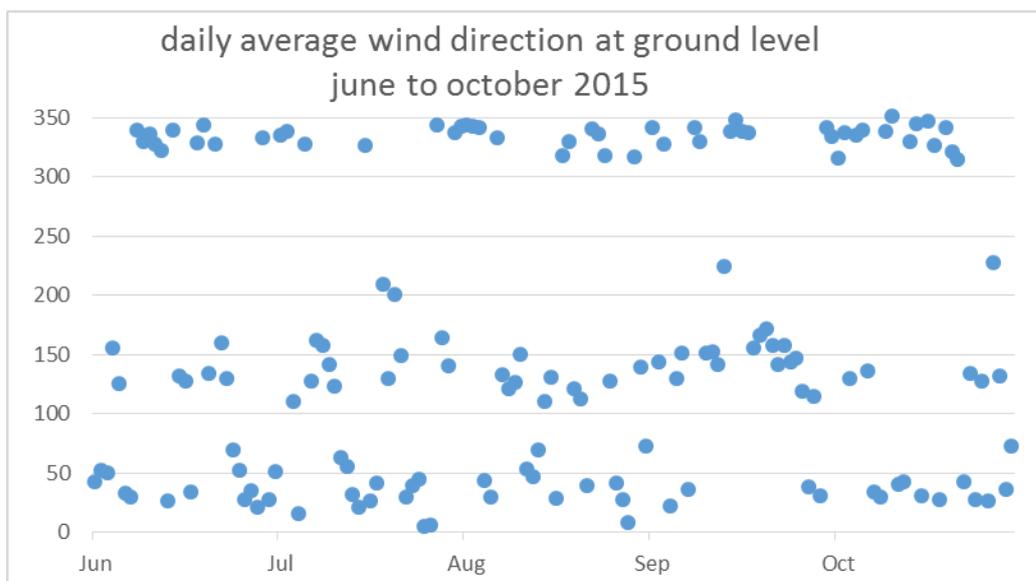
Figure 45. Daily average wind direction – winter 2015.

Figure 45 to Figure 47 show a summary of the wind speed and direction data at ground level for June to October 2015. The prevailing wind direction is northerly, but there are also relatively frequent south-easterlies during the middle of winter. The strongest and most sustained winds with a daily average above 2.5 m/s are from the northerly direction, which is also the orientation of the floor joists.

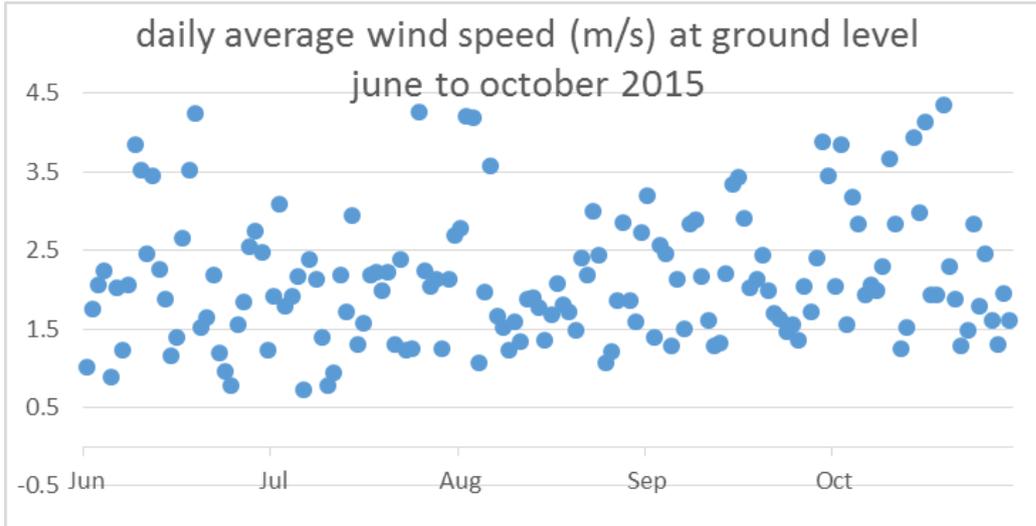
Figure 46. Daily average wind speed – winter 2015.

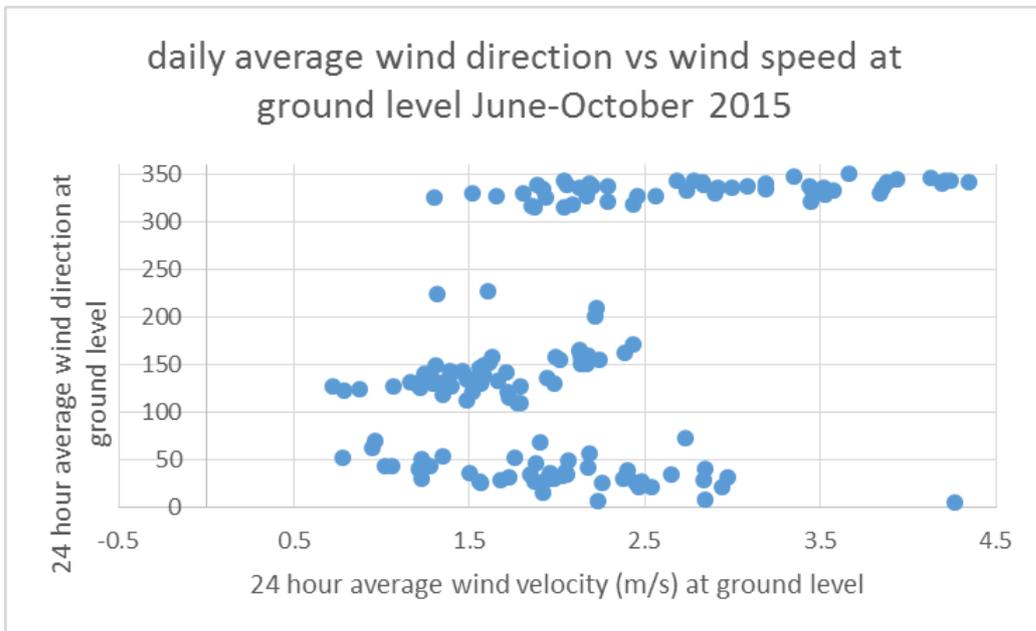
Figure 47. Daily average wind direction versus wind speed – winter 2015.

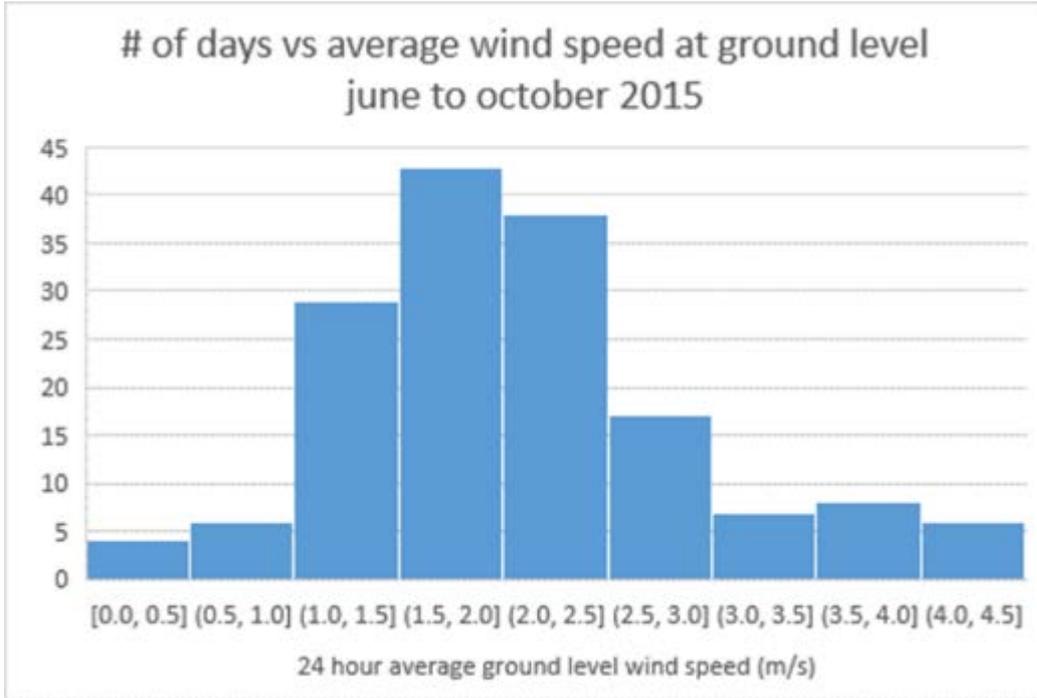
Figure 48. Daily average distribution of wind speed – winter 2015.

Figure 48 to Figure 51 show the frequency distribution of wind speed. The daily average is very rarely less than 1 m/s or more than 4 m/s and only occasionally above 3 m/s. Average daily wind speed for the 5 months from June to October is approximately 2 m/s. This also shows that the wind speed distribution for 2014 and 2015 were essentially the same.

Mostly, the daily average wind speed is in the range 1–3 m/s. When considering an hourly average, the maximum wind speed over the 5-month period was 7 m/s. From the raw data at 1-minute intervals, the maximum was 11.5 m/s in 2014 and 12.5 in 2015.

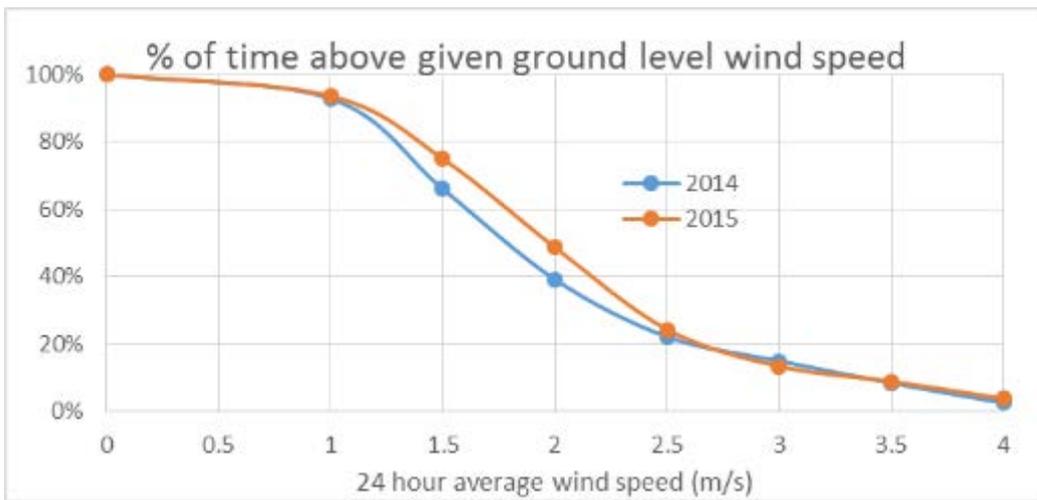
Figure 49. Percentage of time above a given ground level wind speed – winter 2015.

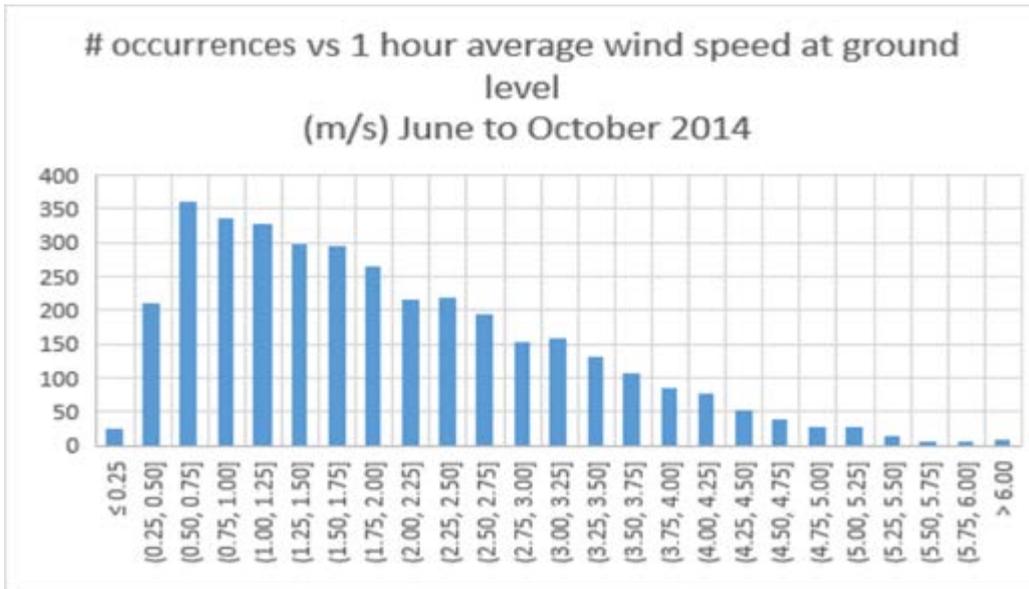
Figure 50. Distribution of 1-hour average ground level wind speed – winter 2014.

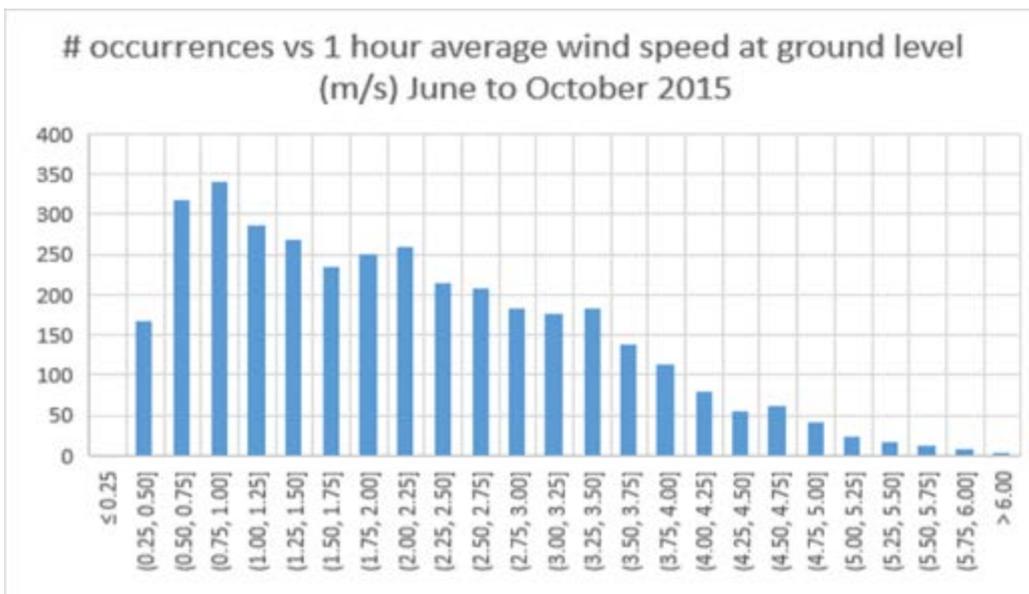
Figure 51. Distribution of 1-hour average ground level wind speed – winter 2015.

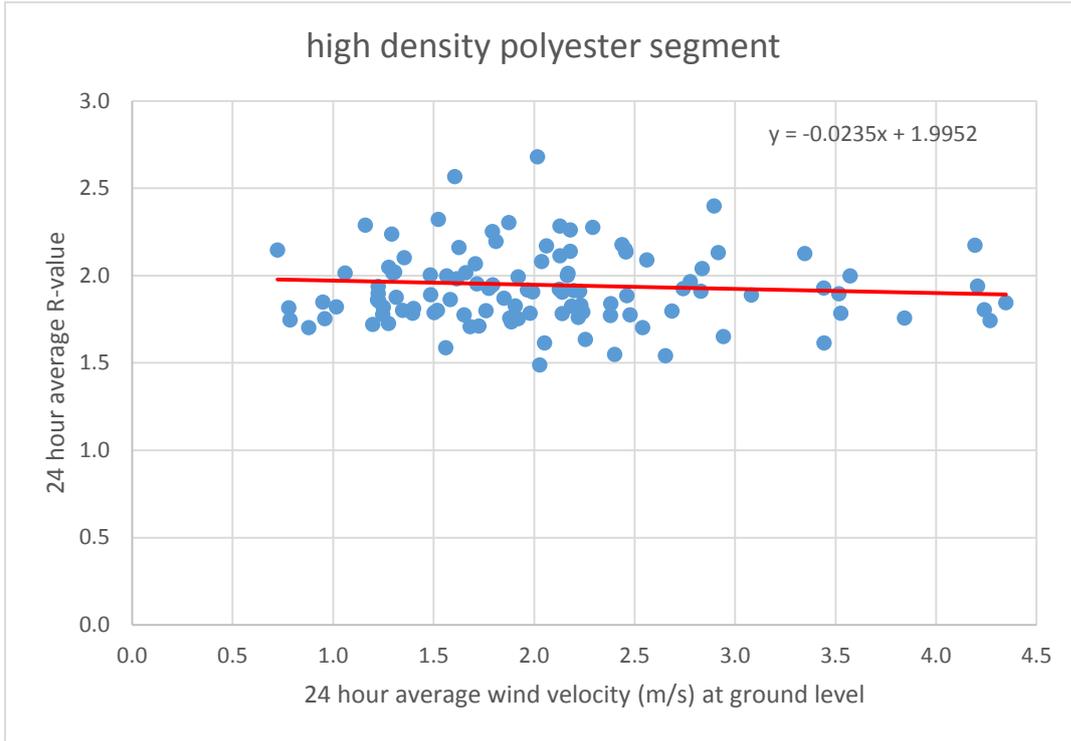
Figure 52. 24-hour average R-value versus wind speed – high-density polyester segment (2014 data).

Figure 52 to Figure 57 present a selection of the results for thermal resistance plotted against wind speed for the 5 winter months of either 2014 or 2015. The R-values are system values and so are typically higher than the actual R-value of the insulation material alone. Comparing the average R-value of the various products or comparing measurements against the theoretical system value is not necessarily meaningful. The purpose of the measurements was to assess the impact of wind wash on representative material types ranging from air impermeable (rigid foams) to highly air permeable (low-density fibrous).

A detailed analysis of the data could not detect a significant impact on thermal resistance of average daily wind velocity up to 1 m/s, even for the low-density fibrous materials. Above that wind speed, the impact on a percentage of the still air R-value was roughly linear for the medium and low-density fibrous products.

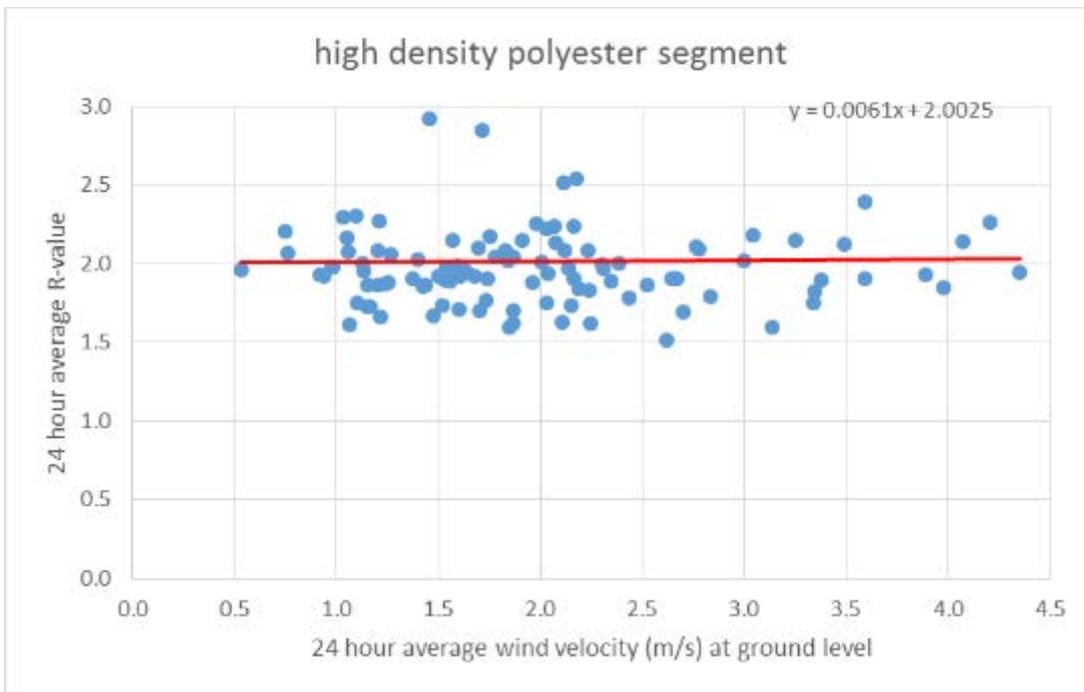
Figure 53. 24-hour average R-value versus wind speed – high-density polyester segment (2015 data).

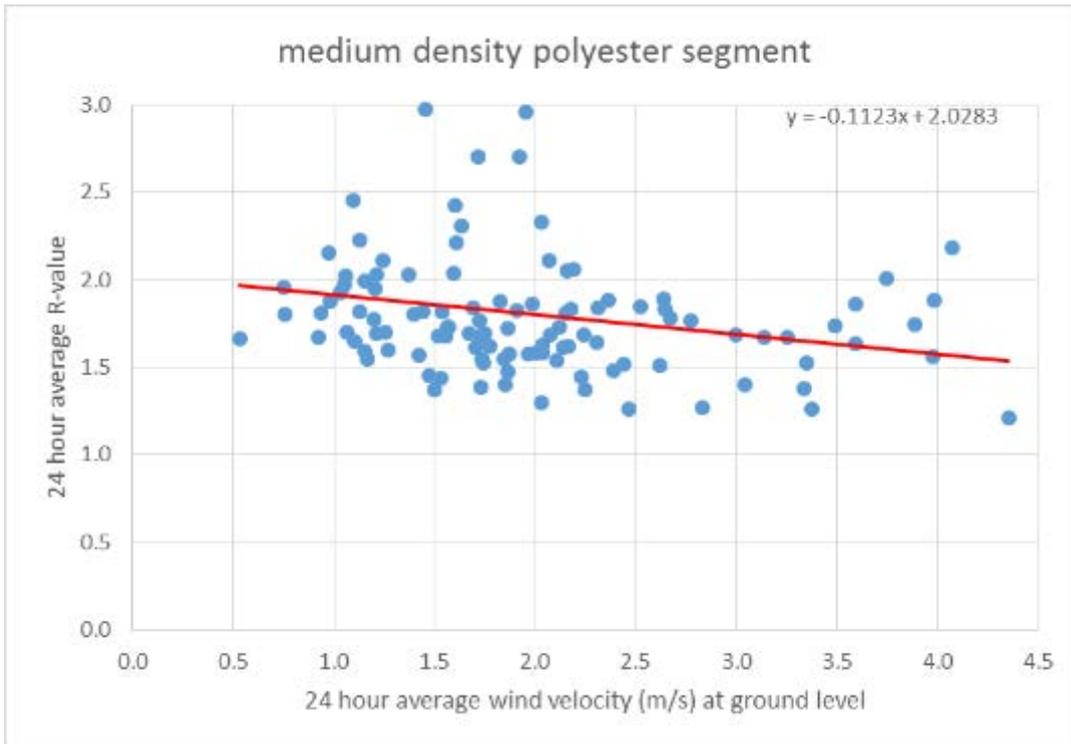
Figure 54. 24-hour average R-value versus wind speed – medium-density polyester segment.
