Managing subfloor moisture, corrosion and insulation performance

BRANZ Study Report SR354

Abstract

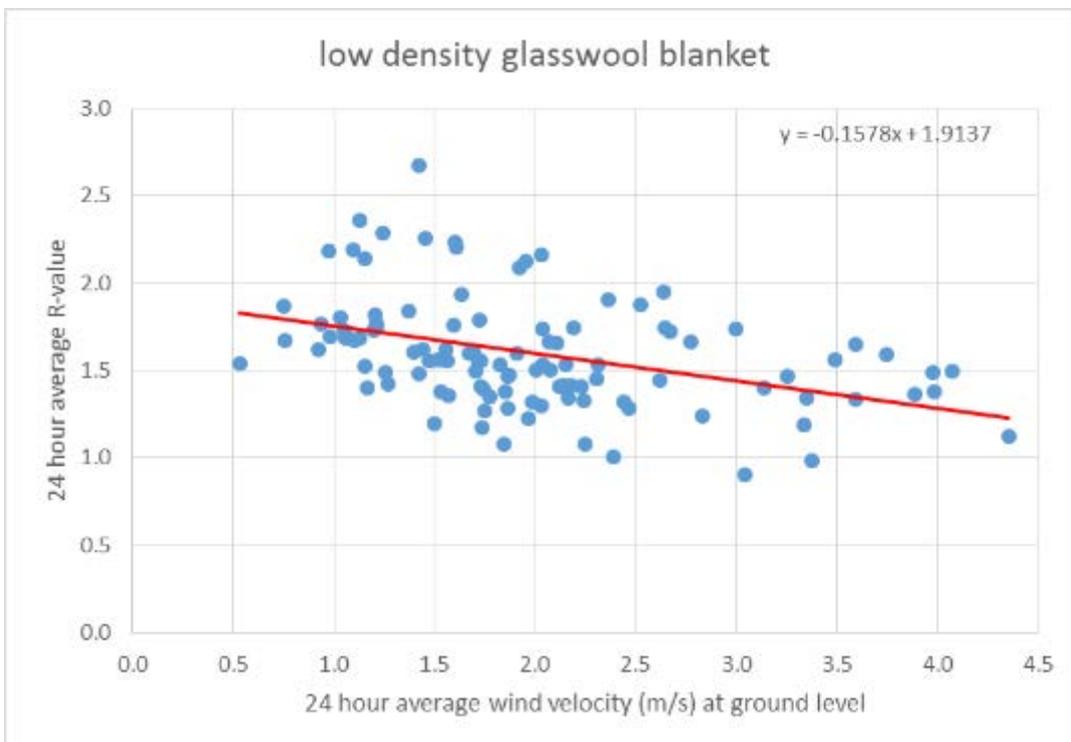
Figure 55. 24-hour average R-value versus wind speed – low-density glasswool blanket.

Figure 52 to Figure 57 present a selection of the results for thermal resistance plotted against wind speed for the 5 winter months of either 2014 or 2015. The R-values are system values and so are typically higher than the actual R-value of the insulation material alone. Comparing the average R-value of the various products or comparing measurements against the theoretical system value is not necessarily meaningful. The purpose of the measurements was to assess the impact of wind wash on representative material types ranging from air impermeable (rigid foams) to highly air permeable (low-density fibrous).

A detailed analysis of the data could not detect a significant impact on thermal resistance of average daily wind velocity up to 1 m/s, even for the low-density fibrous materials. Above that wind speed, the impact on a percentage of the still air R-value was roughly linear for the medium and low-density fibrous products.

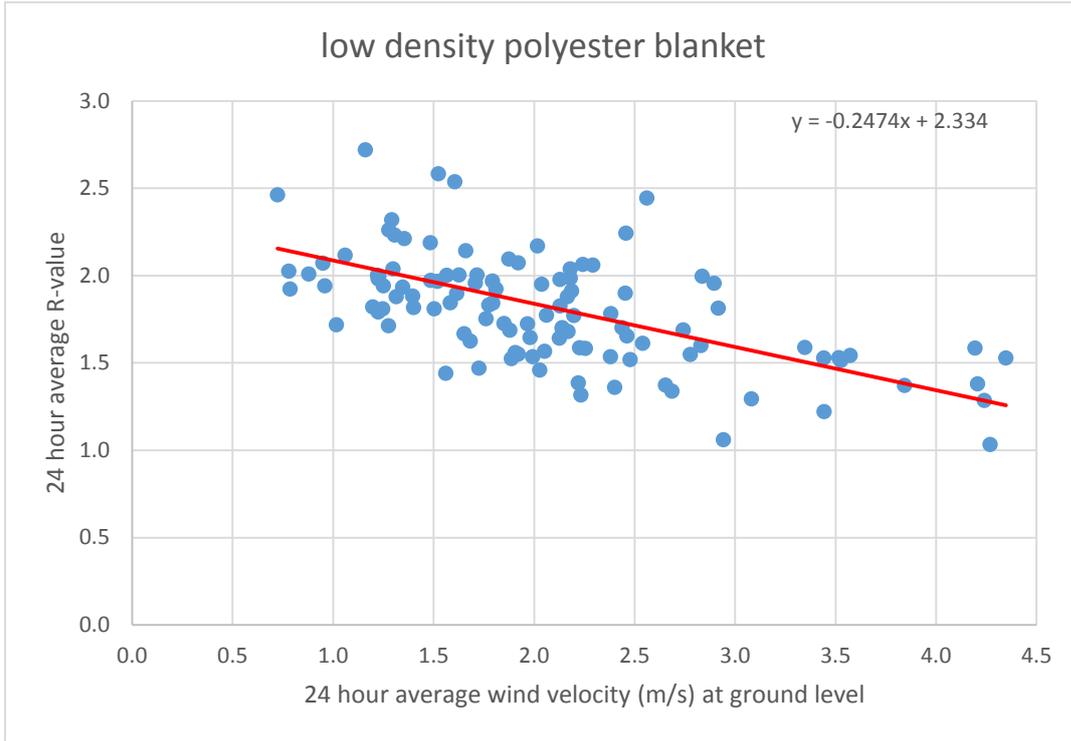
Figure 56. 24-hour average R-value versus wind speed – low-density polyester blanket (2014 data).

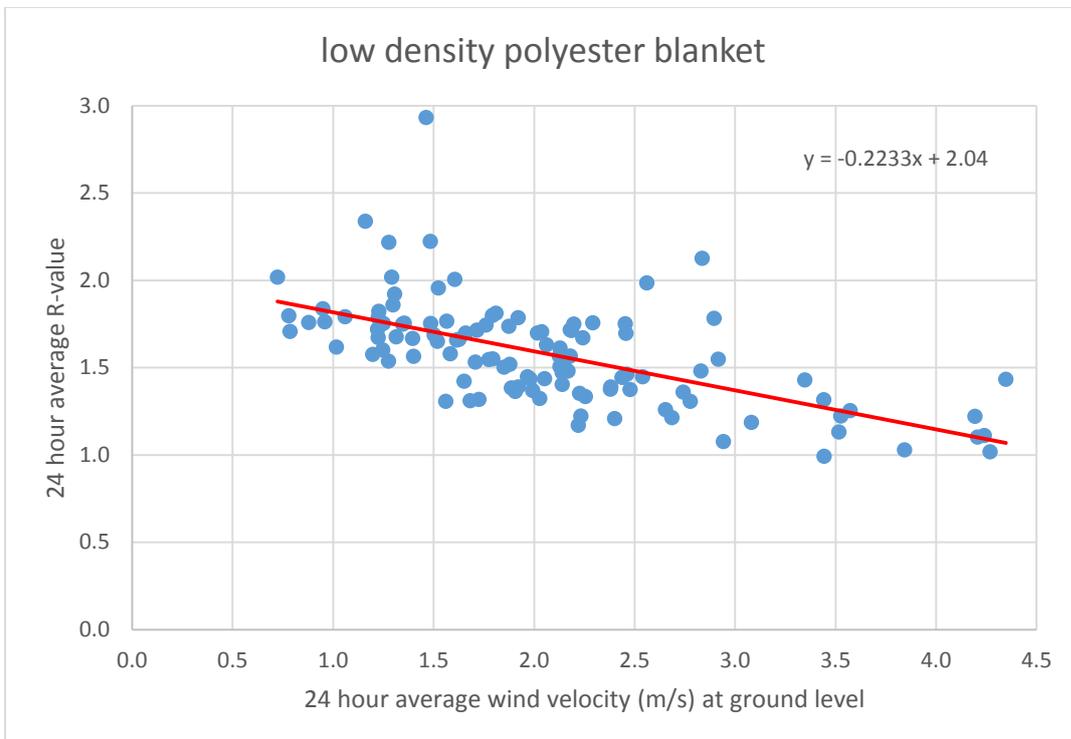
Figure 57. 24-hour average R-value versus wind speed – low-density polyester blanket (2015 data).

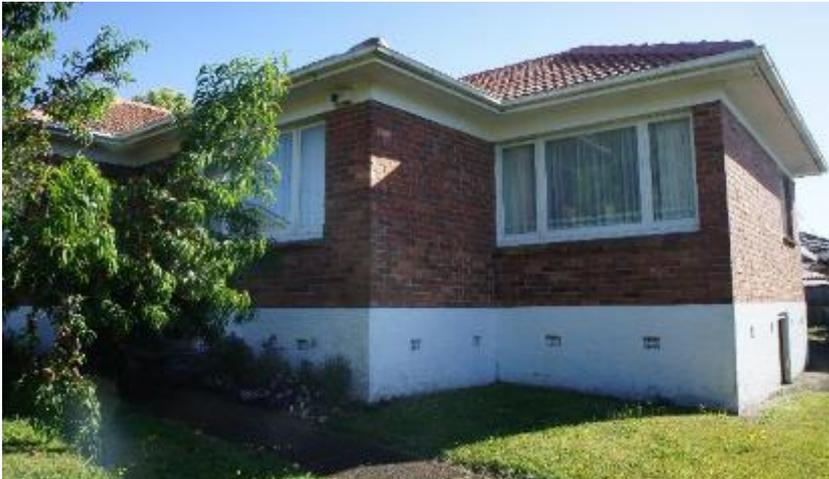
Figure 58. House 1 exterior.

Construction	Concrete perimeter foundation wall and brick veneer wall cladding – see Figure 58 and Figure 59
Underfloor insulation	R1.5 polyester
Subfloor ground	Covered with black polyethylene sheet
Configuration/dimensions	See Figure 60
Ventilation	22 in total vents with a dimension of 200 × 130 mm – each has 20 holes of 20 × 30 mm
Testing arrangement	Steel samples and sensors were installed at seven locations as shown in Figure 60
Monitoring period	4 June 2013 to 4 June 2014

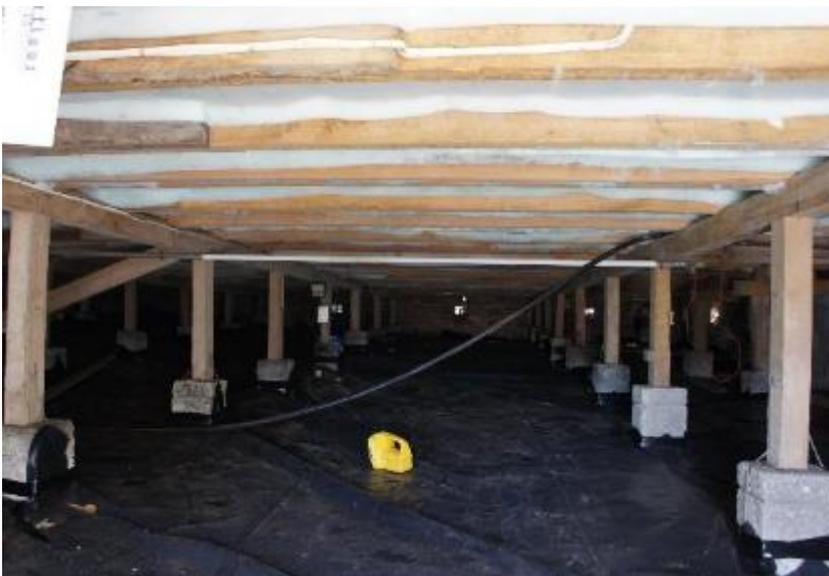
Figure 59. House 1 subfloor space.

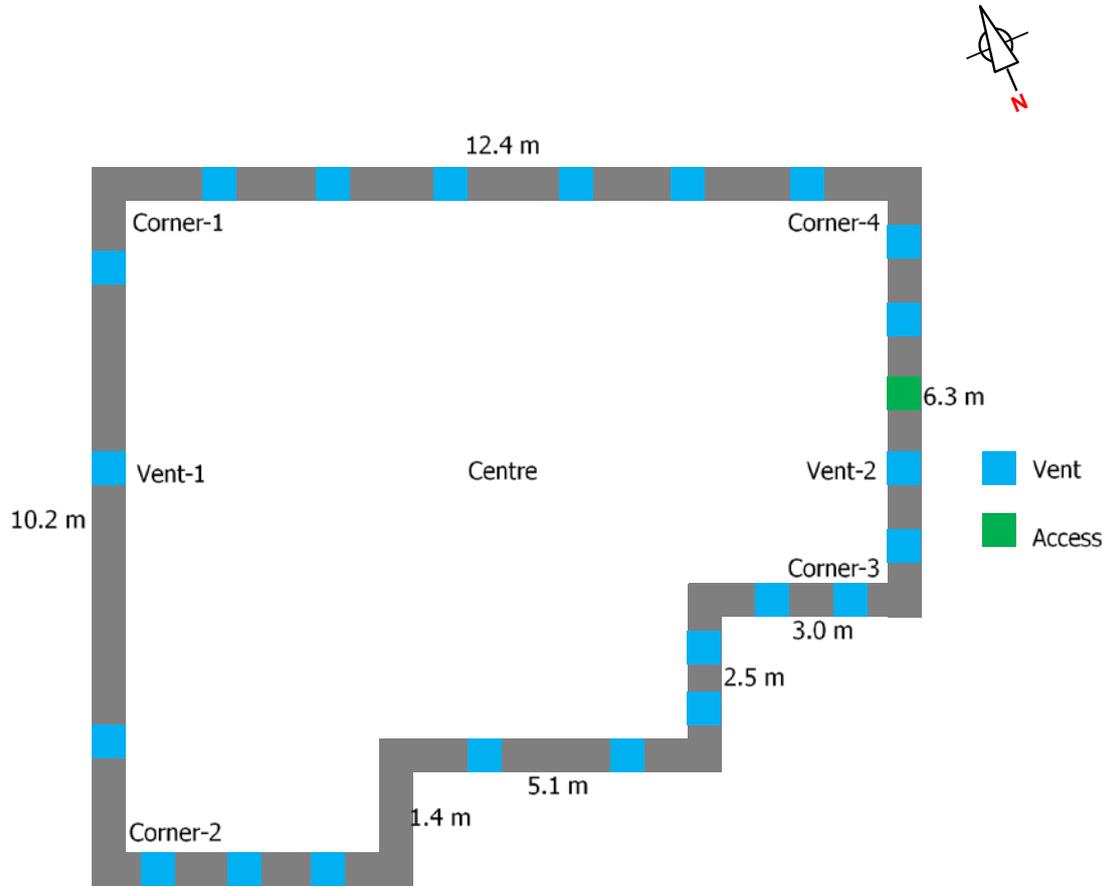
Figure 60. Dimensions of subfloor and sample arrangement of house 1.

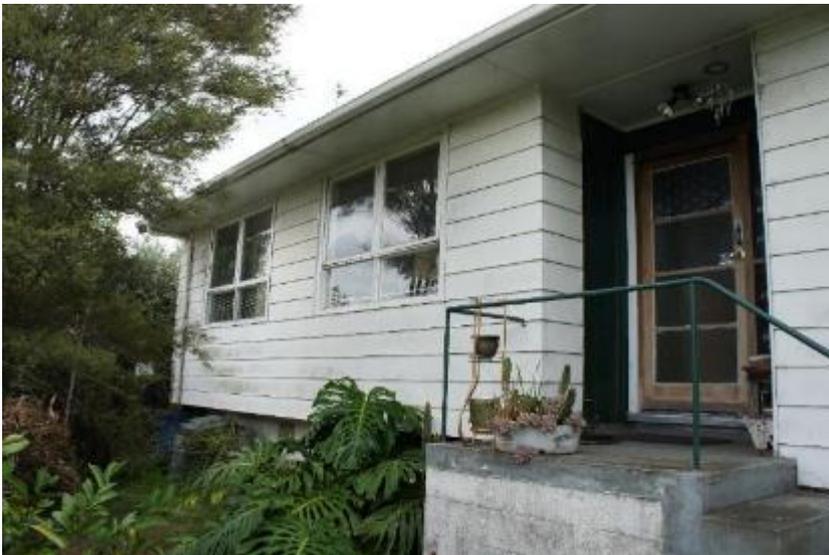
Figure 61. House 2 exterior.

Construction	Brick/concrete foundation wall, fibre-cement weatherboard – see Figure 61 and Figure 62
Underfloor insulation	R1.6 glass fibre
Subfloor ground	Not covered, appeared dry in most areas with some parts with relatively soft and wet soil
Configuration/dimensions	See Figure 63
Ventilation	16 in total vents with a dimension of 380 × 160 mm – each has 55 holes of 22 × 22 mm
Testing arrangement	Steel samples and sensors were installed at seven locations as shown in Figure 63
Monitoring period	4 June 2013 to 4 June 2014

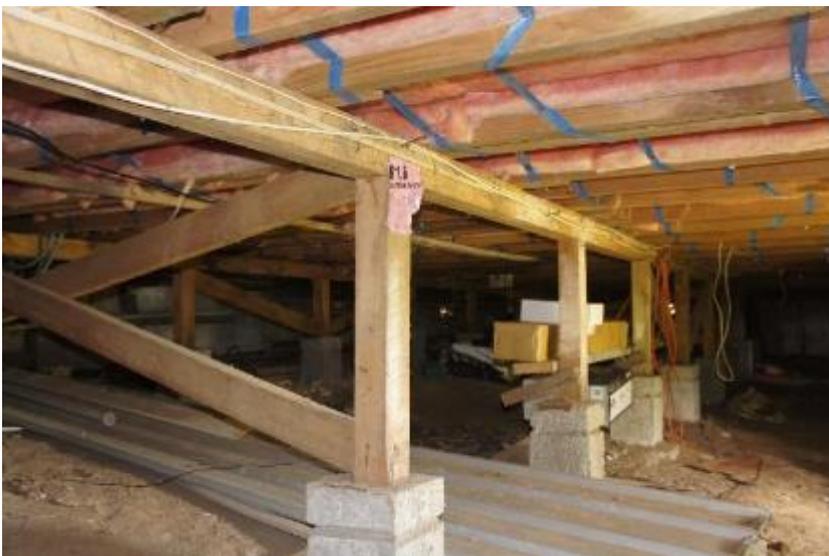
Figure 62. House 2 subfloor.

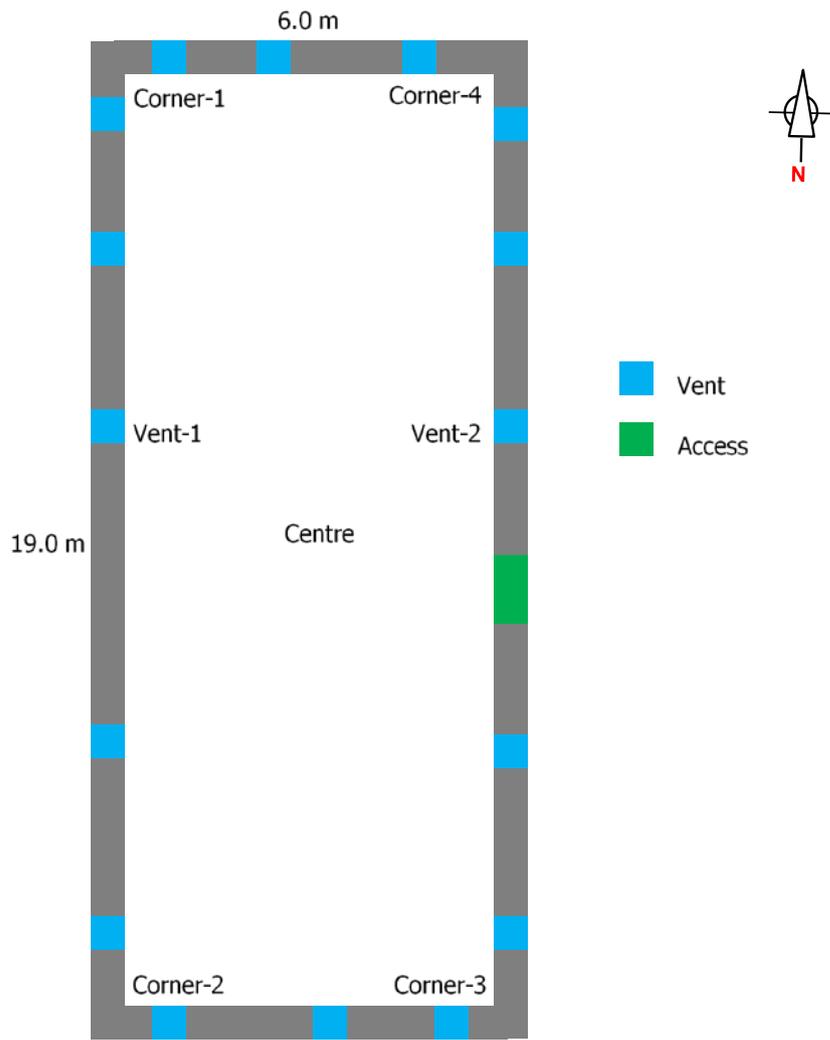
Figure 63. Dimensions of subfloor and sample arrangement of house 2.

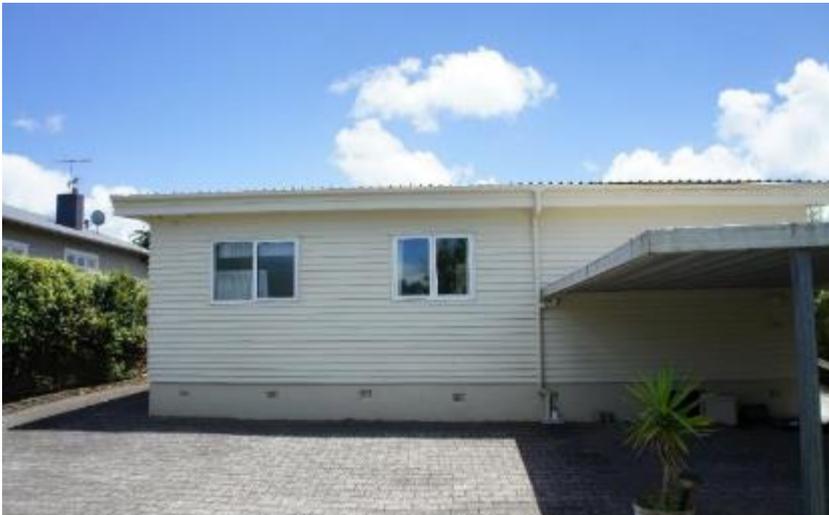
Figure 64. House 3 exterior.

Construction	Perimeter concrete foundation wall, weatherboard – see Figure 64 and Figure 65
Underfloor insulation	R1.5 polyester
Subfloor ground	Covered with black polyethylene sheet, soil was wet, underground water visible in trench along foundation wall in winter season
Configuration/dimensions	See Figure 66
Ventilation	13 vents (only for tested subfloor section) with a dimension of 160 × 100 mm – each has 20 holes of 25 × 15 mm
Testing arrangement	Steel samples and sensors were installed at seven locations as shown in Figure 66
Monitoring period	5 June 2013 to 5 June 2014

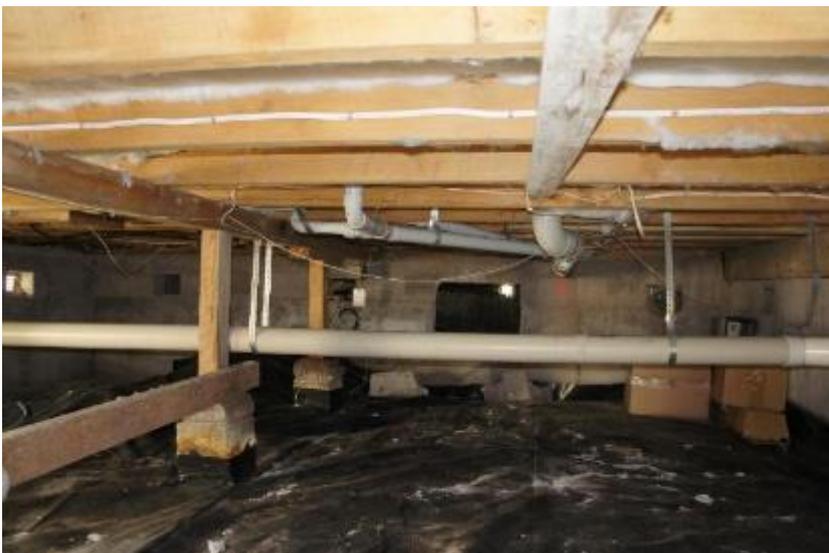
Figure 65. House 3 subfloor.

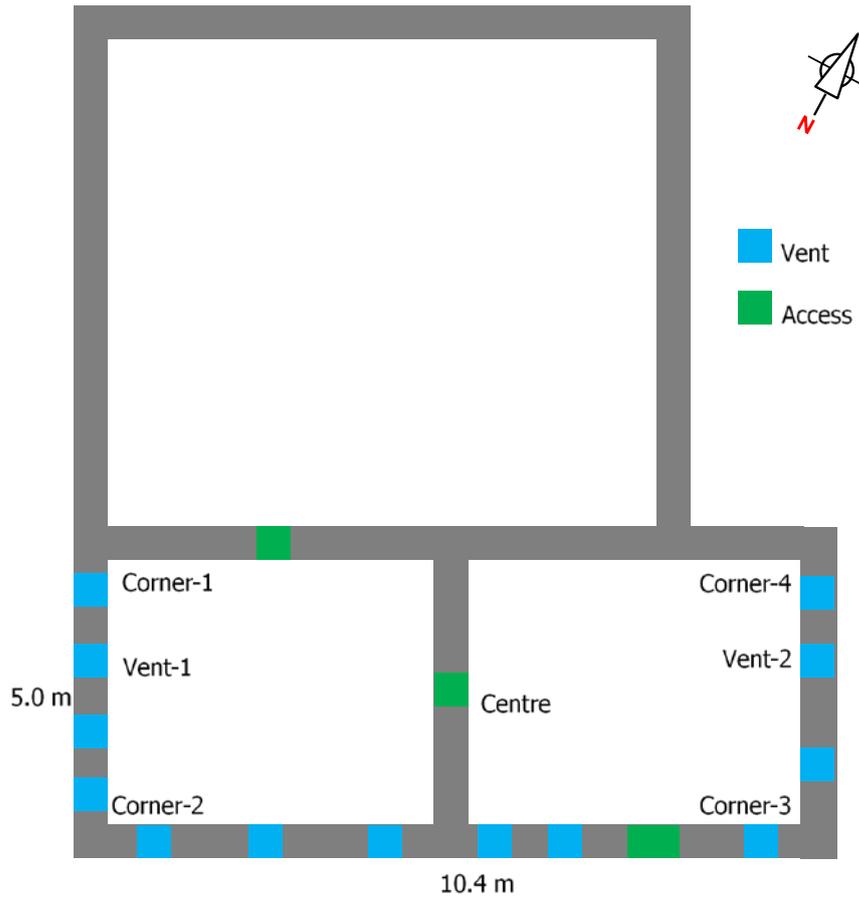
Figure 66. Dimensions of subfloor and sample arrangement of house 3.

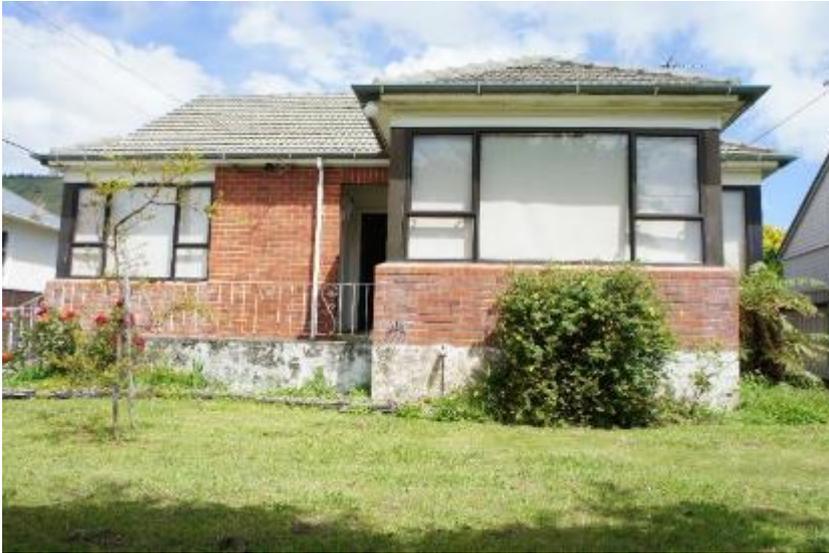
Figure 67. House 4 exterior.

Construction	Perimeter concrete foundation wall, brick veneer wall cladding – see Figure 67 and Figure 68
Underfloor insulation	R1.5 polyester
Subfloor ground	Covered with black polyethylene sheet
Configuration/dimensions	See Figure 69
Ventilation	19 vents in total with a dimension of 180 × 120 mm – each has 15 holes of 20 × 20 mm
Testing arrangement	Steel samples and sensors were installed at seven locations as shown in Figure 69
Monitoring period	20 May 2013 to 20 May 2014

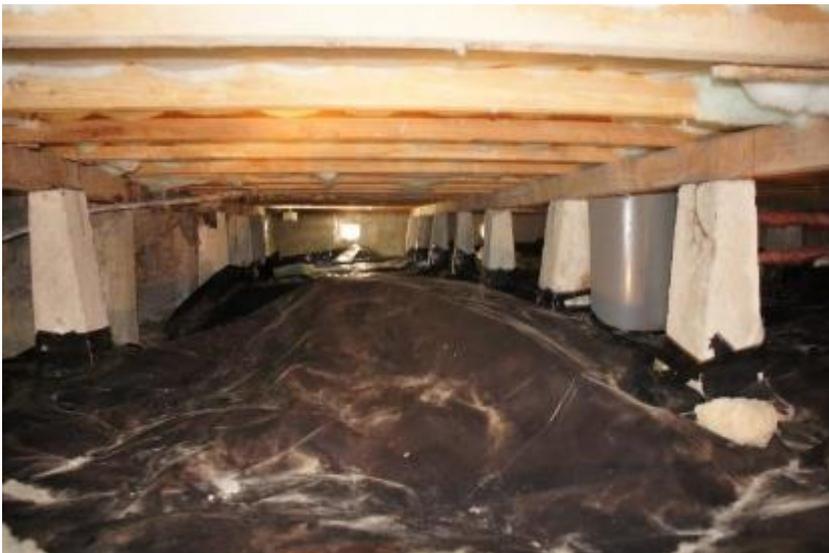
Figure 68. House 4 subfloor.

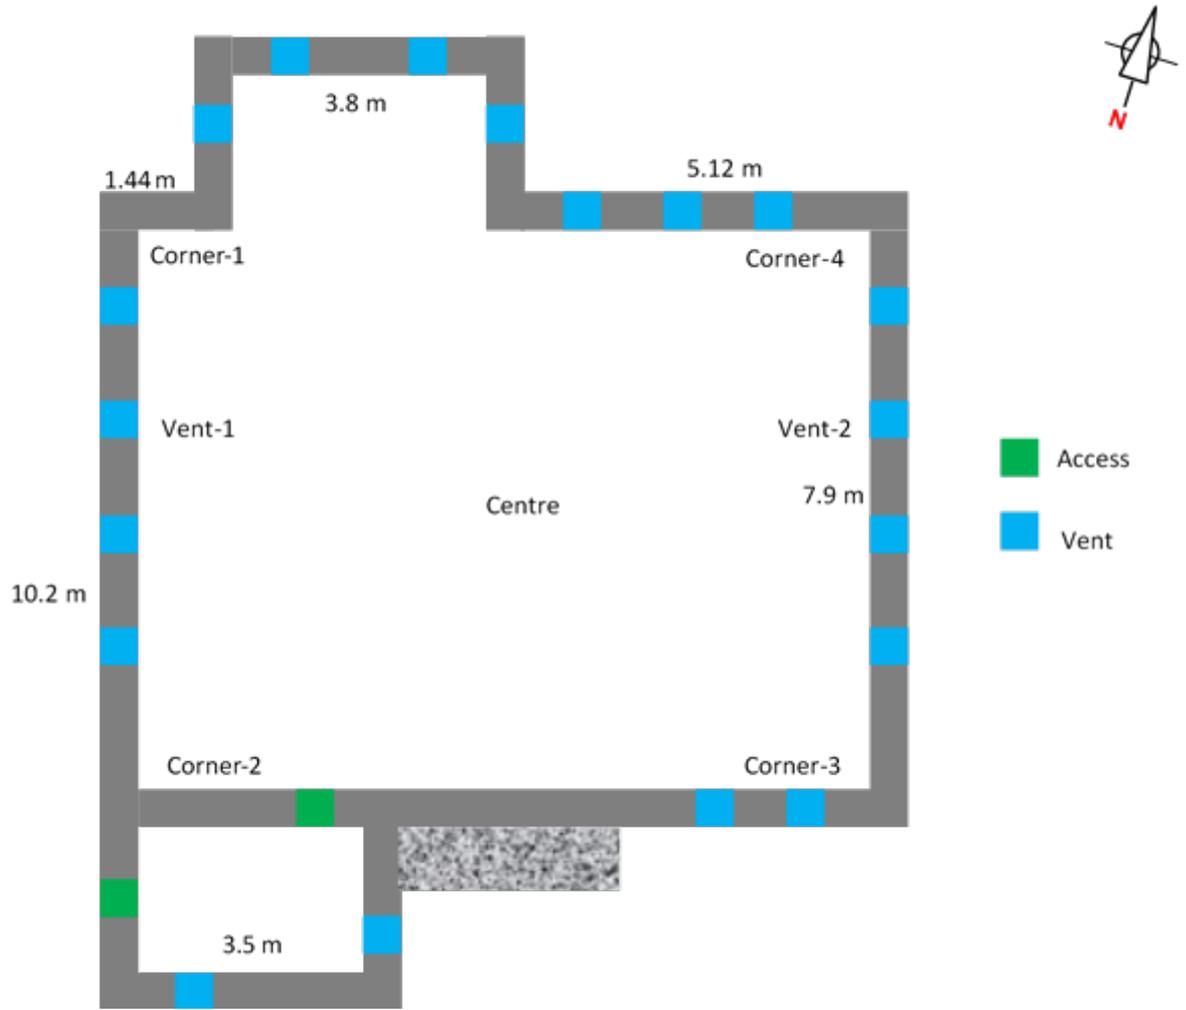
Figure 69. Dimensions of subfloor and sample arrangement of house 4.

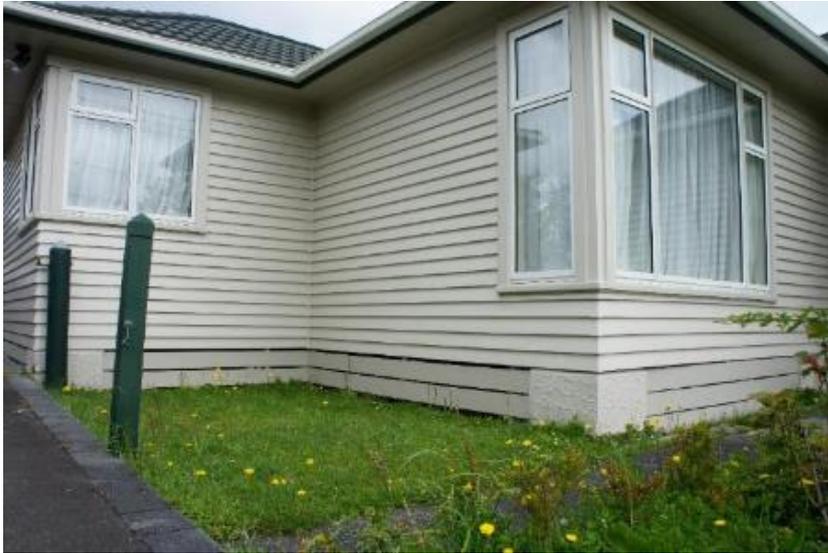
Figure 70. House 5 exterior.

Construction	Concrete corner with timber planks, weatherboards – see Figure 70 and Figure 71
Underfloor insulation	Polystyrene
Subfloor ground	Very wet (with water ponding in rainy season) and not covered
Configuration/dimensions	See Figure 72
Ventilation	10–15 mm wide gaps between timber planks
Testing arrangement	Steel samples and sensors were installed at six locations as shown in Figure 72
Monitoring period	1 August 2013 to 4 August 2014

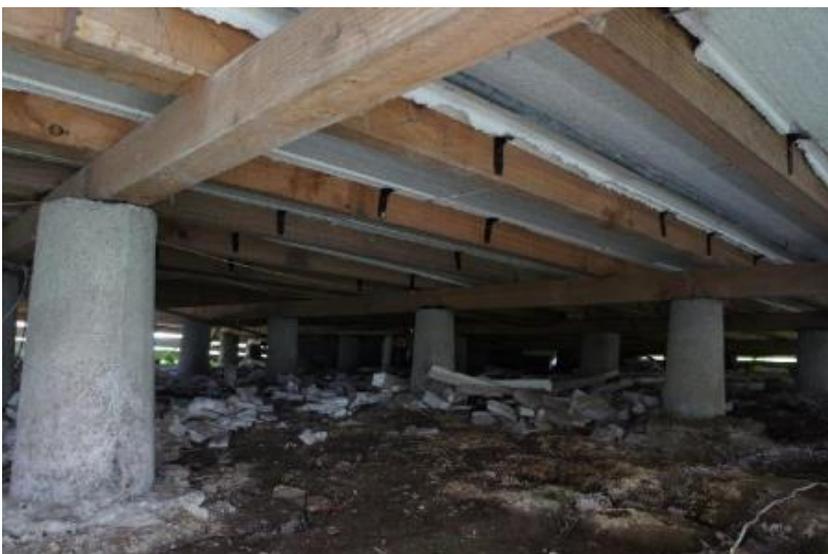
Figure 71. House 5 subfloor.

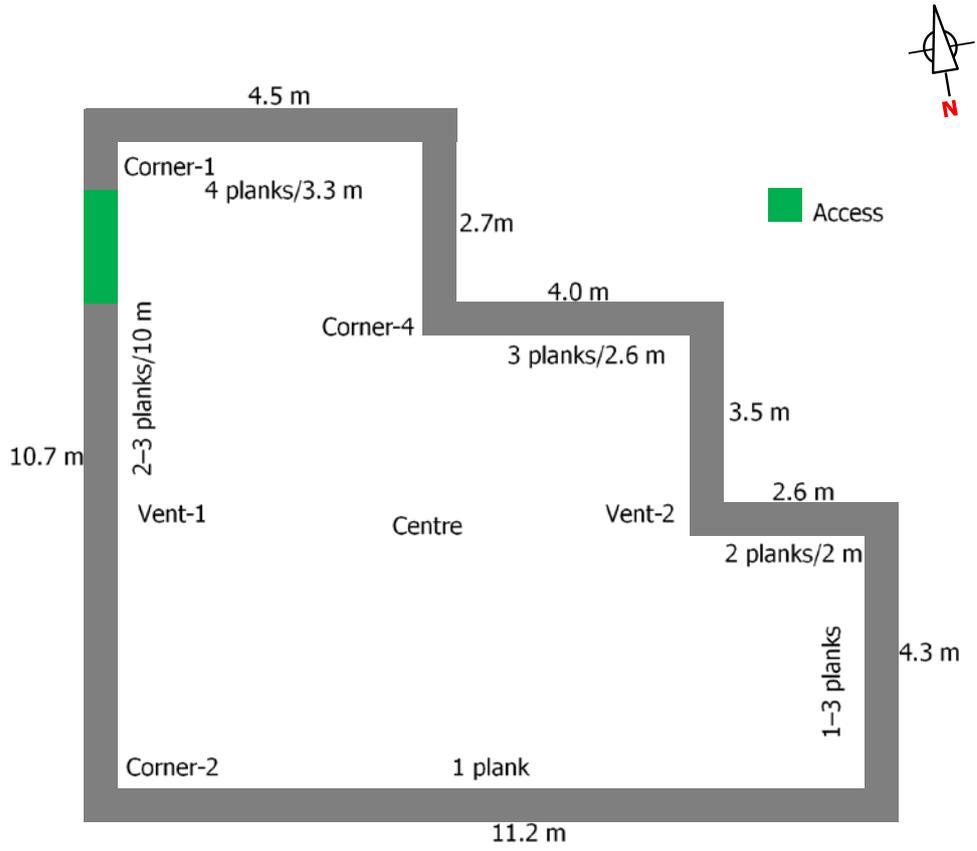
Figure 72. Dimensions of subfloor and sample arrangement of house 5.

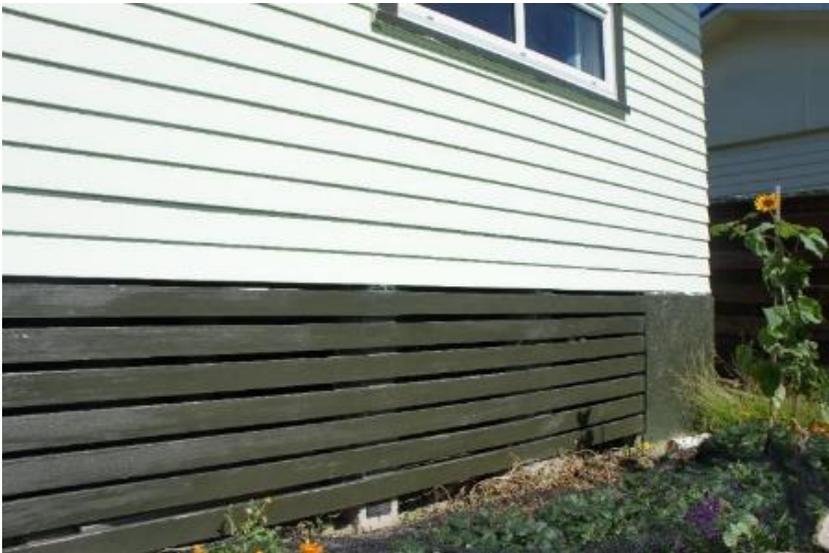
Figure 73. House 6 exterior.

Construction	Concrete corner with timber planks, weatherboards – see Figure 73 and Figure 74
Underfloor insulation	R1.5 polyester
Subfloor ground	Not covered but appeared to be dry
Configuration/dimensions	See Figure 75
Ventilation	~25 mm wide gaps between timber planks
Testing arrangement	Steel samples and sensors were installed at seven locations as shown in Figure 75
Monitoring period	3 August 2013 to 4 August 2014

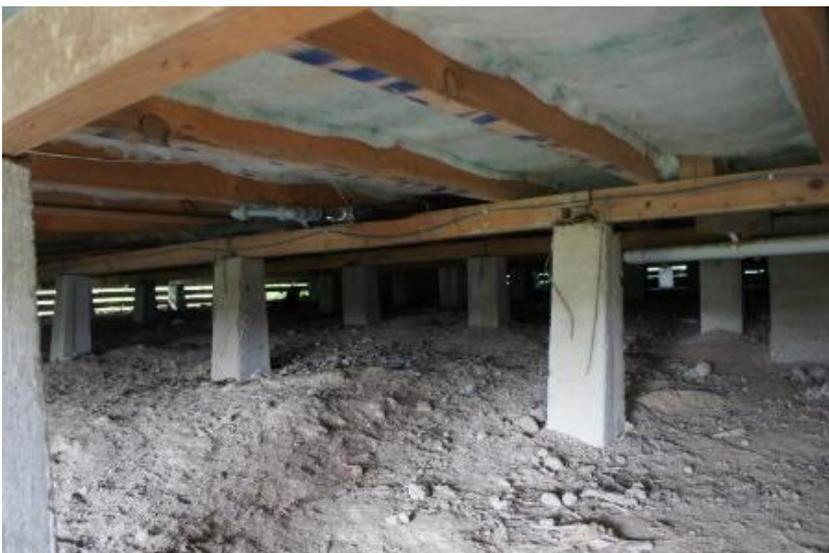
Figure 74. House 6 subfloor.

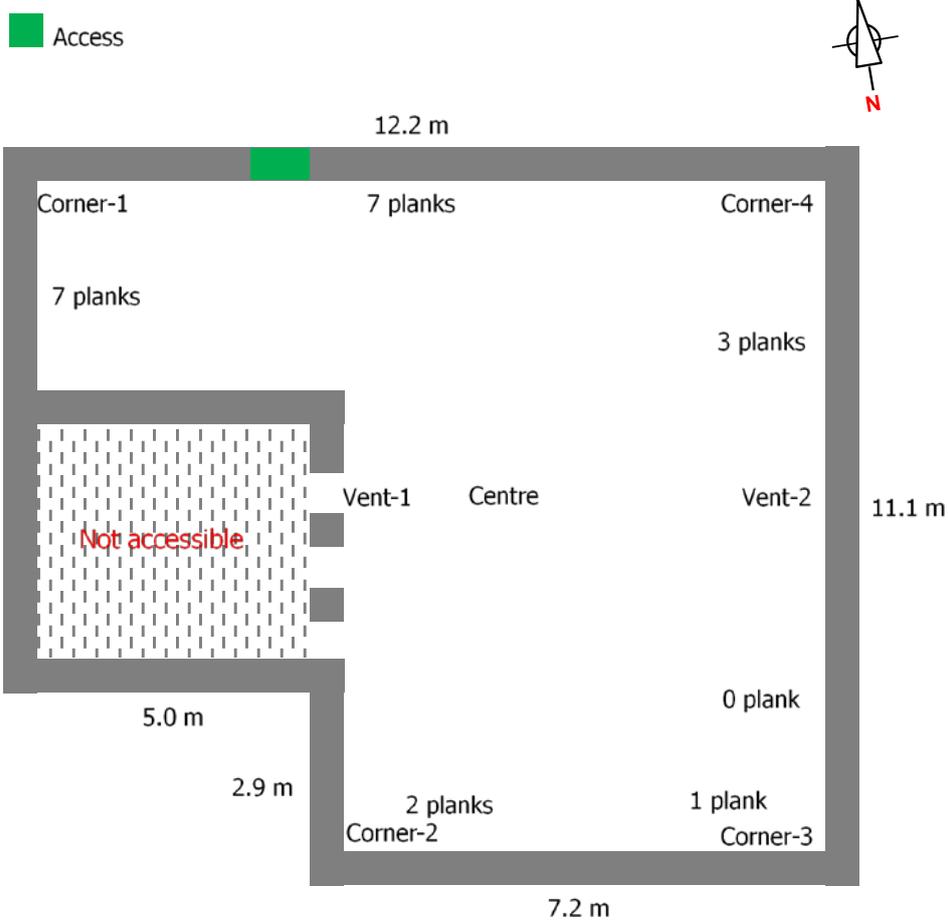
Figure 75. Dimensions of subfloor and sample arrangement of house 6.

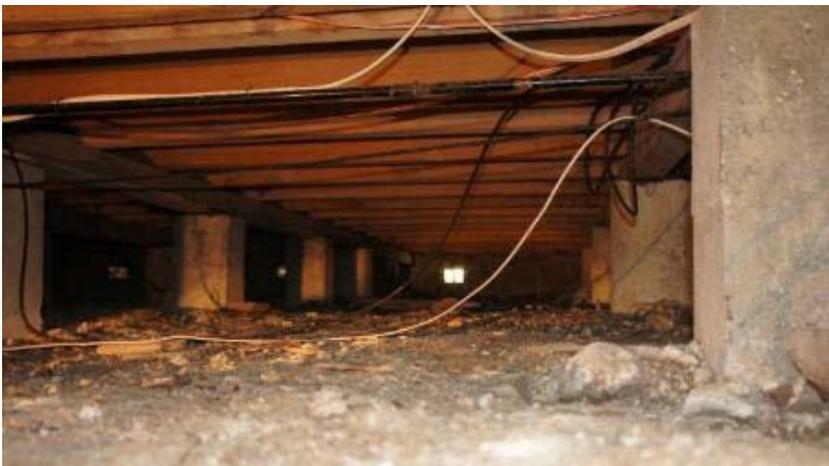
Figure 76. House 7 subfloor.

Construction	Concrete
Underfloor insulation	No insulation – see Figure 76
Subfloor ground	No ground covered and soil relatively wet
Configuration/dimensions	See Figure 77
Ventilation	~14 vents with a dimension of 130 × 200 mm – each has 10 holes of 80 × 10 mm
Testing arrangement	Steel samples and sensors were installed at seven locations as shown in Figure 77
Monitoring period	20 July 2013 to 19 July 2014

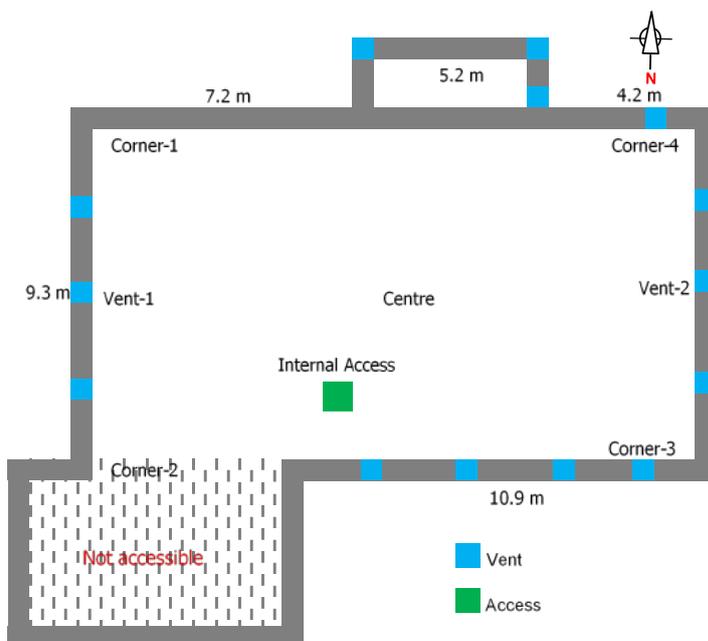
Figure 77. Dimensions of subfloor and sample arrangement of house 7.

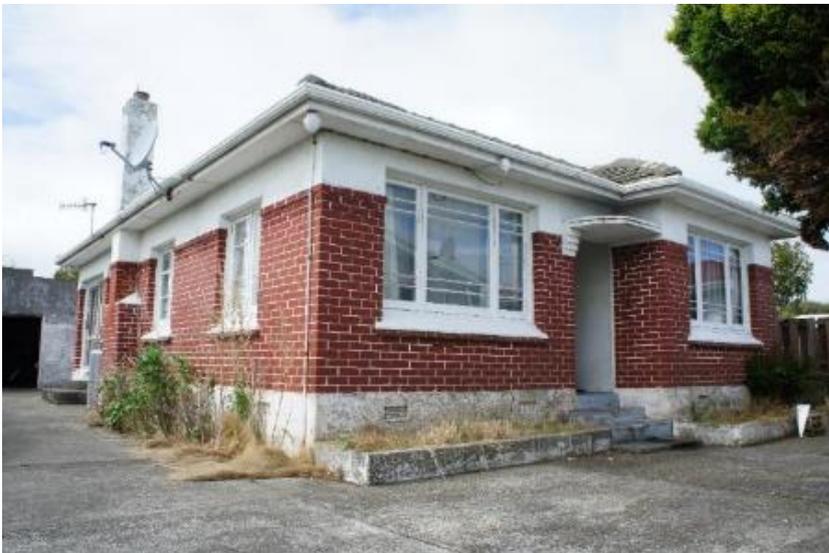
Figure 78. House 8 exterior.

Construction	Concrete perimeter foundation wall, brick veneer wall cladding – see Figure 78 and Figure 79
Underfloor insulation	No insulation
Subfloor ground	No ground covered, soil relatively wet on some parts while other parts appears to be relatively dry
Configuration/dimensions	See Figure 80
Ventilation	~20 vents with a dimension of 300 × 130 mm – each has 40 holes of 20 × 20 mm
Testing arrangement	Steel samples and sensors were installed at six locations as shown in Figure 80
Monitoring period	20 July 2013 to 20 July 2014

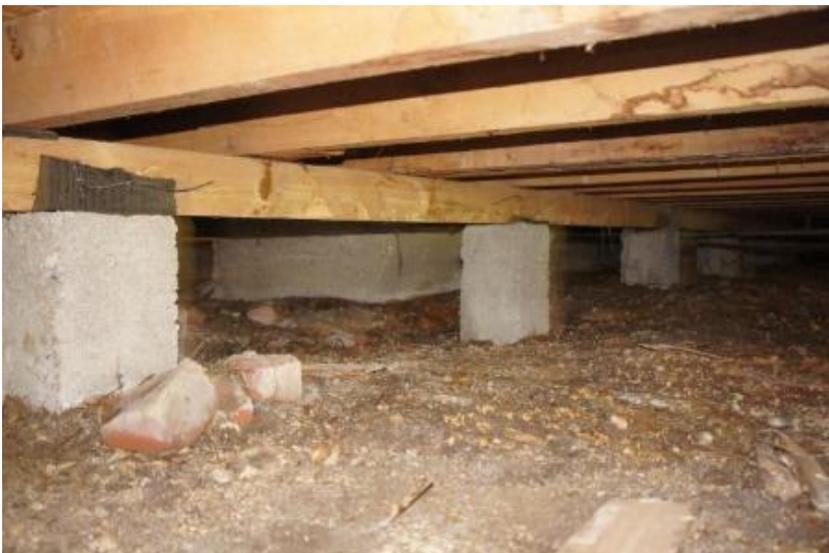
Figure 79. House 8 subfloor.

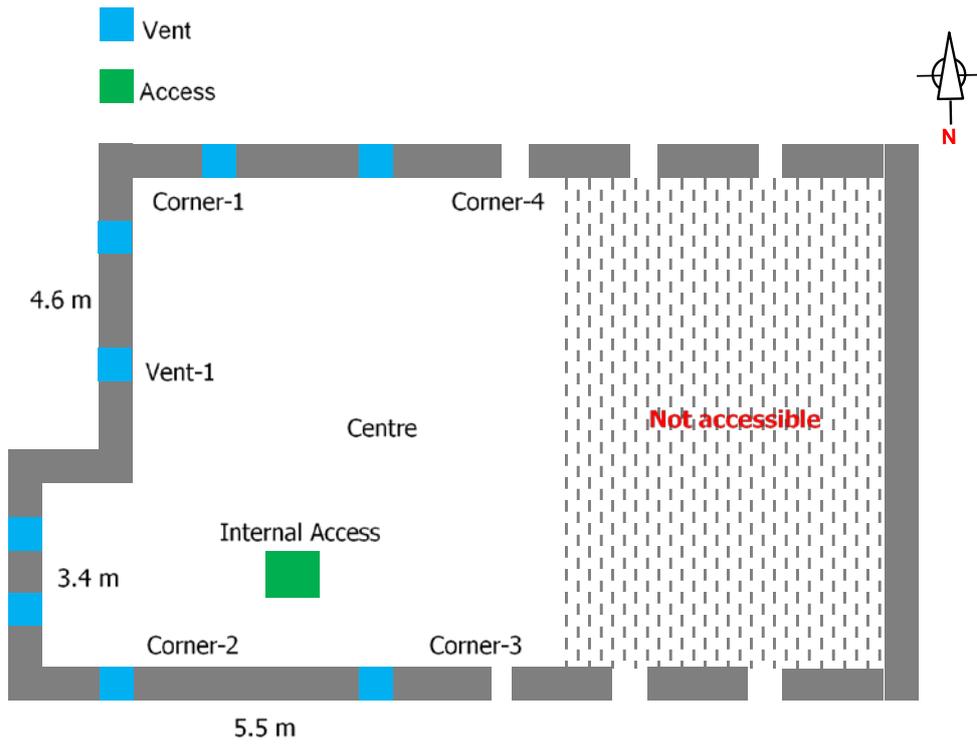
Figure 80. Dimensions of subfloor and sample arrangement of house 8.
