## THE RACKING BEHAVIOUR OF CURTAIN WALL GLAZING DURING SIMULATED EARTHQUAKE

A. B. King and S. J. Thurston

From Proceedings of the Tenth  
World Conference on Earthquake  
Engineering, 19-24 July 1992,  
Madrid, Spain

Building Research Association of New Zealand (BRANZ), New Zealand

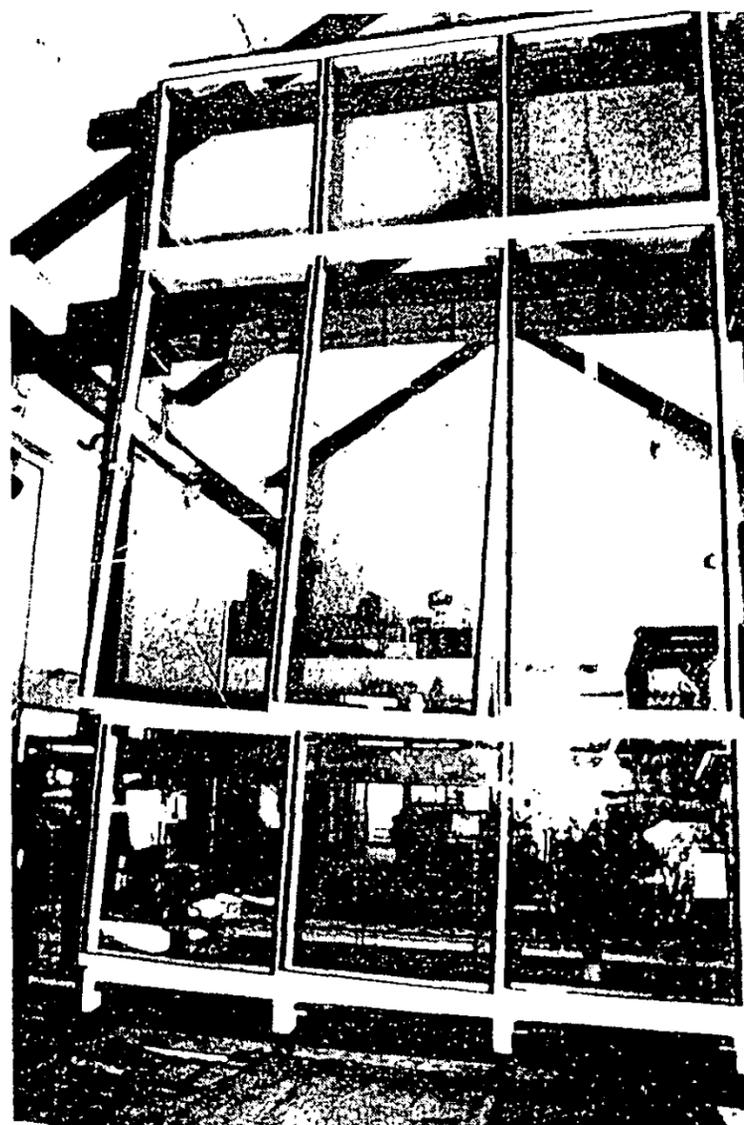
Figure 6: Four sided unitised panels.

The four-sided silicone panels were subjected to displacements in excess 80 mm (0.03H) without "failure". The shear distortion was accommodated by a combination of slip between the units, and relaxation of the support brackets. At high drift levels, the complete panels were observed to rotate (being eccentrically supported) at which stage the panels disengaged from each other (Figure 6). One of the glass panes developed a diagonal crack (within the upper half of the panel) as a result of out-of-plane distortion which occurred following this disengagement. The glass remained attached to the frame through the silicone and therefore did not fulfil the "failure" criteria.
