Study Report

SR370 [2017]

BRANZ 2015 House Condition Survey: Comparison of house condition by tenure

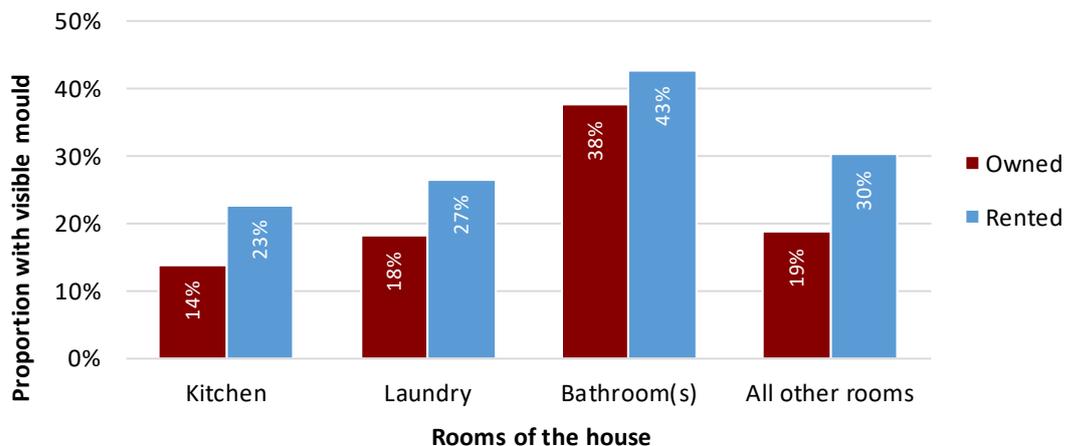
Figure 23. Mould visible in different areas of the house. (Source: HCS 2015)
